THE HISTORY OF BLACK MILL, ST MARTIN'S HILL, CANTERBURY

TANIA WILSON

Archaeological investigations of the Black Mill site

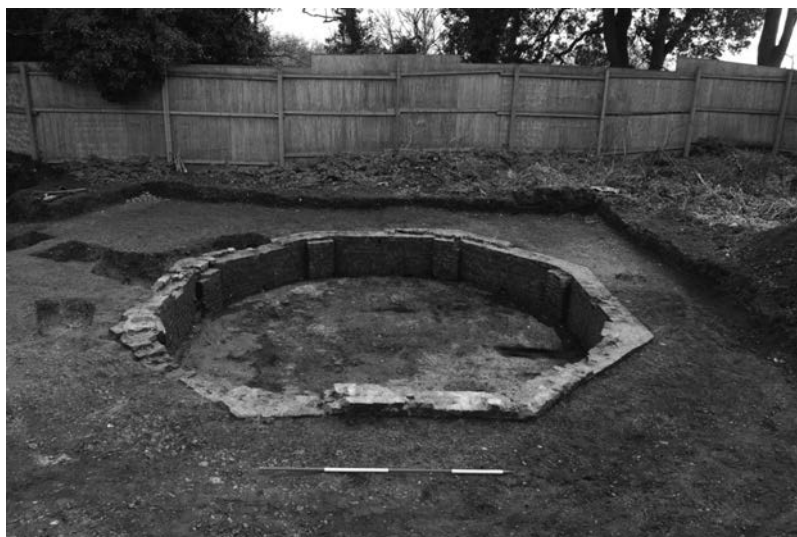
The remains of the mill base

The octagonal walls (**Fig. 2**) were constructed of red unfrosted brick, bonded with a grey speckled mortar. They were regularly coursed in a rough English bond and survived to a height of 0.95m. Internally, at the junction of each wall and bonded with the walls, was a series of buttresses (**Plate I**). Within the east wall, at the base, a deliberate gap was left in the brickwork which corresponded with the gravel-filled trench. The brick mill base had an external width of 6.5m.
