A ROMAN BATH-HOUSE AT LITTLE CHART, KENT

By JOHN EAMES

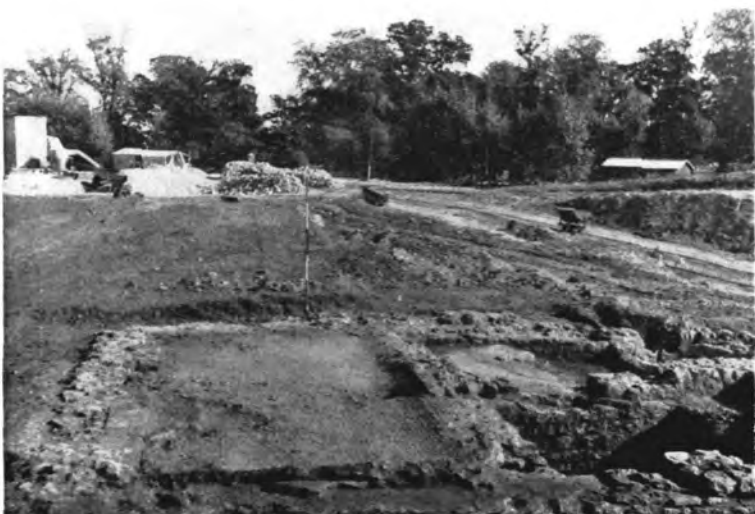
PLATE II

Apodyterium (A), *frigidarium* (B) and *tepidarium* (C), from the west.

No trace remained to suggest the position of the main entrance to the building, but reason demands that it shall have been in room A, which must have served on an *apodyterium*. The larger part of its floor of plain red brick tesserae, each 1 in. to 1½ in. cube, was undamaged though it lay up to 6 in. higher than the surviving level of the foundation walls. It had, however, owing to the subsidence of the filling beneath, assumed an evenly dished shape. The tesserae were bedded on a layer of hard, yellowish mortar some 3 in. thick, which in its turn overlay up to twice that depth of a softer mortar. Below this was a thin spread of mortar containing pulverized brick, perhaps the diluted surplus of the concrete underfloor in room B. The main body of the fill consisted of brown clay containing fragments and chippings of rag, the lowest layer of it, however, immediately above the rock floor, being of greenish clay and rather large stones.

The doorway into room C, the *tepidarium*, lay near its eastern corner and was marked by the bedding mortar of tesserae on a brick threshold. These were continuous with the floor of room B and the same paving of rag tesserae once ran without interruption through rooms, B, C and D. Whether C and D also had decorative patterns in the centre cannot now be determined. In this room also the tesserae were bedded on 3 to 4 in. of concrete, topping a builders' make-up similar in general character to that of room B.

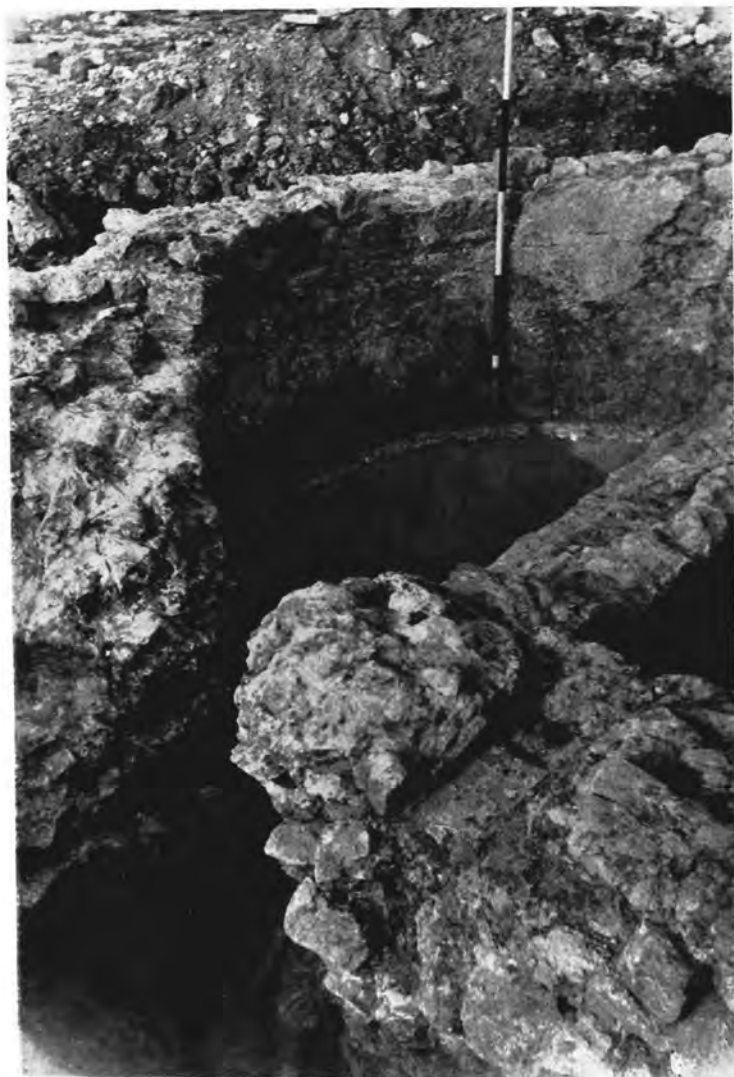
The apsidal bath of the *frigidarium*, showing (left, below) the period 2 drain of the bath and (above, in the foreground) the original drain of the *frigidarium* floor.

On the south-western side of the room was an apsidal plunge bath (pl. III), to which access was gained by two steps, the upper level with the floor of room 2 and paved with bricks, of which only fragments of the bedding remained, and the lower covered, like the risers of both steps and the walls of the plunge, with concrete about 1 in. thick, con-

Blockage or fracture of this drain made it necessary to open another, which was inserted into the eastern corner of the plunge. This was some 3 ft. below the level of the rock surface outside, and, to provide an outfall for the new drain, the natural rock and greensand were cut away from a point 14 ft. 3 in. from the east corner of the building, leaving the raw exterior face of the foundation wall exposed. This cut sloped down for 4 ft. 5 in. and then dropped into a gully which ran away in a south-eastern direction.

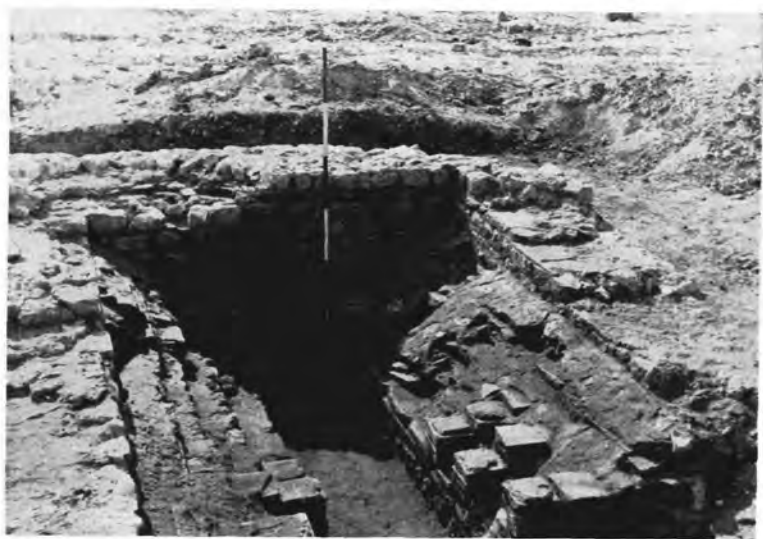
Calidarium (D) : the hypocaust, looking south.

The floor had been carried on a series of brick piers arranged in pairs down the length of the room. The distance between the two piers was

The piers themselves rested on two stepped ramps, 2 ft. 6 in. wide and running the full length of the room. The steps had been smoothed into a glacis with a covering of cement, which extended down to the top of the lowest riser. Between the two ramps and their piers the floor of the central channel of the hypocaust was of concrete, resting on a pitching of stones directly on the natural clayey sand.

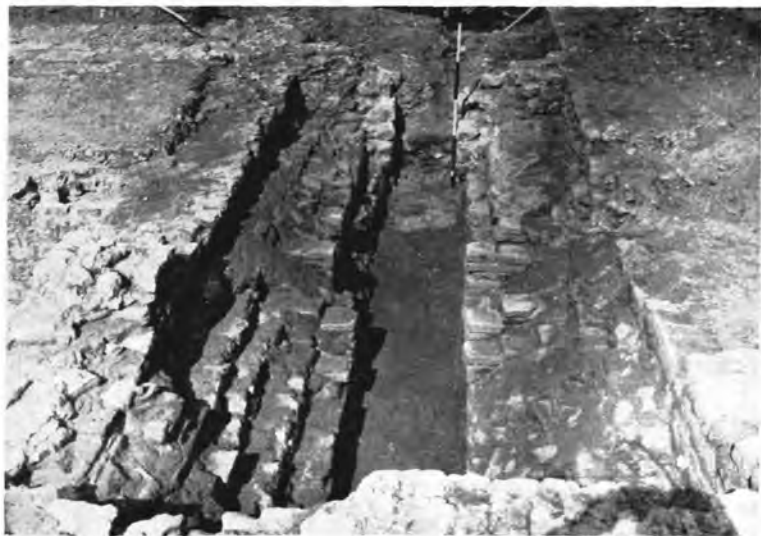
Calidarium (D) : the hypocaust, looking towards the stoke-hole (E).

The stokehole was an extension of the *calidarium* hypocaust, and was separated from it by brick-faced stub walls, carried forward as far as the full width of the benches and leaving a furnace arch of the same width as the central channel of the hypocaust. They served also to carry the main north-eastern wall of the building against which the pent-roof of the stokehole would have in all probability abutted.

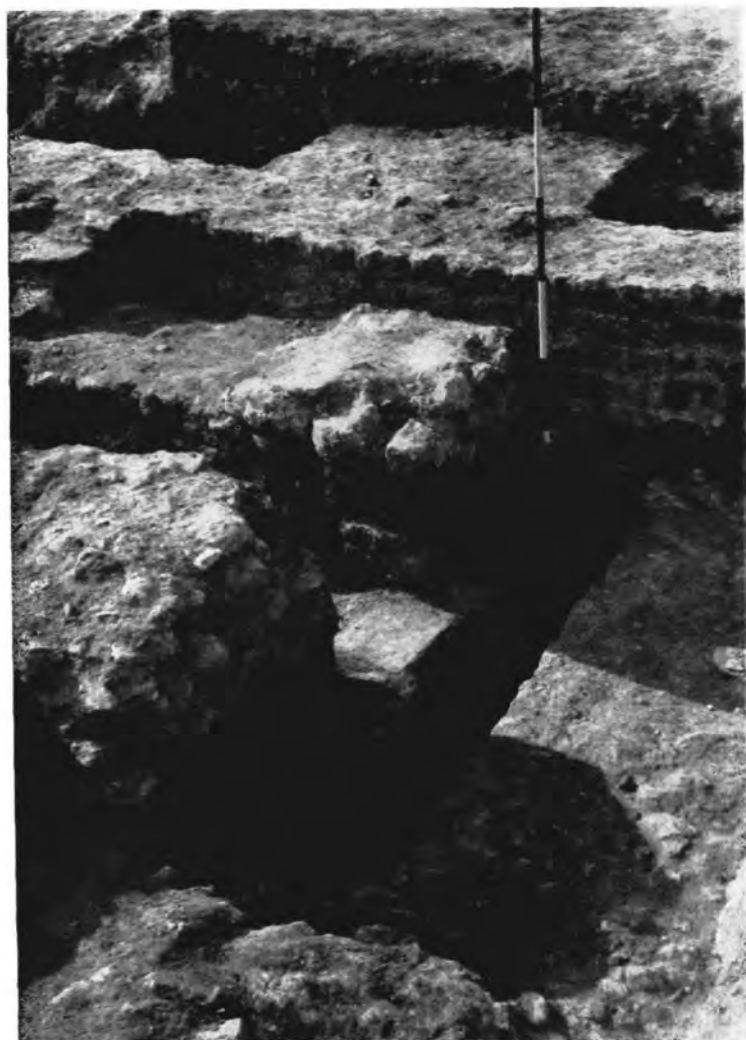
PLATE VI

The period 2 furnace. To the right of the pole can be seen traces of the demolished rear wall of the period 1 stoke-hole.

In order to increase the size of the furnace to cope with the extra demands made upon it by the addition of the apsidal tank, it was virtually doubled in length. The square furnace piers of period 1 were largely demolished and were replaced by two rectangular piers of rough rag masonry set in clay, with a core of rubble and earth. Where the new piers extended beyond those of period 1, they overlay 3 in. of ash which covered the earlier stokehole floor of rammed clay and fragments of rag topping a mortar fill over bed-rock. The concrete furnace floor was also extended with a paving of broken brick roughly set in mortar. A single whole brick was incorporated in the floor at the mouth of the furnace. The inner faces of the piers leaned irregularly towards one another and presumably enclosed the furnace in a roughly corbelled tunnel.

The resultant furnace structure would have almost filled the stokehole, which was, therefore, enlarged by demolishing its rear wall and most of that on the south-eastern side down to the floor level. Both these walls had in period 1 been built against cuttings in the natural, which was now quarried back beyond the limits of excavation, but, behind the stokehole, to a point which could be established by surface indications and a small trial hole to be 7 ft. 3 in. further back.

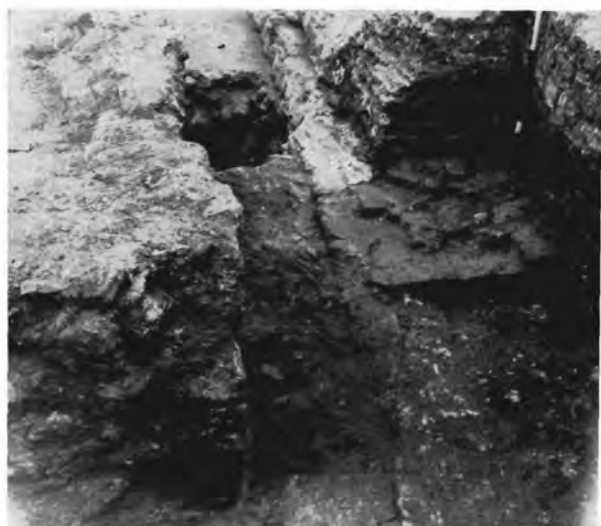
The furnace : period 2 structure removed on the right, revealing the remains of the period 1 furnace. Robber hole in the background.

The furnace itself was extended to nearly 5 ft. by building into the adjacent corners of the stokehole rectangular piers of mortared brick rubble, regularly faced with brick. The floor of the furnace was paved to the full extent of these piers with rectangles of broken brick, set on edge herring-bonewise in concrete, in four parallel rows. The junction of the furnace floor with that of the hypocaust had been destroyed by the robber hole.

The corrosion of the brickwork of the furnace arch eventually became sufficient to necessitate its replacement. The old brick facing and part of the rubble and mortar core were dressed back, further at the spring of the arch than at floor level where the lowest course remained untouched, and the whole archway was renewed in dressed rag.

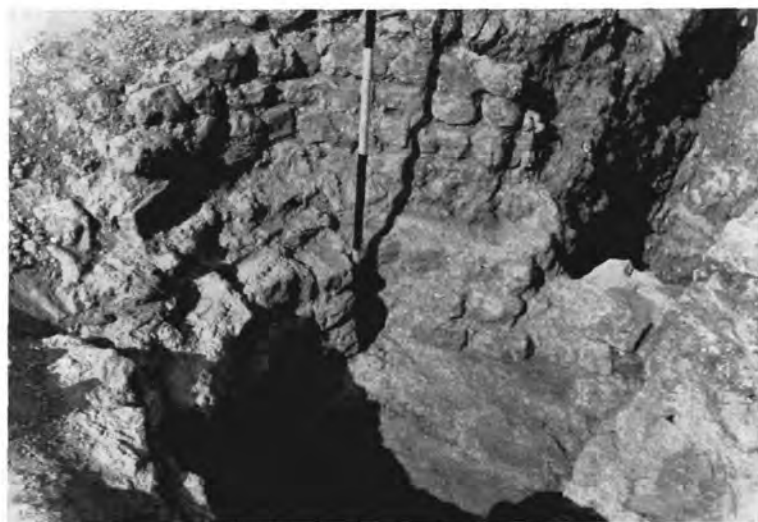
Apsidal tank, added in period 2 to the *calidarium*.

addition near the centre of the north-western wall of the *calidarium*. No trace of the tank, which must have stood at the floor level of the *calidarium*, remained. The hypocaust was heated with air borrowed from that of the *calidarium* by way of a channel roughly broken through the intervening wall. The roughness of the passage was partly smoothed by a patching of the sides of the channel.

The hypocaust had been built by excavating a roughly semicircular hole in the soil filling the gap of about 4½ ft. between the outer face of the *calidarium* and that of the natural. The rough rag masonry rose as a lining against the sides of this hole in a series of narrow steps, impinging at the rear of the hypocaust against the face of the natural itself. The apse wall above rested on the surface soil, sandwiching between itself and the rock surface, where it overlay the latter, a thin layer of period 1 surface soil.

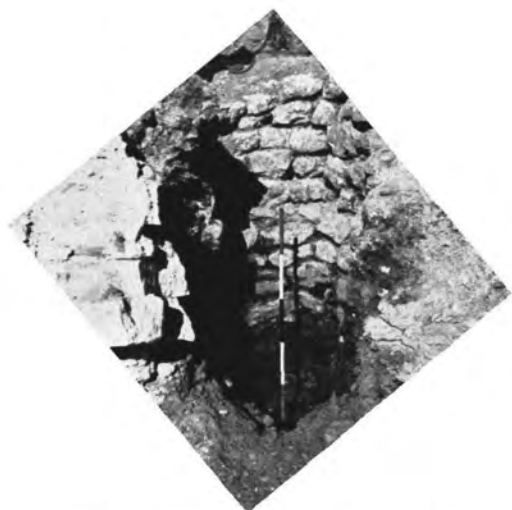
PLATE IX

The well, with steyning partly removed.

While excavation on the bath-house was in progress, blasting operations at the quarry face, at a point 82 yd. from the corner of the calidarium, exposed the outer face of the steyning of a cylindrical well.

The upper part of the well, to an estimated depth of 6 ft. 2 in. from the modern surface, had been swept away unobserved in the mechanical removal of the quarry overburden. The excavated portion, 10 ft. 6 in. deep and about 3 ft. 4 in. in diameter, had been quarried through the rock and lined with roughly squared, unmortared stones. Excavation was discontinued 2 ft. below the level of the quarry floor. These last 2 ft. were subsequently filled in; the upper part, discovered in the working face, has now been quarried away. A considerable depth remains untouched, for layers of reddish ash in the filling were depressed towards the centre of the well as much as 3 ft. below their outer edges.

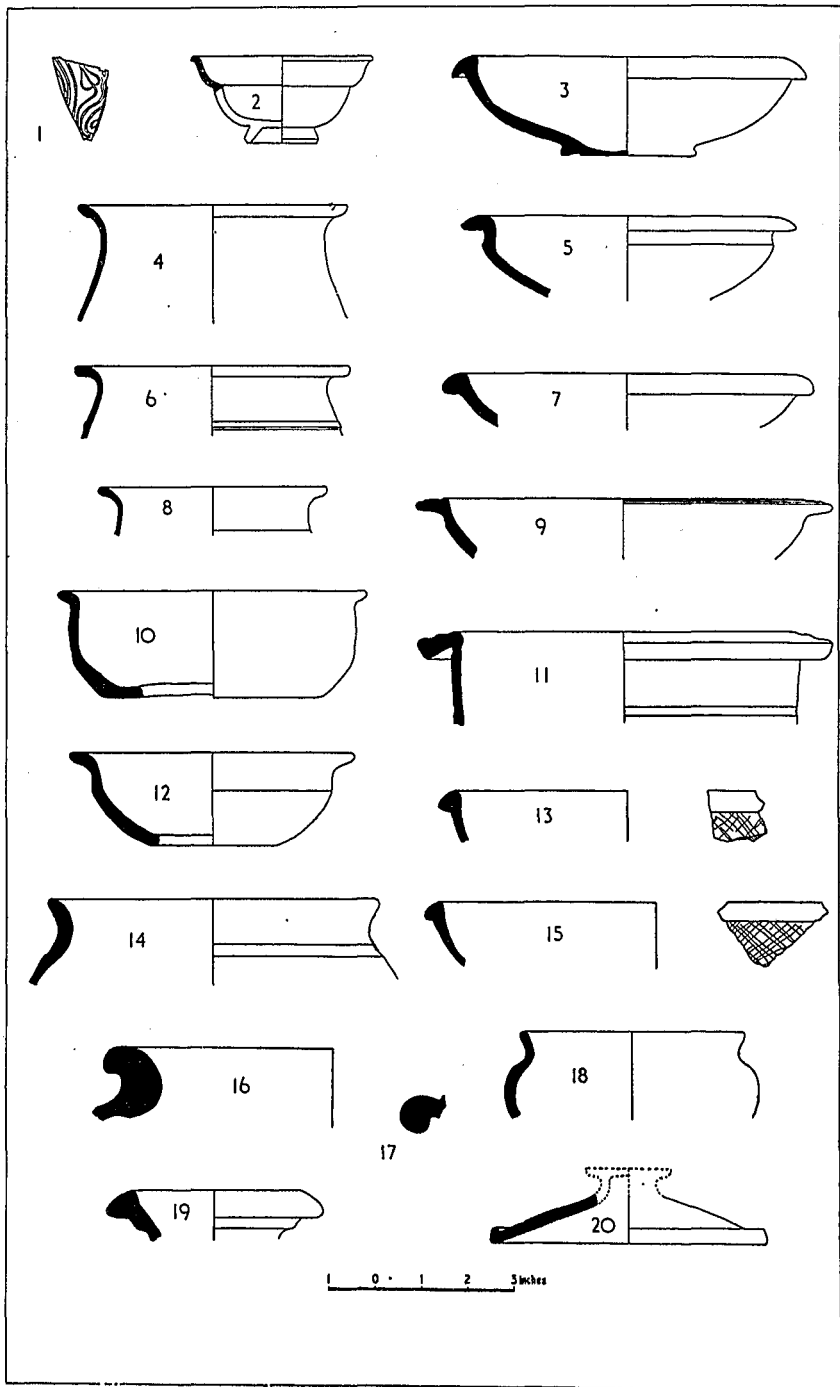
FIG. 5

THE POTTERY (Fig. 5).

Fig. 5 : 1. Form 30 Drag. Good pinkish-red glaze. Vine scroll with pointed heart-shaped leaf; double outline. Perhaps Claudius-Nero.

Fig. 5 : 2. Form 27 Drag. Dull, reddish glaze; overfired. Full bead-rim; perhaps a grooved foot-ring. Mid first-century.

Fig. 5 : 3, 5 and 7. *Bowls*. Well levigated, pale grey ware; black wash mostly disappeared. Terra nigra rarely occurs after Claudius.
