## INTERIM REPORT ON WORK CARRIED OUT IN 1993 BY THE CANTERBURY ARCHAEOLOGICAL TRUST\*

### EXCAVATIONS AND EVALUATIONS

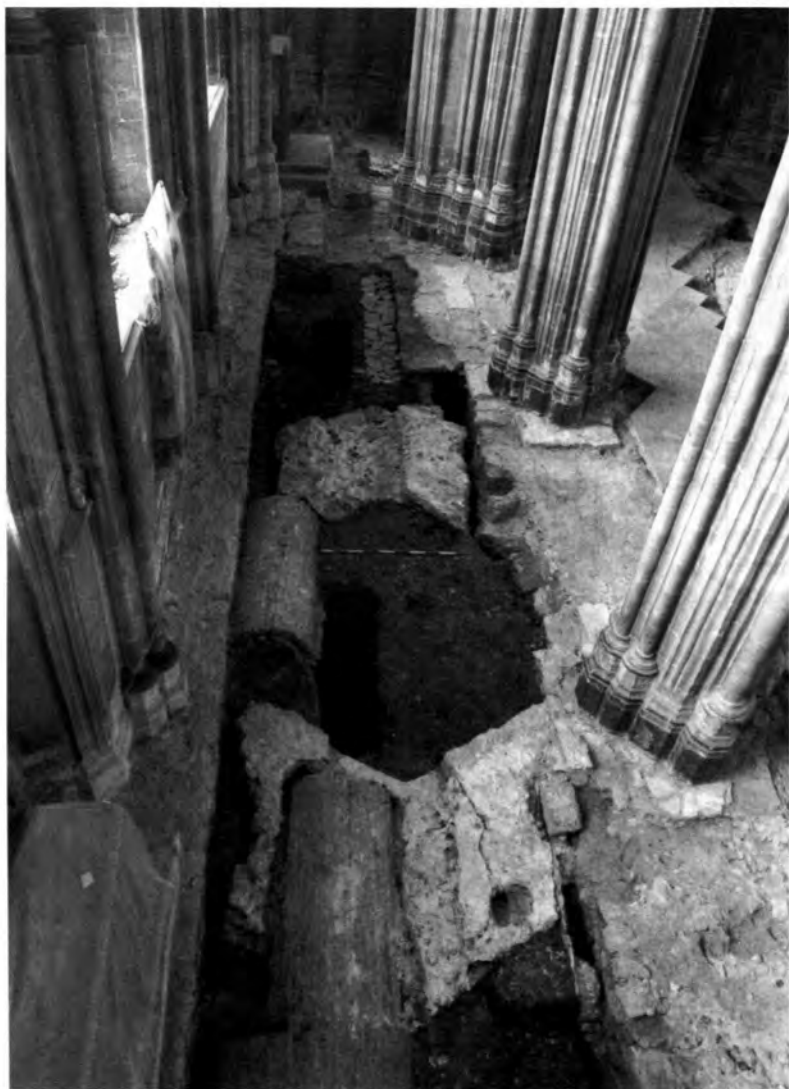
Canterbury Cathedral. South-west stair turret of the Anglo-Saxon Cathedral. Looking west. Scale: 2 m.

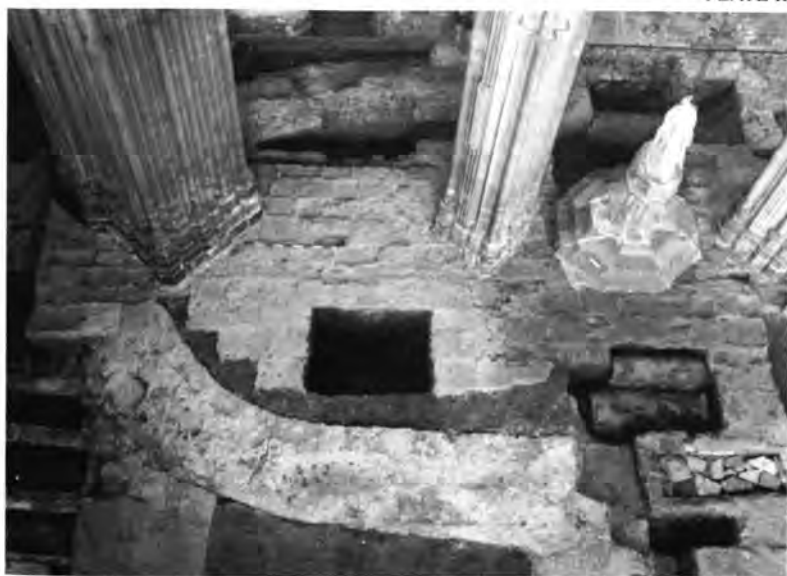
Canterbury Cathedral; Western Apse of the Anglo-Saxon Cathedral. Looking north.  
Scale: 2 m.

Phase V saw the demolition of the squared western end and its replacement with a major west-work (the Oratory of St. Mary). A substantial part of this west-work was uncovered in the excavations, in the form of a deep polygonal apse with flanking hexagonal stair-towers (Plate I). At the same time the arcade walls were strengthened and towers added to the eastern corners – one of which was located in the south-west transept. Parallels for Phase V are to be found in the Ottonian Romanesque churches of the tenth and eleventh centuries in France, Germany and Switzerland.

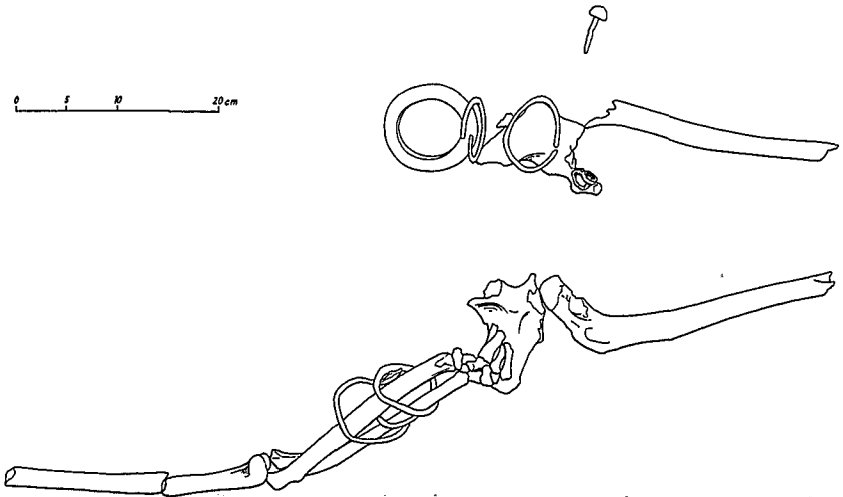
Fig. 3. Plan of the excavated burial showing the location of grave goods.

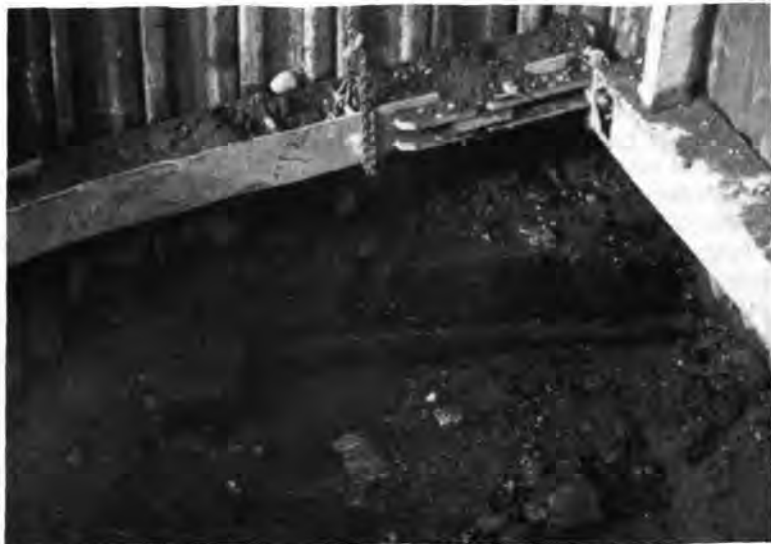
Dover, Bench Street, Roman Quay timbers. Looking north-east.

In a deep contractor's excavation at the junction of Bench Street and Townwall Street a short section of a large timber structure was exposed. This apparently formed part of a massive timber box framed harbour wall of typical Roman construction (Plate III). Two horizontal side timbers aligned roughly east-west formed the southern wall of the structure and horizontal cross-beams braced it laterally. The timbers were set within a construction trench 0.77 m. deep, but the upper parts of the structure had been subsequently removed, presumably by marine erosion. The surviving top of the timbers was at +0.559 m. O.D.

The structure is of a very similar build to a more extensive harbour wall discovered in 1855-56, off Dolphin Lane. The new discovery lay on roughly the same axis, but was located about 180 m. to the south-west of the previous find, on the other side of the present river. It clearly represents a completely separate and otherwise unknown harbour structure and greatly modifies our view of the extent of the Roman harbour works at Dover.

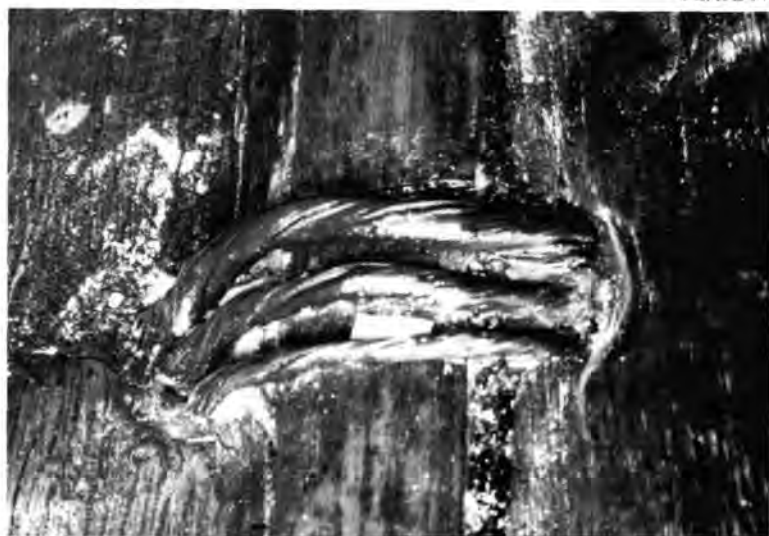
Dover Bronze Age boat. Detail of yew rope binding.

From its construction, the craft must have been the product of a master boat-builder working within a long established tradition. The two oak base planks were held together by transverse timbers passing through a pair of central longitudinal rails carved from the main base timbers. The side planks were held in place by individual stitches of twisted yew wood with moss caulking between the joints (Plate V).

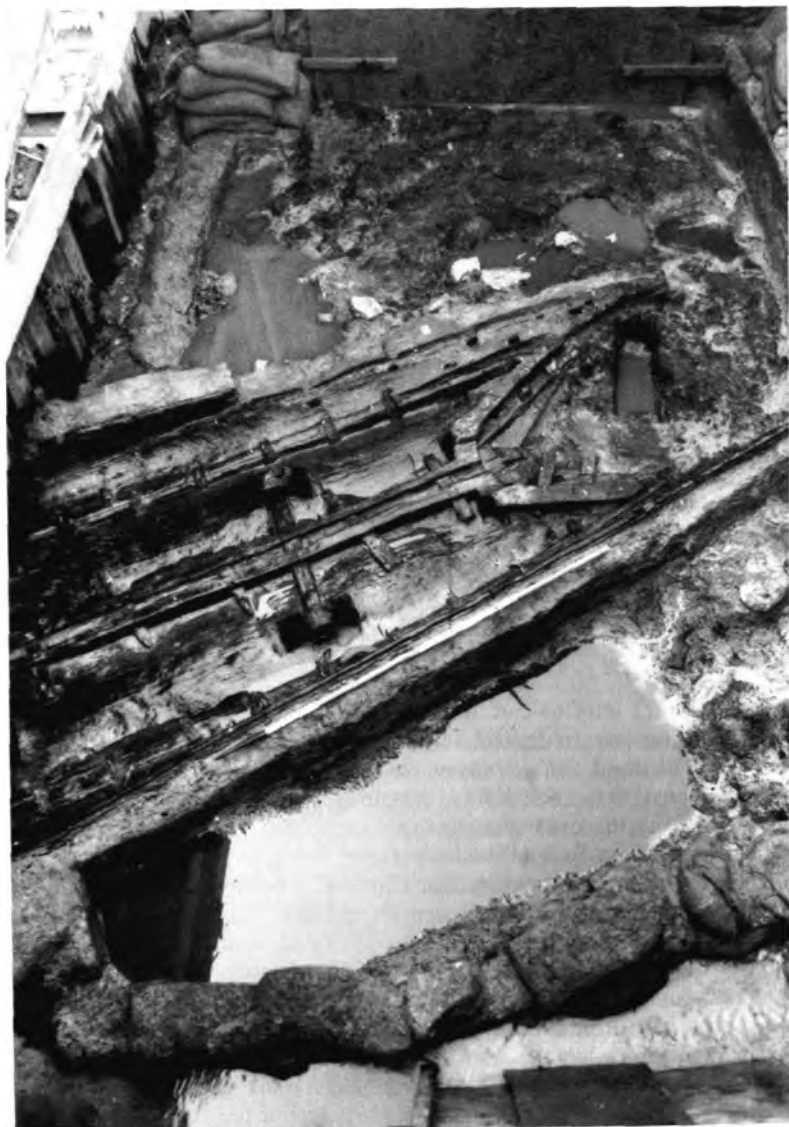
Dover Bronze Age boat. View of the southern end of the boat. Looking north east.  
Scale: 2 m.

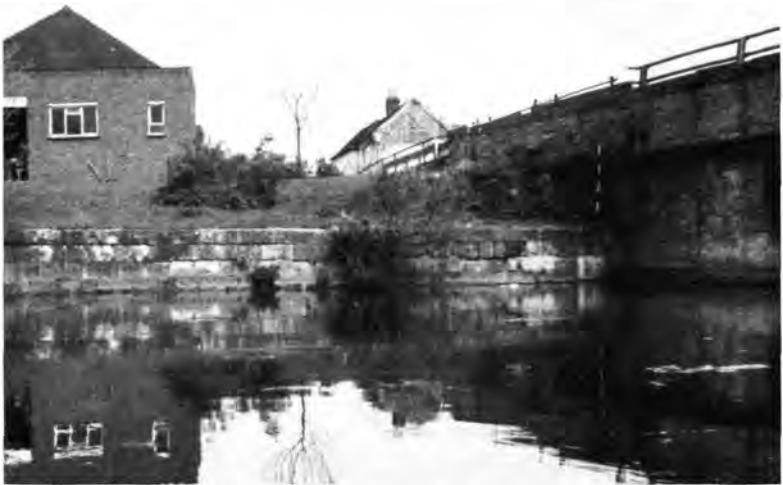
Hythe, Duke's Head Bridge. Looking east. Scale: 2 m.

The detailed recording of the bridge showed that four bridges had been erected at the Duke's Head site. The first of these was a timber swing bridge built in 1805. This original structure was replaced in 1808–09 by a static timber bridge with oak decking. By this date all 20 of the original bridges across the canal had to be rebuilt due to dilapidation and wear. By 1810, guard houses were required to be built against each bridge crossing the canal to prevent smuggling and to protect against wilful damage. These were manned by one non-commissioned officer and eight men. In 1813, a much larger and more substantial bridge was erected. This was constructed out of brick, with stone abutments. Contemporary records mention the presence of a crane located on the upper bank behind the wharf. The crane was originally installed to build the bridge, but was retained for the

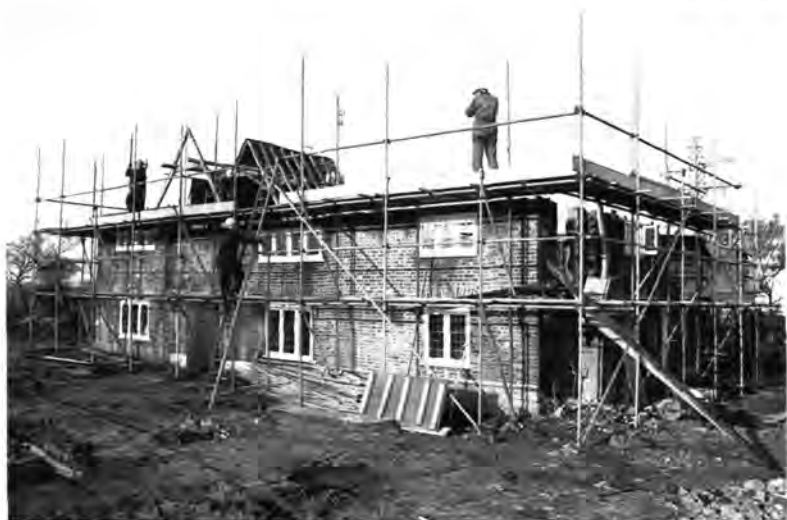
Longport House, Cheriton, during dismantling. Looking north-west.

Externally the house, which was entirely clad in later brickwork, did not appear at first to be of much interest. Once inside the building, however, a considerably longer and more complex history began to reveal itself. The first, and easiest, phase of the building to be identified was a mid sixteenth-century timber-framed cross-wing. This element, with clasped side-purlin and wind braced roof, was attached to the south-west end of the main range. Without further investigation it would have been natural to assume that the wing was a later addition to the main range. However, once later lathe and plaster had been removed, it became apparent that the arrangement was not so simple.

The cross-wing's former jetty was uncovered, buried at the junction with the main range. Clearly the main range, which now had to be a later phase, was built against the jettied exterior of the cross-wing.

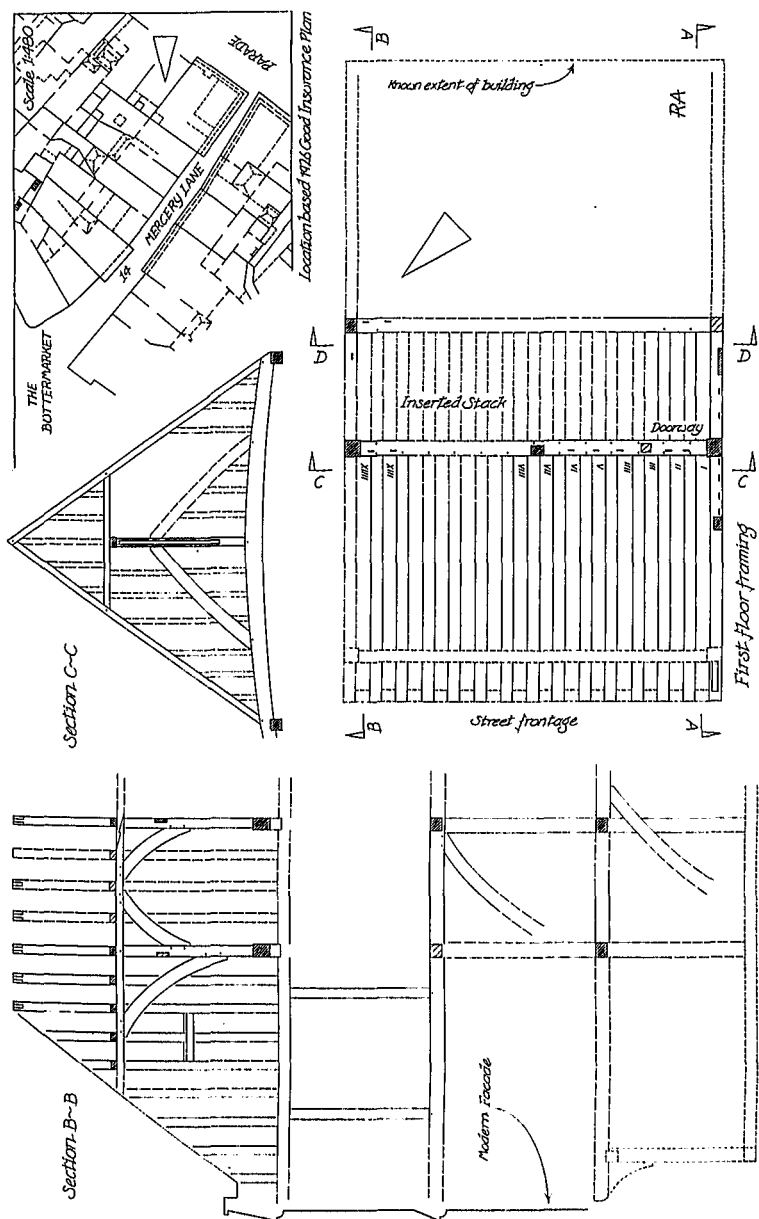
Fig. 12. 14 Mercury Lane, Canterbury; location plan and sections taken from the survey.

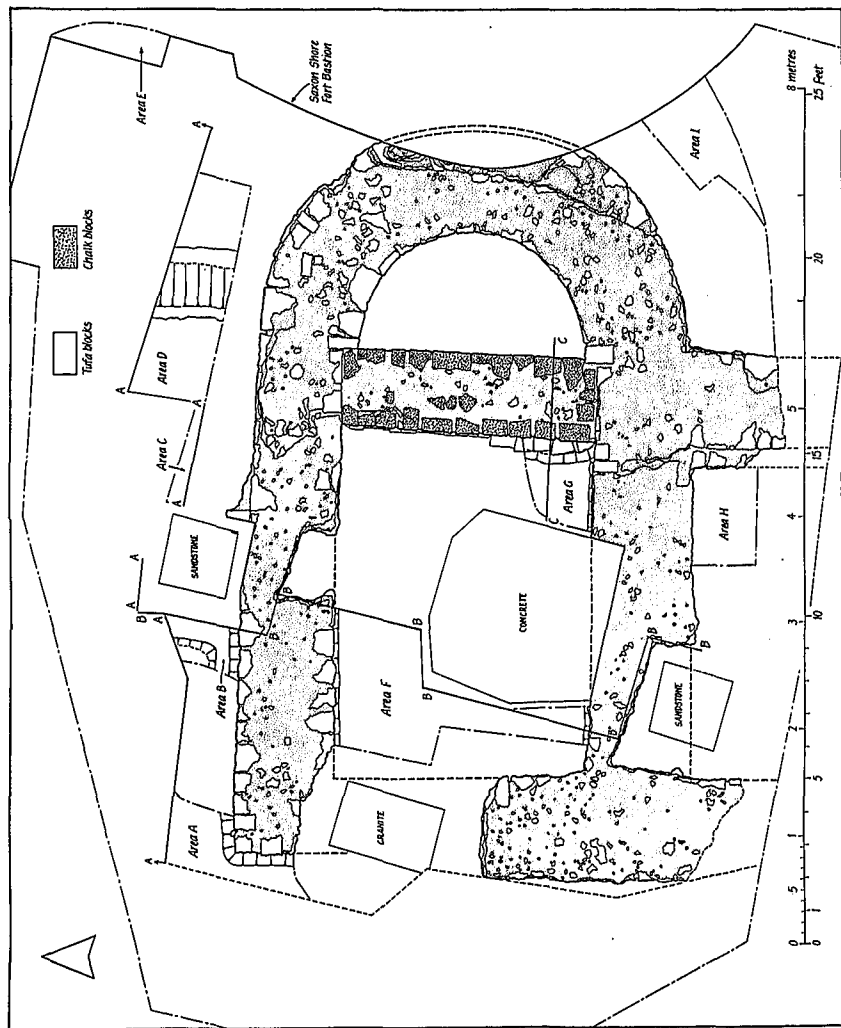
Fig. 14. Plan of the North Tower of the East Gate House of the Classis Britannica fort (II), Dover.
