## ST LEONARD'S TOWER: SOME ASPECTS OF ANGLO-NORMAN BUILDING DESIGN AND CONSTRUCTION

MICHAEL NORTH

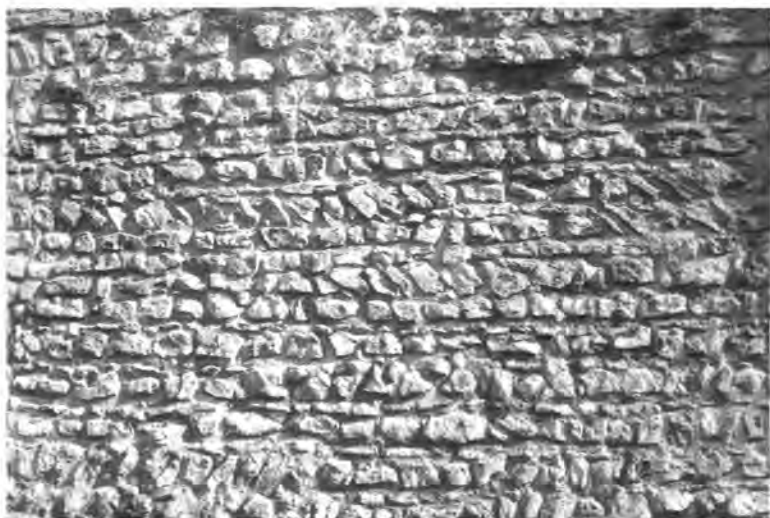
St Leonard's Tower: typical coursed ragstone walling (south face).

The tower is square in plan with thick walls of ragstone rubble interspersed with levelling courses of thinner masonry (**Plate I**) and plain, round-headed, tunnel-vaulted openings throughout. Calcareous tufa was used selectively for the ashlar work, with grey material used for internal surfaces which were presumably intended to be plastered, and white or cream-coloured material reserved for window dressings and quoins.

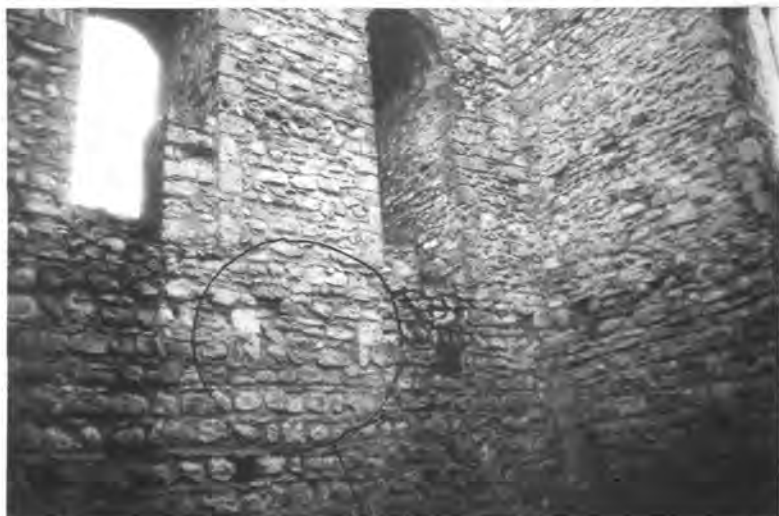
St Leonard's Tower: window seat and tufa brackets (circled).

The windows of the upper chamber are (more or less) parallel-sided, with deep, single steps to the inner sills and rebates for shutters. The openings are also high above the (first) floor level and are more numerous than in the basement: two in the east face and one in each of the north, south, and west faces. The north-eastern opening in the east face has a stone 'seat' built into the inner sill which tapers towards the outer end to allow the shutter to be opened or closed (**Plate II**). The feature is located above a blocked eastern entrance to the basement (see below) and might therefore have been used by a watchman or doorkeeper.

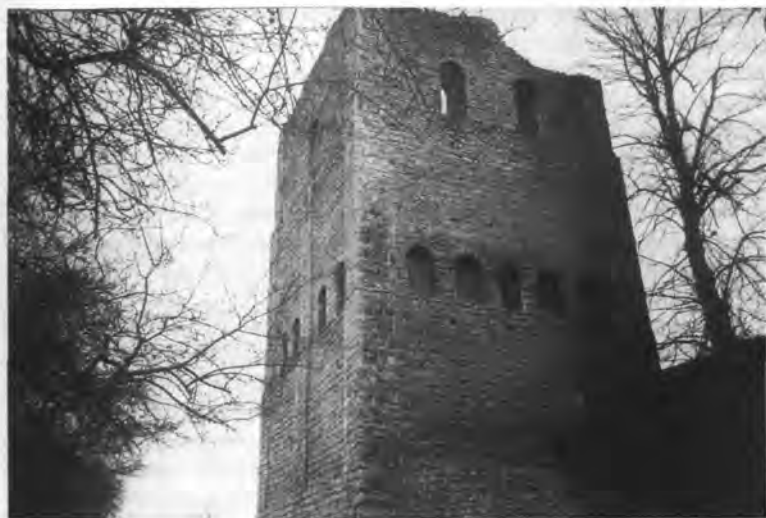
St Leonard's Tower: blind recesses in the south and east faces.

The tower is divided externally into three stages by slight offsets and tufa stringcourses marking the outer sills of the windows. The north-east, south-east, and south-west angles are clasped by pilasters, and a pilaster strip runs up the centre of the south face to the sill of the upper window. Decorative features are otherwise limited to rows of plain, round-headed recesses or niches articulating the south and east faces and incorporating the centred lower window opening in the east face (**Plate III**).

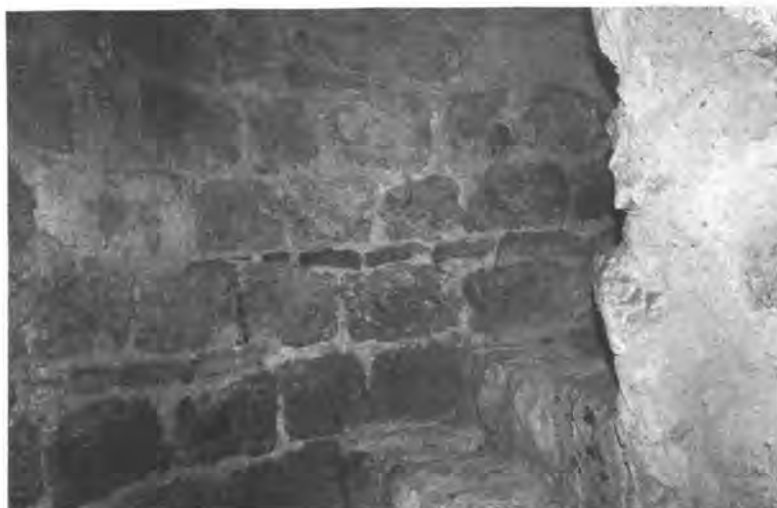
St Leonard's Tower: typical levelling courses in the vice wall.  
*Photograph: author*

Accurate construction of the stairway was partly dependent upon the construction of the vice wall, where 9in. courses were intended to correspond with, and thus regulate, the height of the treads.<sup>23</sup> The stairway, rising 15ft in one turn, should have reached a height of 22.5ft in the 1½ turns needed to coincide with the first-floor lobby in the north wall or 26.25ft in the 1¾ turns needed to make an exit in the west wall (i.e. above the ground-floor lobby). However, cumulative errors in the courses, which were adjusted periodically with thinner stones (**Plate V**), caused the stair builders to gain an extra 9in. in the first turn. Subsequent courses (and steps) settled down to a regular pattern but earlier errors were not corrected and the height of the lobby floor was then increased with an additional step to just under 23.5ft to compensate for the extra height gained by the stair builders.

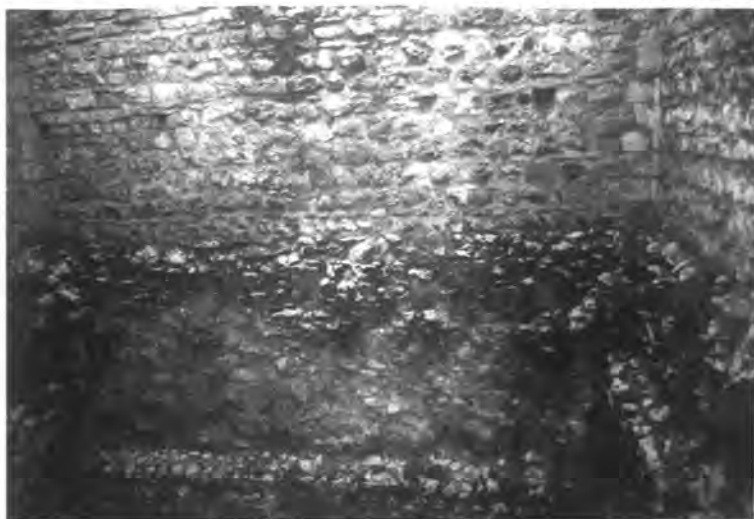
St Leonard's Tower: removed masonry at the internal offset level (south and west walls). *Photograph: author*

however, most of the material was removed systematically and evidently for a structural purpose. First, and because of the discrepancy between the height of the lobby and the offset, the latter was reduced in height in all four walls to a point below the level of the floor joists. Facing stones were then removed from the south wall, the removal terminating in a horizontal line at the level of the tops of the large beam sockets (**Plate VI**). A smaller socket at the south-west internal angle, corresponding with the bottoms of the beam sockets (i.e. the level of the stringcourse and the proposed springing level) suggests that facing stones were being removed to that level and that the work of removal was incomplete. In the opposite (north) wall the removal of facing stones was terminated at a slightly higher level (actually, 7.5ft below the offset) though a neat hole at the north-west internal angle again corresponds with the level of the stringcourse. In this case the hole penetrates the vice wall (which, as we have seen, almost touches the internal angle) at an open section of the stairway. It appears, then, that the vaulting work was abandoned at this point, firstly because a vault would have encroached into the stairway, and
