NEWBURY FARM, TONGE: KENT'S EARLIEST KNOWN AISLED HALL HOUSE

RUPERT AUSTIN

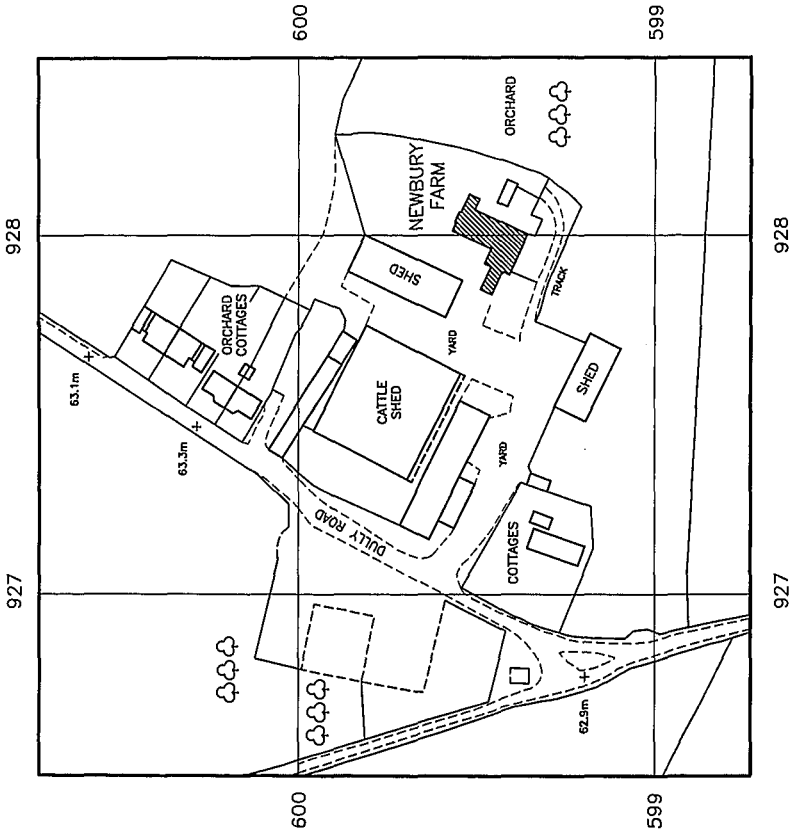
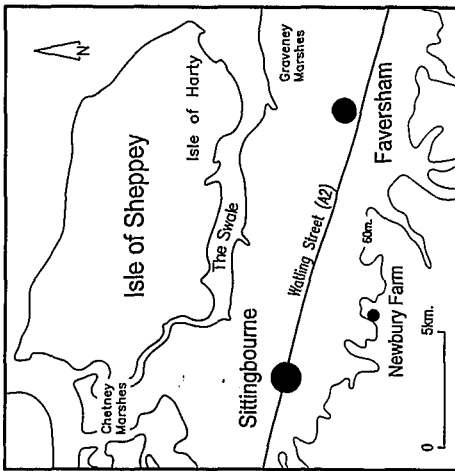
Fig. 1 Location and site plan. Location based on Ordnance Survey Data Licence No. 52855A.

Newbury Farm is located in a rural setting 3 miles to the south-east of Sittingbourne. The farmhouse lies to the rear of a group of modern estate cottages and agricultural buildings fronting Dully Road and is a Grade II* listed building (**Fig. 1**). It is the only historic building that survives within the farmstead. The property contains the remains of one of the earliest timber-framed aisled hall houses in the country and the only known dated example of this period in Kent. A substantial two-storey stone cross-wing was added to one end of the hall in the late thirteenth or early fourteenth century. Both cross-wing and hall were extensively modernised during the sixteenth and seventeenth centuries and again in the nineteenth century (**Plate I**).

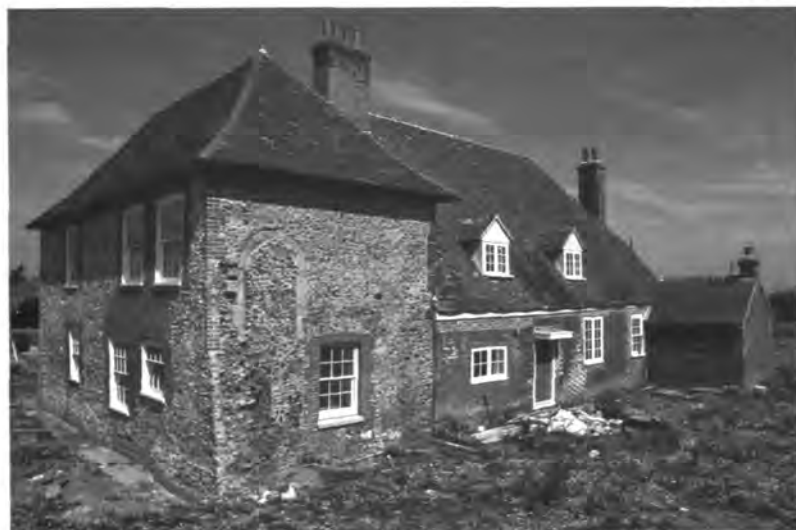
General view of the exterior of Newbury Farm, looking north-west

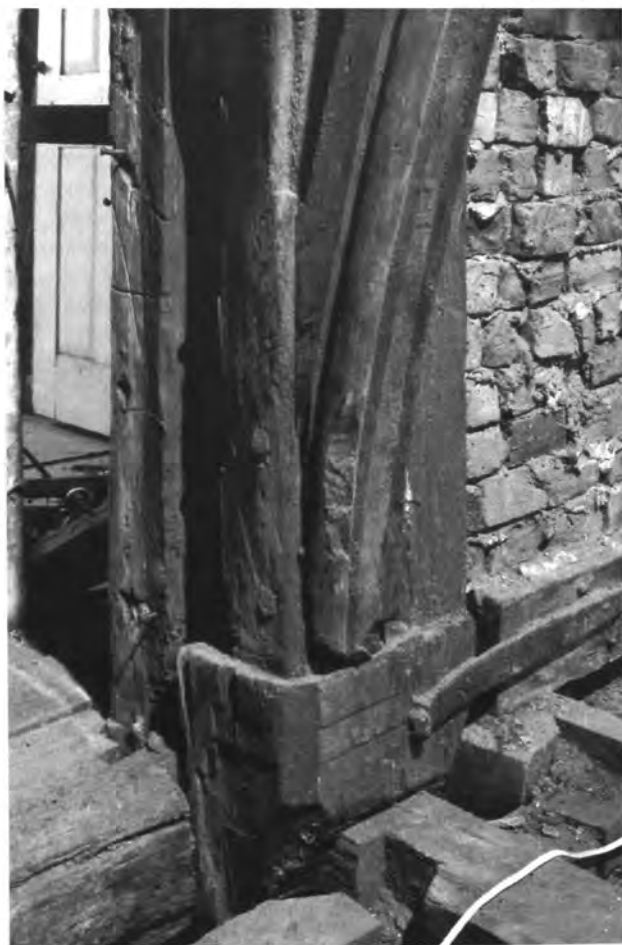
Central truss arcade post, looking north-east

Eight timbers from the central truss of the open hall survive within the building (**Fig. 3**). These include the east arcade-post, the west arch-brace and its spandrel strut, a tie-beam and an intact roof truss. The arcade-post is certainly the most substantial of the surviving timbers (**Plate II**). At ground level below a carved capital this post is of octagonal section. Typically for an early building the arcade-post is not jowled but has a rear upstand that passes behind the arcade-plate, a feature that is common to nearly all the members of the group.⁷ Evidence for the east aisle of the hall, in the form of two empty mortices, can be seen on the outside face of the post. The first mortice lies below the capital and is for an aisle-tie. The second, for an aisle-brace, is approximately 100cm above the capital.

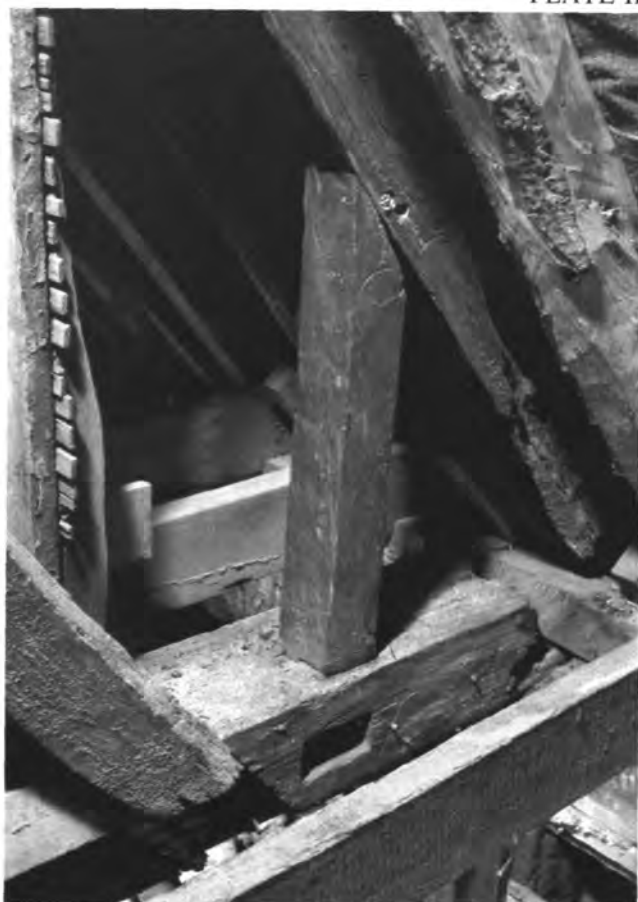
PLATE III

East end of central tie-beam, looking north showing cornice-plate mortice and ashlar piece

A flat uncambered tie-beam spans the central truss of the hall. Barefaced dovetails with square housed shoulders secure the ends of this tie-beam to the arcade-plates. Empty mortices for the hall's cornice-beams can be seen on the ends of this timber (**Plate III**). Two arch-

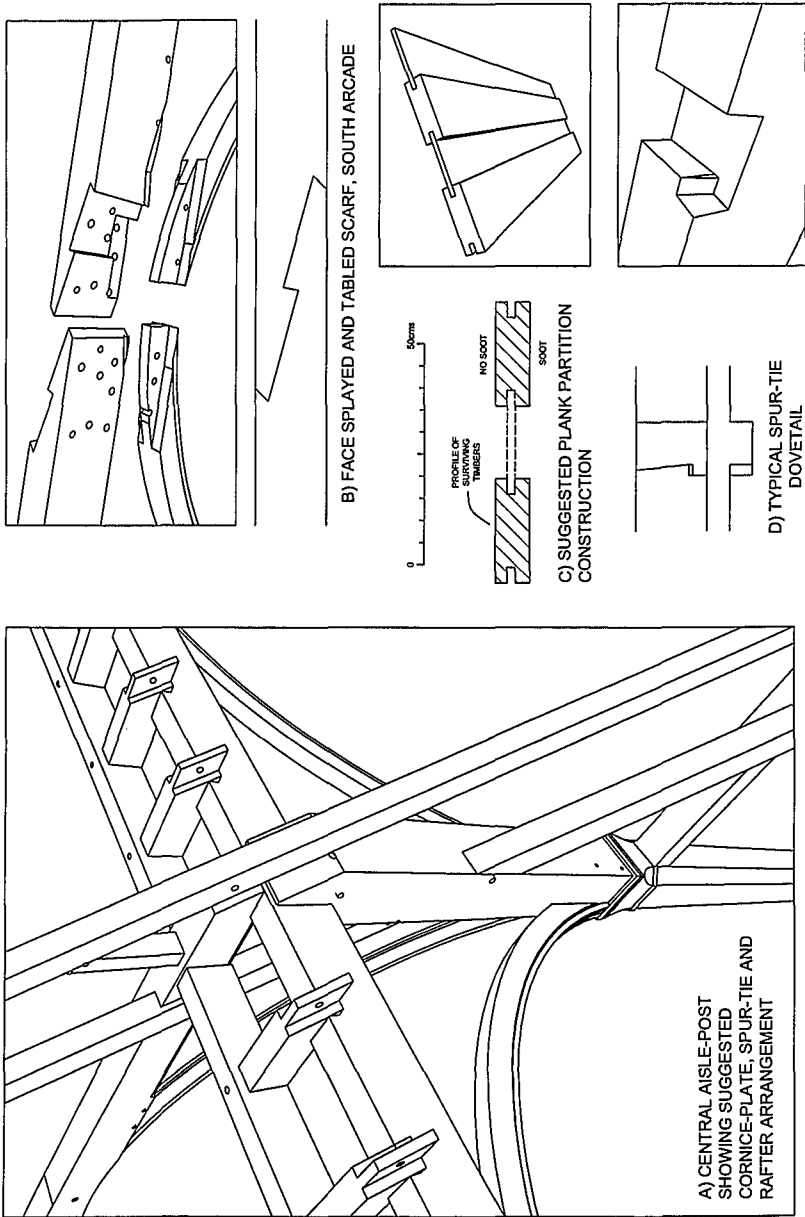
Fig. 4 Aisle Hall House Carpentry Details.

Barefaced dovetails atop the hall's arcade-plates reveal where the common rafters of the roof were located (**Fig. 4D**). It is suggested that spur ties were located in these dovetails, connecting the common rafters to the cornice-beams (the common rafters must have passed behind the arcade-plates in a similar manner to the principals, **Fig. 4A**). This archaic arrangement differs from that employed in later buildings where the rafters sit in housings atop the plates.

Surprisingly, two possible timbers from the aforementioned partitioning were discovered reused elsewhere within the property during works. These measured 23.5 x 7.7cm in section and are heavily soot blackened on one face only. Grooves for the intermediate members of the partition, perhaps thin planks, can be seen on the sides of these timbers (**Fig. 4C**).

A stop-splayed and tabled scarf with undersquinted abutments was revealed during works joining the two lengths of the east arcade-plate (**Plate VIII** and Fig. 4B). Unlike later examples of its type this is face splayed (laid on edge rather than flat), an orientation that would seem structurally poor. A change to stronger edge splayed scarfs may well have been underway at this time. Two lengths of arcade-plate joined by a second splayed scarf were revealed along the west side of the hall during works but these were the only original timbers to have survived here; the arch-braces have been removed by later brickwork.

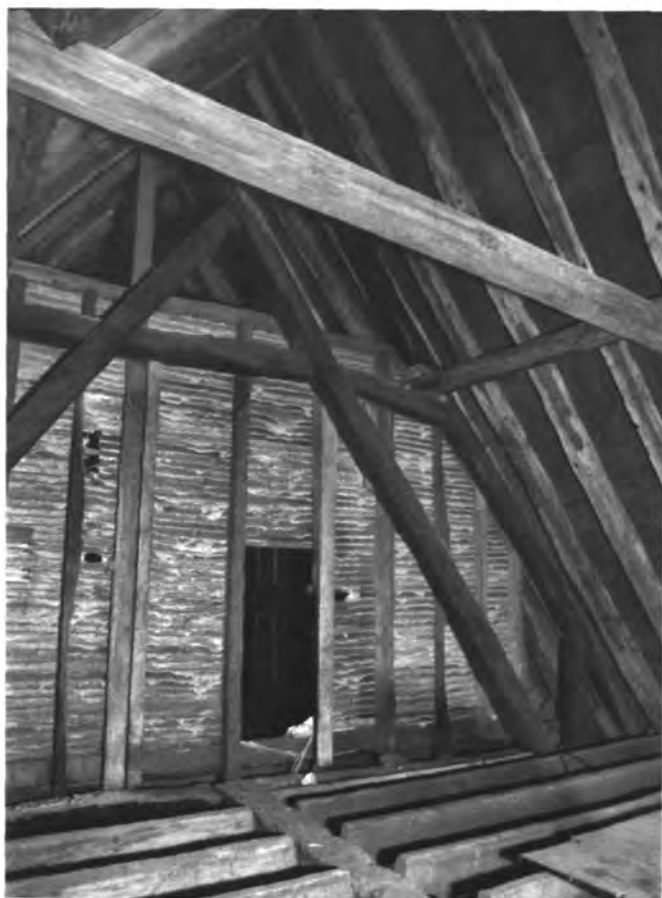
PLATE IV

Remarkably, an original roof truss has survived above the central tie-beam of the hall (**Plate IV**). This comprises rafters, passing braces, ashlar pieces and collar. Interestingly, the rafters pass behind the outside edges of the arcade-plates and are uniquely tenoned onto the ends of the tie-beam. Both rafters have now been truncated at tie-beam level but must have continued over the aisles in one length.

The passing-braces within the roof truss are halved across the south face of the tie-beam and collar. These braces now stop at the tie-beam but originally continued down to meet the arcade-posts. Several details suggest that the passing-braces within the roof are later additions. The brace mortice in the east arcade-post for example lies alongside the spandrel strut mortice. Close inspection of the two mortices here reveals that the brace mortice was cut later, severing the peg that secured the spandrel strut into two pieces. The braces also interfere with the spandrel planks.¹¹ This discovery is something of a surprise since passing-braces are a feature of nearly all the surviving buildings in the group. It is perhaps significant that, unlike Newbury, none of the other examples have spandrel struts in their cross-frames. It is suggested that the braces were inserted at an early

Central roof truss, looking north showing passing braces

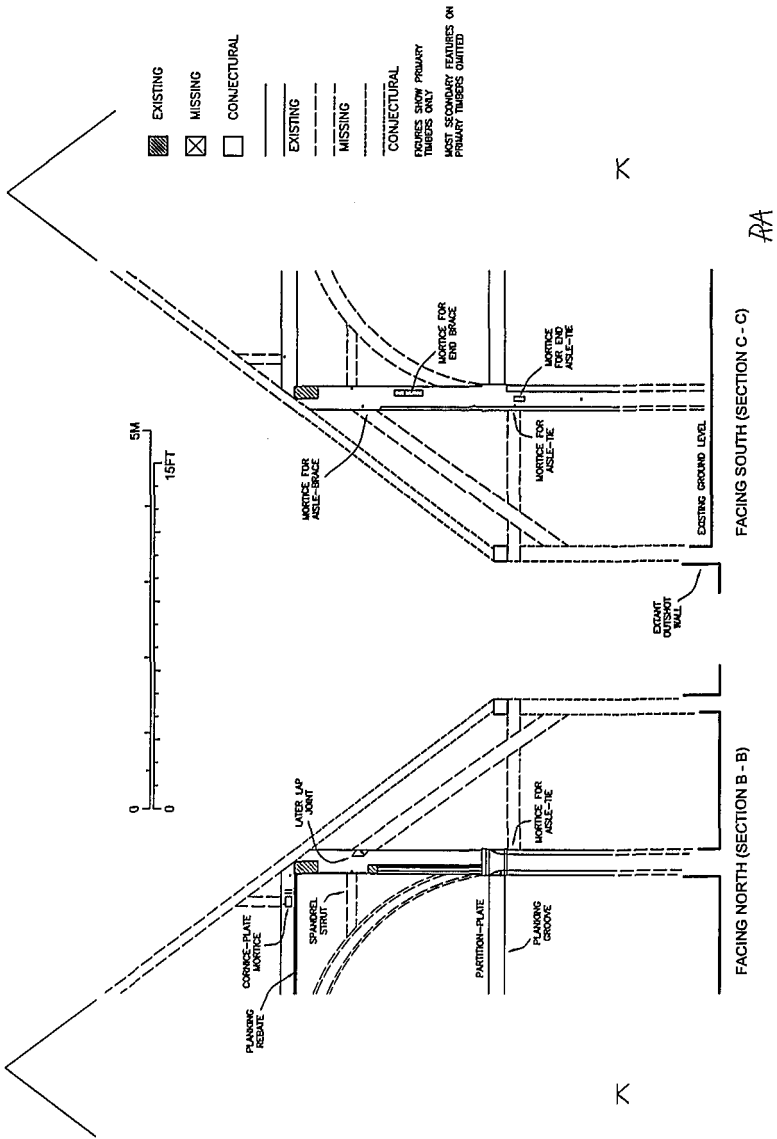
Fig. 5 Partially restored views of north end truss.

Only the east arcade-post, tie-beam and a length of partition-plate survive at the north end of the hall (**Fig. 5**). Fortunately these timbers reveal much about the arrangement of the building here. The surviving arcade-post is similar to that of the central truss but there are several differences that reflect its position at the end of the hall (**Plate V**). Its capital, for example, has only been carved on the hall side of the post, the rear face left plain. Empty mortices for arch-braces can be seen above the capital.

Two sets of grooves can be seen beneath the tie-beam (at its east end) and on the inside face of the arcade-post. The southern grooves are for the planking in the spandrels of the arch. The northern grooves however are for the partitioning that divided the hall from the northern bay of the house. A similar groove lies beneath the partition-plate, confirming that the partition continued down to ground level. This lower groove is wider than that on the soffit of the tie-beam, suggesting perhaps that the partition was more substantial at ground level. Grooves on the outside face of the arcade-post confirm that the partition continued across the aisle. No evidence for doors leading through the partition into the northern bay of the property survived.

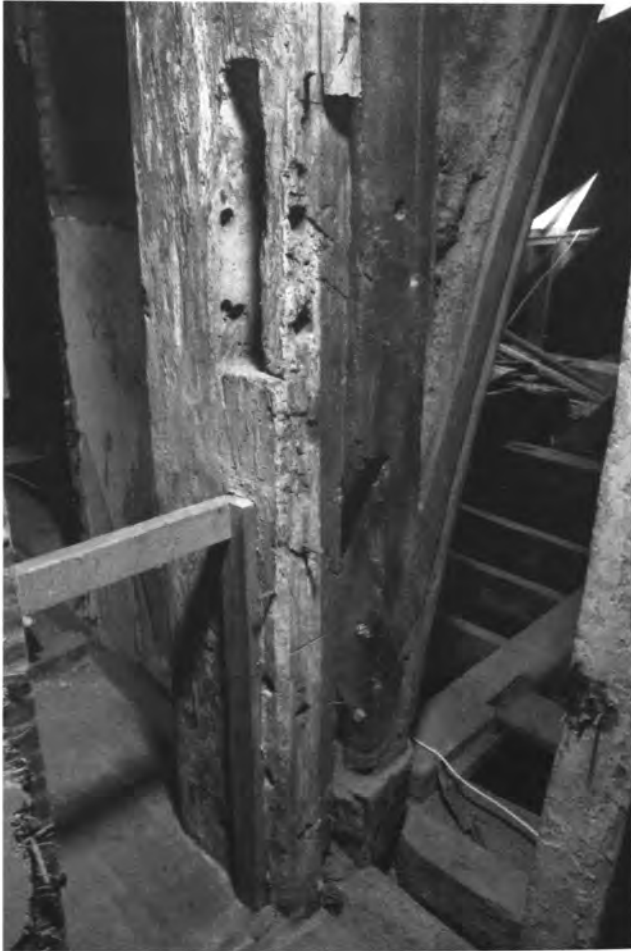
Evidence found on the north end truss confirmed beyond doubt that an in-line bay once lay to the north of the hall and that this was an integral part of the structure. A two storey timber-framed wing of probable late seventeenth-century date is located here today (**Fig. 6**). It seems likely given the evidence and from our understanding of the other examples within the group that the missing bay was unfloored. An empty mortice was discovered below the east arcade-post's

North end truss arcade-post, looking south-east

capital. This is perhaps for a n-s aligned end aisle-tie that secured the north wall of the building to the post, something that implies the building terminated in an end aisle.

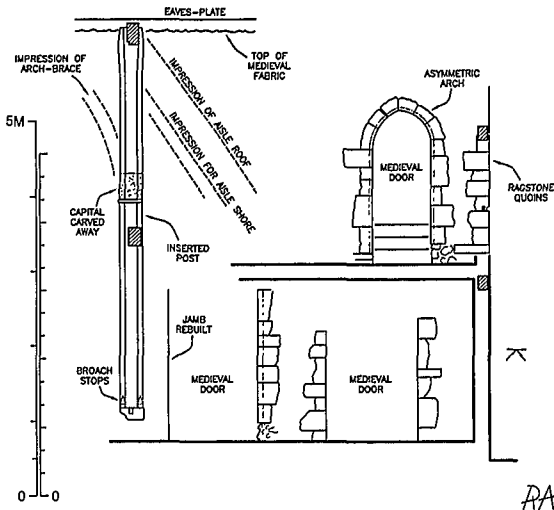
Fig. 7 Section G-G to south.

A similar in-line bay probably lay to the south of the hall but was removed by the stone cross-wing (see below). Although the south end truss of the hall no longer exists we know that it survived the construction of the wing. The new wing was built directly against the truss, its masonry partly encasing the earlier timbers. Although the timbers have been removed a number of slots and impressions remain in the masonry and render (Fig. 7). These impressions reveal that the south end truss was of similar form to the north end truss. They

confirm that the hall was not only aisled to the east but also the west (until now only an east aisle was proven) and that both aisles survived the construction of the cross-wing. The outline of the west aisle roof also survives in the render of the cross-wing, its pitch matching that of the main hall roof at approximately 53-54°.

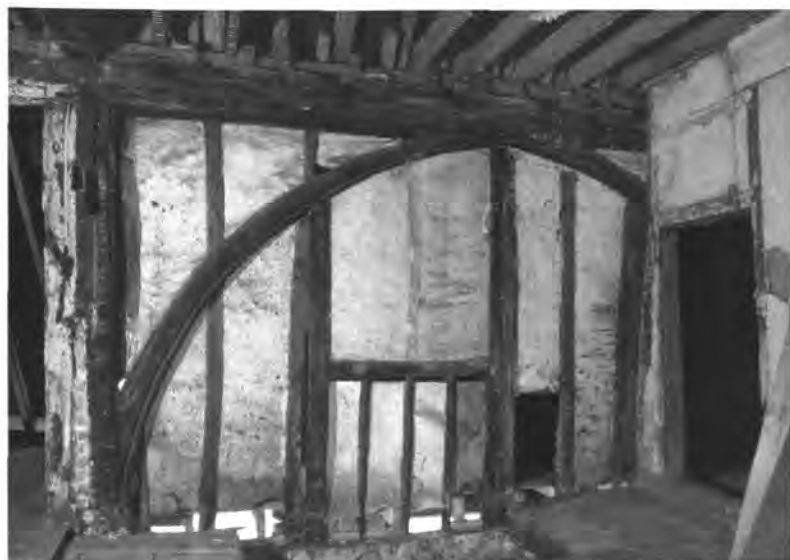
PLATE VI

Three arcade-braces (one is incomplete) survive beneath the arcade-plate along the east side of the hall (**Fig. 8**). They form similar arches to that spanning the centre of the hall but are slightly pointed rather than semi-circular (**Plate VI**). The braces are similarly

East arcade (south bay, looking west) showing arcade-braces and inserted window

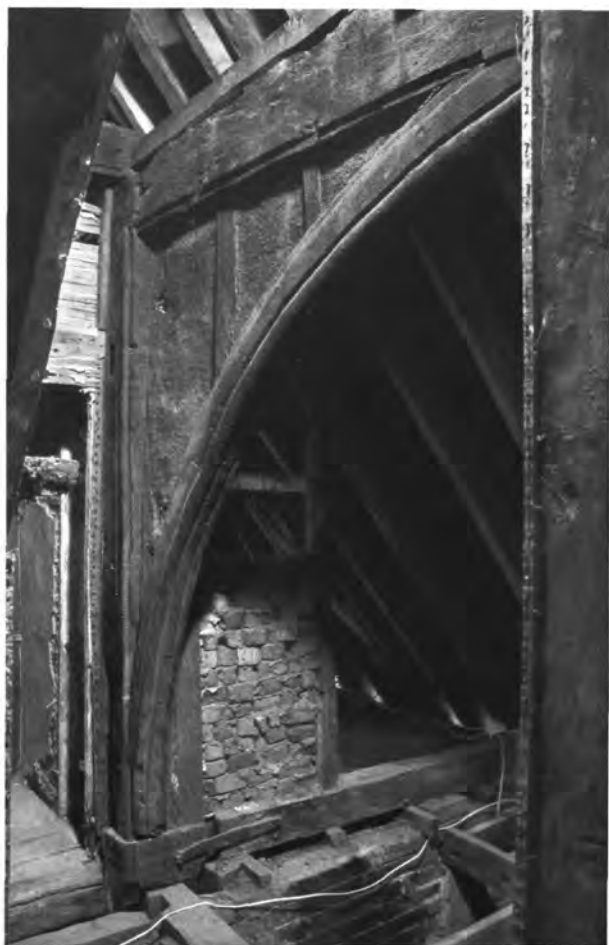
PLATE VII

East arcade-brace (south bay, looking north) showing planking rebate

embellished with double rolls although the roll facing the hall is more pronounced than that facing the aisle. Rebates for planking can again be seen within the spandrels (**Plate VII**). The outer faces of all the timbers of the east arcade are heavily weathered, indicating that they

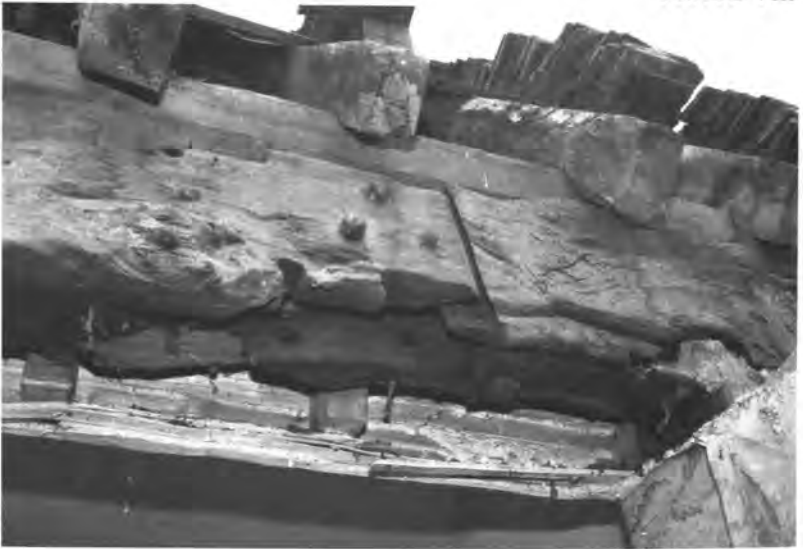
Face-splayed and tabled scarf (east arcade, south bay)
