# Archæologia Cantiana

## SOME MAJOR KENTISH TIMBER BARNs

By S. E. RIGOLD, F.S.A.

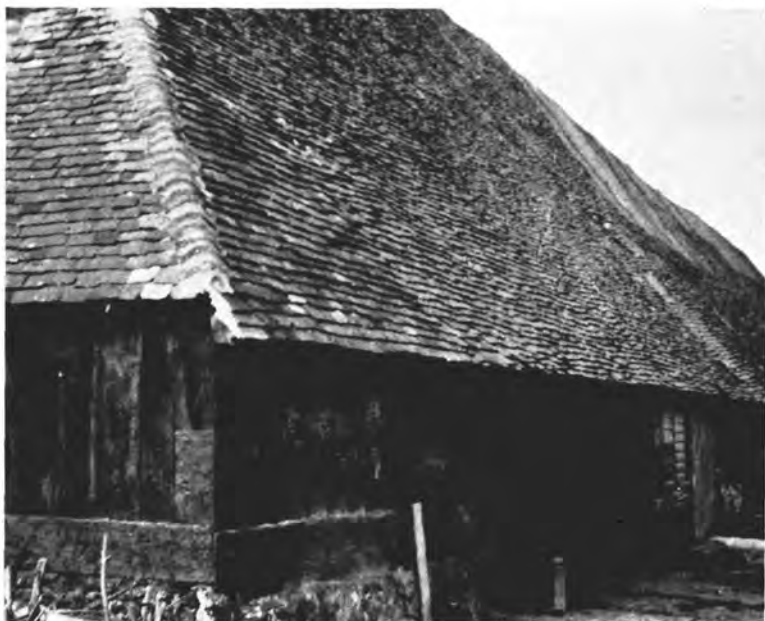
A. Frindsbury: S.E. Corner, showing Cladding.

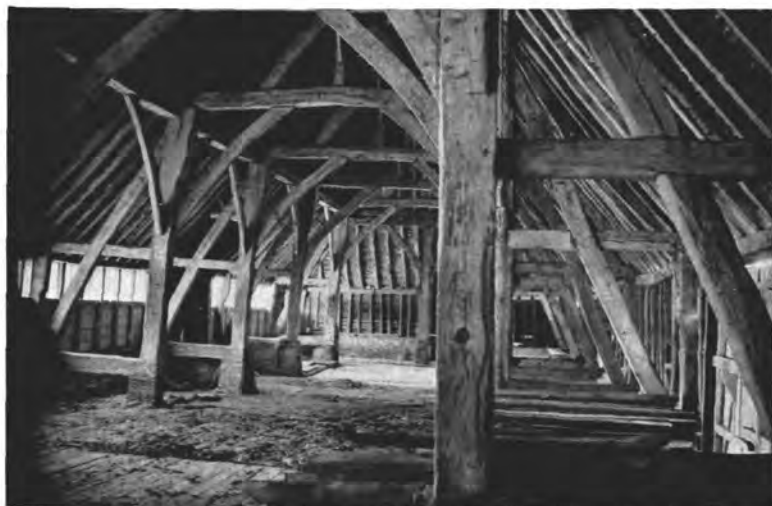
B. Brook: Interior of Barn from N.E.

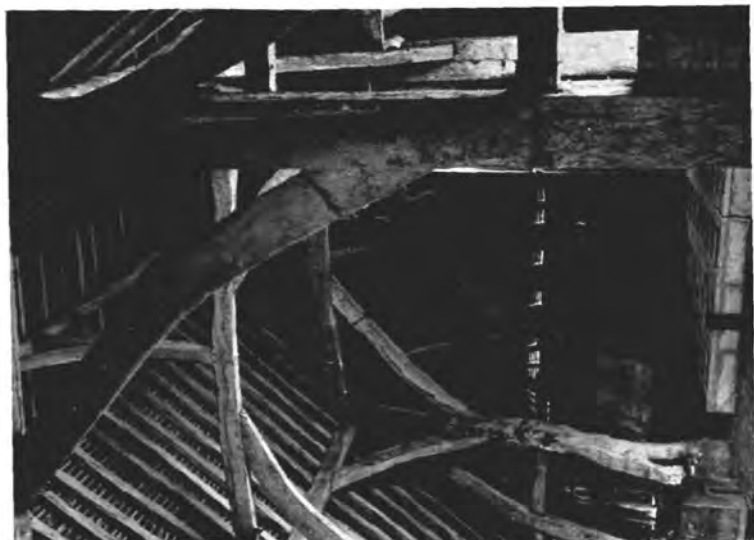
*S.E.R.*  
B. Faversham Minor: S.W. part, showing unshaped Posts.

All this suggests a middle-period barn of first quality, and the fine finish is carried right to the roof, where the crown-posts are all stop-chamfered. But then, in striking contrast, several of the posts are not squared at their bases (i.e. as always, at the *tops* of the trees, when growing), but present untrimmed trunks—in two cases untrimmed forks supporting the posts on two 'legs'. The fantastic effect cannot be accidental.

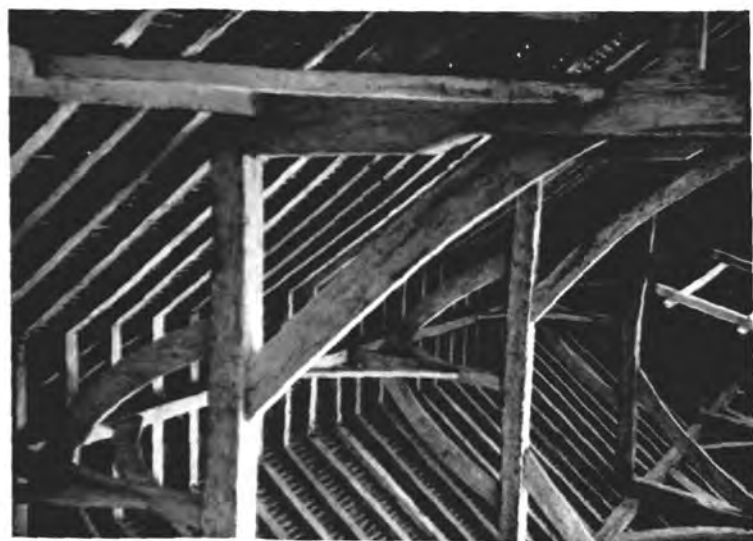
*S.E.R.*  
A. Brook: Roof from S.W., showing Jowls and Crown-posts.

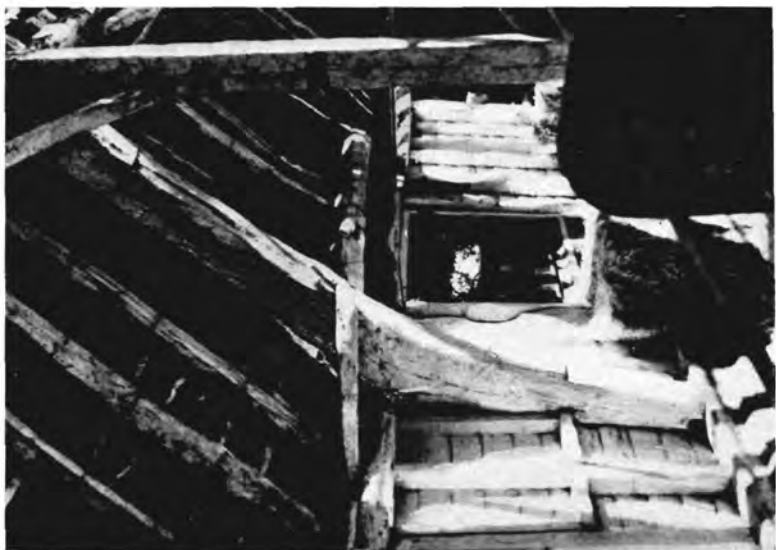
B. Town Farm, Wrotham: Base-cruck.

*An Exceptional Barn, allied to Class II, Town Farm, Wrotham* (TQ 620606). Though hardly a major barn, this (Fig. 3) is included because it contained the first ground base-cruick to be discovered in Kent.<sup>47</sup> It was found in 1961 by Mr. Alfred Baker, when it had just been repaired for use as a byre. By 1965 the farm had been sold, the barn demolished and a tennis-court on the site. The barn had been much altered; originally it had comprised a pair of 9½-ft. bays on either side of a 12½-ft. passage-bay, with aisles and terminal outshots. Later the S aisle and hips had been removed, the west outshot thrown into the adjoining bay and posts at this end renewed. The single-base cruick, 10 in. thick (Pl. VI, B), spanned the north aisle to the east of the passage-bay, doubtless to allow a waggon to turn. There were suggestions of shores to the other posts flanking the passage-bay, but nowhere else. A post had been inserted to support the head of the base-cruick, and its long arch-brace removed. The arcade braces were relatively thin and not early-looking, those of the second post from the south-west being of ogee form. The only archaic feature beside the base-cruick was the low aisle that it dictated, and the base-cruick itself may have been re-used even before the alterations.

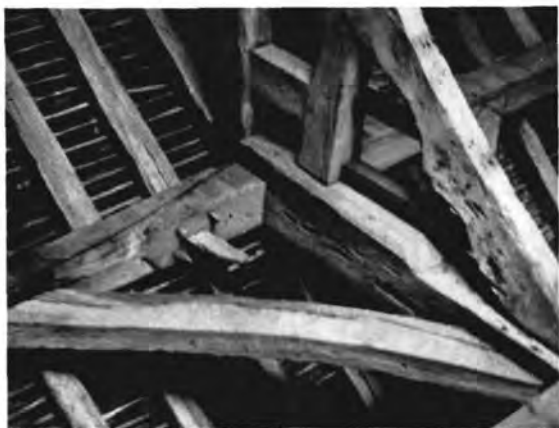
A. Frindsbury: Post-head, showing strutted  
Spandrel and keyed Scarf.

These occur in simple form, with unbroken plane of contact at Frindsbury (Fig. 1, A; Pl. VI, A), where the keys are very prominent and the butts not cut across but 'sallied', almost exactly as in the barn at Great Coxwell, Berks. (probably c. 1275),<sup>8</sup> and in the more usual form, which is 'tabled', i.e. with a step in the middle of the plane of contact, at Littlebourne (Fig. 1, B), where the 'table' is slight and sometimes absent, at Mersham (probably), and, without 'keys' at Brook (Fig. 1, C) and in parts of Godmersham and perhaps of Lenham 'Minor'. These instances are associated with other relatively early features and may all come within the fourteenth century.

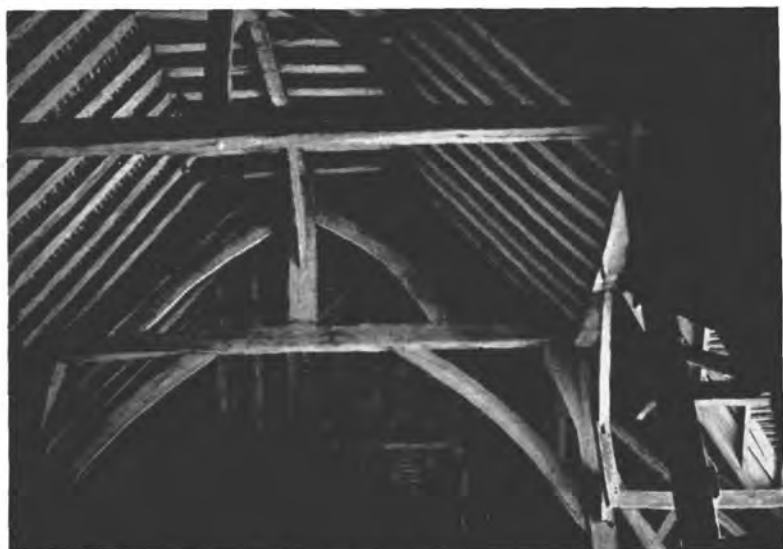
A. Godmersham: Roof at N. end.

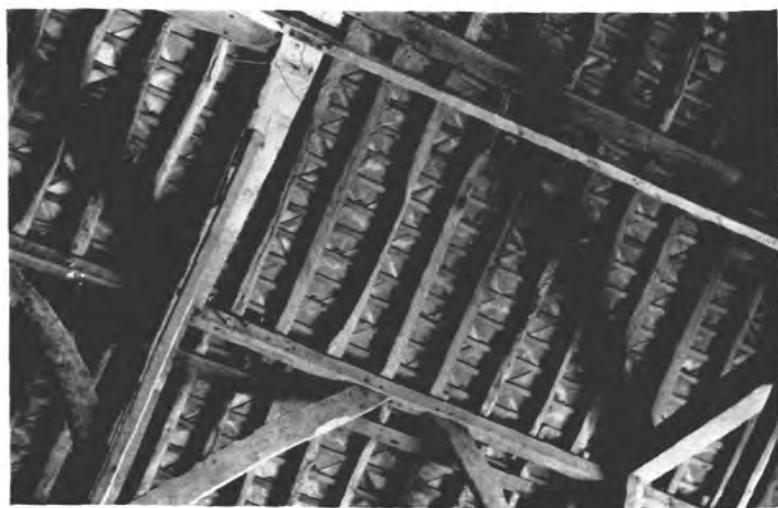
B. Austin Lodge, Eynsford: Halved Scarf and eccentric Braces.

*Austin Lodge, Eynsford (TQ 538638) (Fig. 9).* Properly Orkesden, once a sub-manor of Eynsford. A barn of respectable size (120 ft. by 36 ft.) in ten bays (four central bays and two passage-bays with midstreys (compare Broomfield), rising in floor-level throughout its length, with half-hipped ends. It has no post-plates but low-set ties

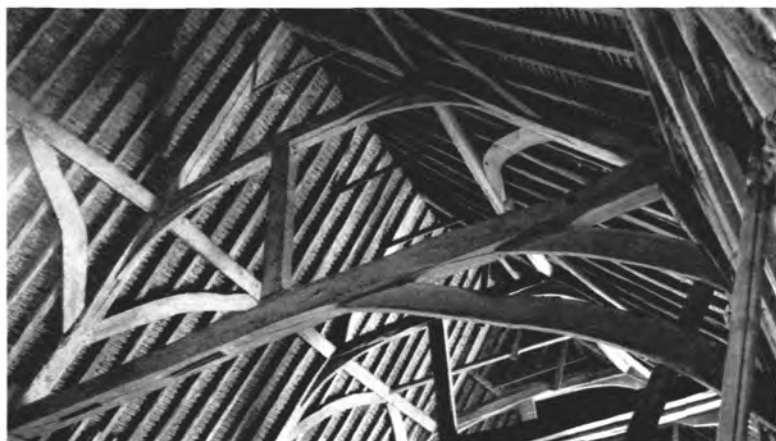
B. Nettlestead: Roof Truss.

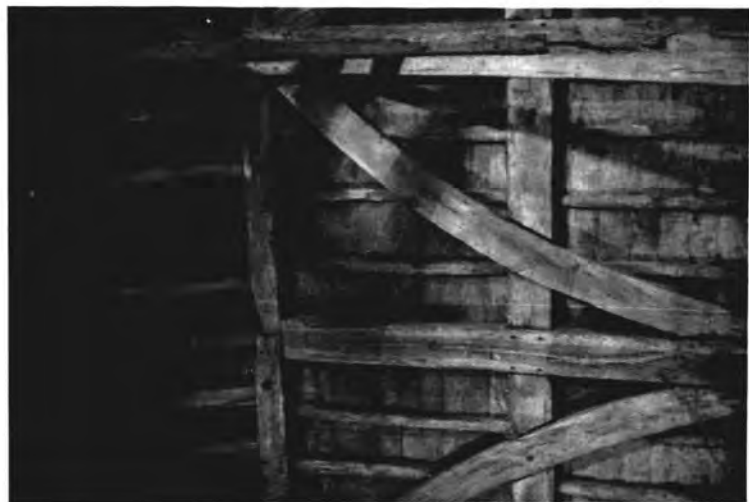
B. Nettlestead: Braces in Wall-frame.

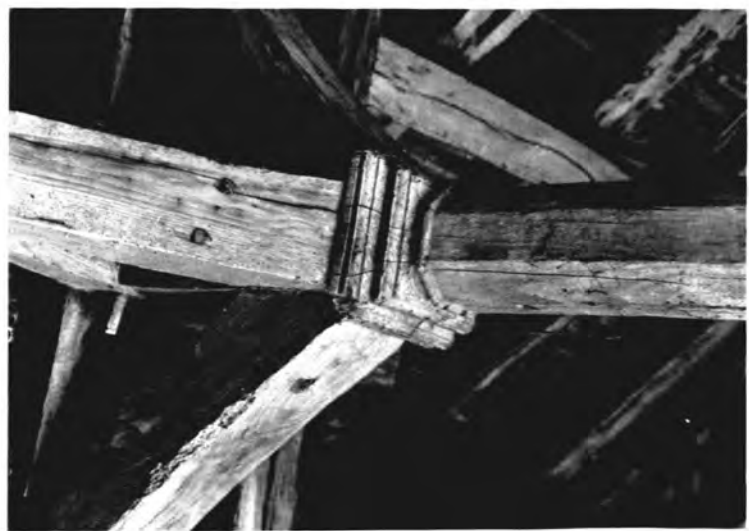
A. Nettlestead: Crown-post in Gatehouse.
