EXCAVATIONS AT THE 'OLD PALACE', BEKESBOURNE, NEAR CANTERBURY*

TIM TATTON-BROWN

'THE OLD PALACE', BEKESBOURNE 1976-78

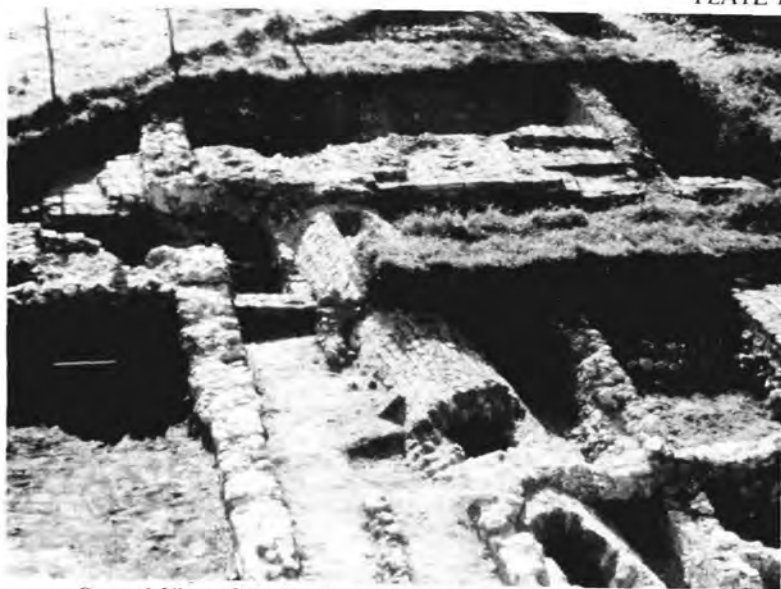
General View of the Excavations showing the Brick vaulted Drain.

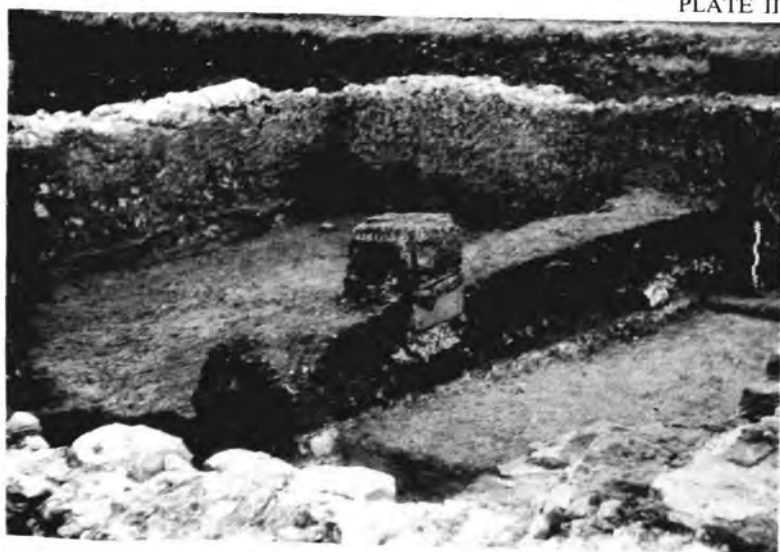
The medieval half Cellar.

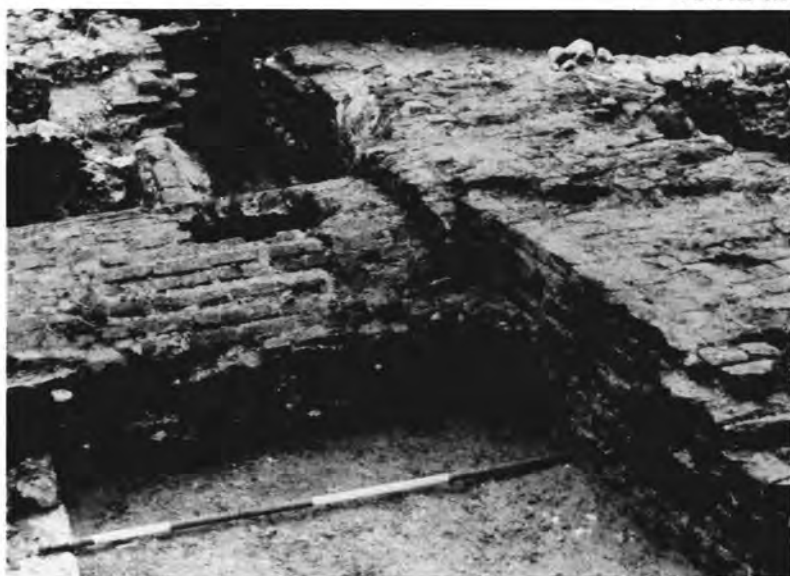
PLATE III

The sixteenth-century Brick Walls and Drain cutting through the medieval half Cellar.

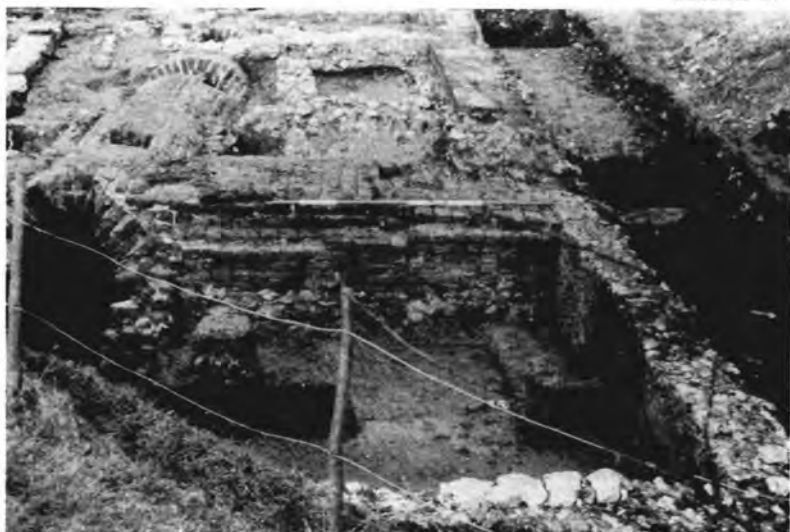
PLATE IV

Detail of Brick Garderobe Bases and vaulted Drain.

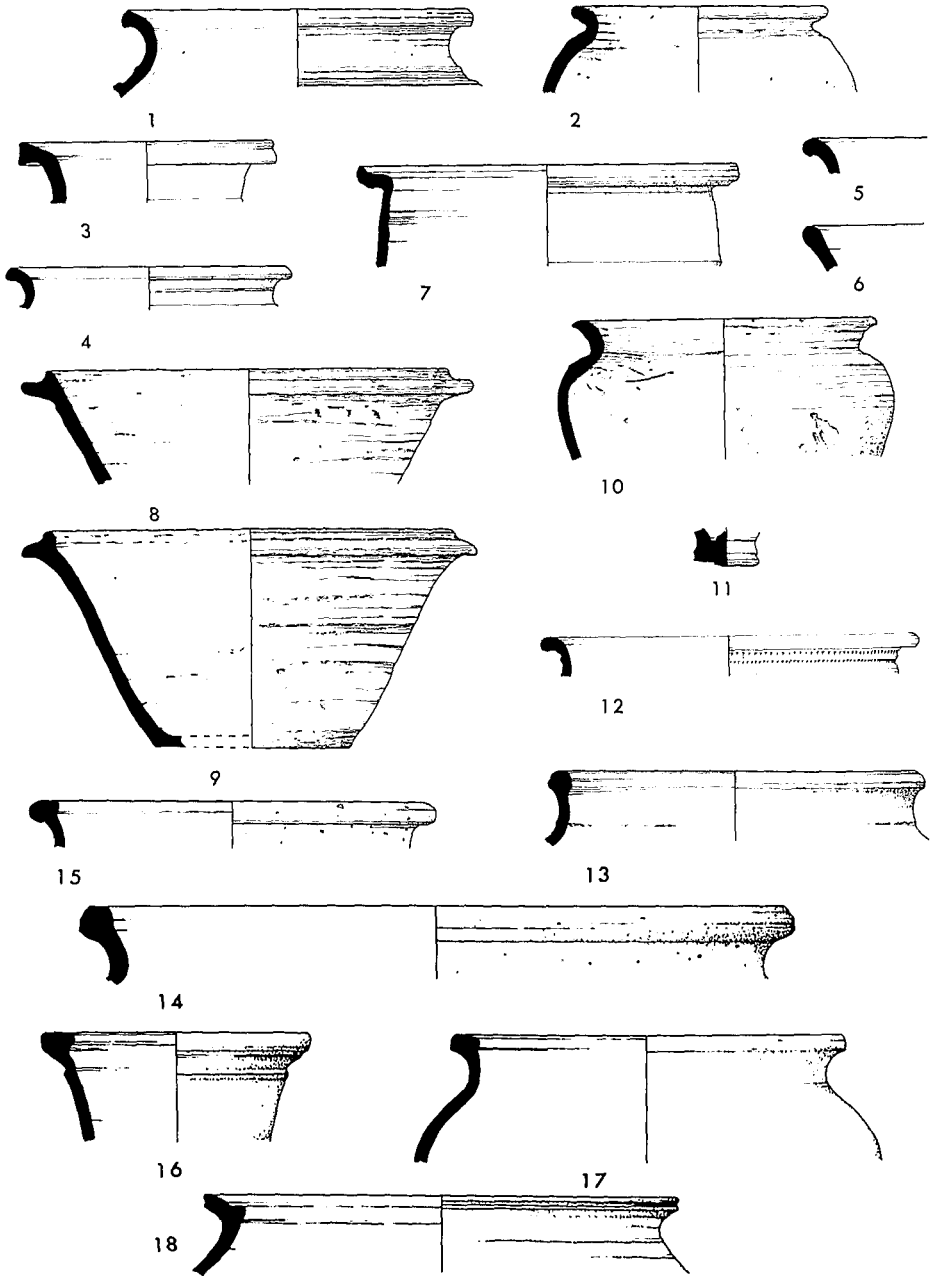
Fig. 9. Pottery Drawings, 1-18. ($\frac{1}{4}$)

1. (II — 27) Jar in fairly hard dark grey ware — rim and neck lightly burnished.
2. (IV — 9) Jar in reduced dark grey ware. Light burnish as 1.
3. (I — 19) Flagon in grey ware speckled with grog. Oxidized orange-brown surfaces.

4. (II — 7) Jar in grey sandy ware.
5. (II — 23) Jar in oxidized orange-pink sandy ware.
6. (II — 16) Dish in grey ware with fine sand-temper.
7. (II — 27) Flanged-rim bowl in dark grey sandy ware — soot encrusted.
8. (II — 16) Flanged bowl in light grey grogged-ware, with all surfaces roughly burnished.
9. (II — 16) Flanged bowl with ware and surface treatment as 8. Sooted.
10. (IV — 3) Jar in light grey grogged-ware with orange-buff surfaces. Light burnish on shoulder and inside rim.

11. (I — 21) Base of Oxford region import in fine light-grey ware, oxidized pale pink. Dirty brown colour-coat. Worn.
12. (II — 17) Bowl in fine orange ware with dull red colour-coat. Two narrow rouletted bands below rim. An Oxford region import (see discussion).

13. (II — 29) Cooking-pot in dark grey sandy ware.
14. (II — 6) Cooking-pot in grey sandy ware with light shell-temper mostly on the surface.
15. (II — 6) Cooking-pot in light grey sandy ware mixed with shell. Pale orange oxidized surfaces. Exterior sooted.

16. (I — 8) Jug in light grey sandy ware, with marked inner rim bead. Dull brown-green glaze.
17. (I — 8) Cooking-pot in grey-dark pink sandy ware with sparse shell temper. Sooted exterior.

18. (I — 8) Cooking-pot in hard light grey sandy ware with pink-grey oxidized surfaces. Internally ledged to receive lid.
19. (II — 17) Cooking-pot in grey sandy ware. Buff surfaces. Exterior sooted.

The collection of Belgic sherds is unexciting but useful — those illustrated (Fig. 9, nos. 1–3) probably belong to the mid-late first century A.D. Continuing occupation is suggested by Romano-British coarse wares, in particular no. 7 (Fig. 9); a form common in the late-first and early-second centuries A.D. The two native copies of flanged bowls and the jar with burnished shoulder (Fig. 9, nos. 8–10), represent the later Roman phases. Occupation during this period is confirmed by the two Oxford region imports, in particular no. 12 (Fig. 9) belonging to Type C75 group of Dr Young's series,²⁴ and dated by him to A.D. 325 – 400 +.

No Saxon pottery was found in the excavation and the site was probably not reoccupied until the very late-twelfth, or more certainly the early-thirteenth century. The very shelly wares of the mid-late twelfth century are absent; nos. 14–15 and 24 (Figs. 9 and 10) have only a light shell addition to a predominantly sandy fabric. Their forms, too, together with those of the accompanying purely sand-tempered wares (e.g. Figs. 9 and 10, nos. 13, 17, and 19) emphasize an early-thirteenth century date. The sandy fabrics can all, presumably, be sourced at Tyler Hill kilns, Canterbury, with nos. 16, 18, 20–21, 23, and 25 (Figs. 9 and 10); these wares on this site

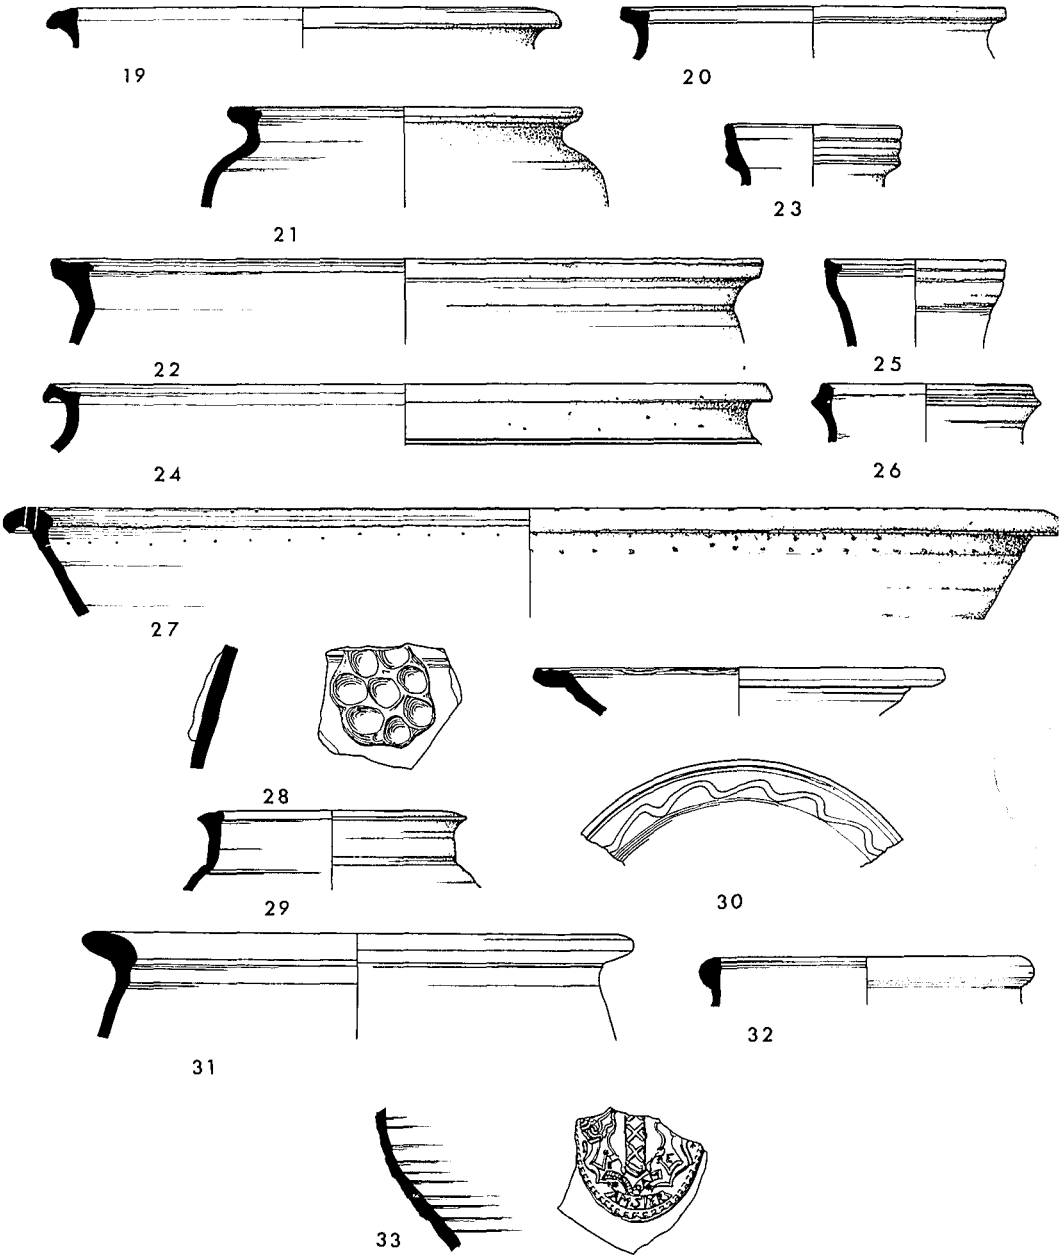
Fig. 10. Pottery Drawings, 19-33. (1/4)

20. (II — 25) Cooking-pot in grey sandy ware with sparse chalk temper.
21. (IV — 6) Cooking-pot in grey sandy ware. Sooted.
22. (II — 7) Cooking-pot in oxidized brown-red sandy ware. Sparse shell-temper mostly on the surface.

23. (II — 4) Jug in grey sandy ware with dark pink-red surfaces.
24. (II — 6) Cooking-pot in grey sandy ware with markedly everted and hooked rim. Medium shell and red grit inclusions to fabric.

25. (II — 13) Jug in dark grey sandy ware, oxidized orange inside and dark red-brown outside. Brown-green glaze over two cream painted bands.
26. (II — 7) Jug in grey sandy ware.

27. (II — 6) Dish in light-grey sandy ware with oxidized buff-pink surfaces. Two rows of holes, stabbed down from the rim top, and one below the inner rim bead, pushed outward. Rim and interior splashed with light apple-green glaze.

28. (II — 7) Jug sherd in orange sandy ware. Decorated with an applied 7-petalled 'rose', covered with a thick lustrous brown-green glaze.
29. (II — 3) Jug in light grey hard sandy ware, finer than above. Rim top bevelled outward to a sharp edge.

30. (II — 6) Dish in orange slightly sandy ware. Exterior sooted. Interior covered with a thick, matt orange-brown glaze. Glaze covers single applied pipe-clay wavy line, on rim flange.
31. (III — 4) Dish or bowl in fine hard grey ware. Dark olive-green glaze with metallic lustre on underside of rim and interior.
32. (II — 6) Jar in fine hard orange ware with orange-brown glaze inside and on distinctive D-sectioned rim.
33. (I — 19) Imported Bellarmine jug sherd in grey stoneware. Stamped.

are well into the mid-late thirteenth century. The large dish and jug rim (nos. 26 and 27, Fig. 10) are typical of the early-mid fourteenth century. Sherds from a Saintonge 'lustrous' green glazed jug, an Aardenburg jug and a Surrey ware measure belong here.

The angularity and hard sandy fabric of no. 29 (Fig. 10) is still a Tyler Hill type product, and should be late-fourteenth century, tentatively very early-fifteenth century.

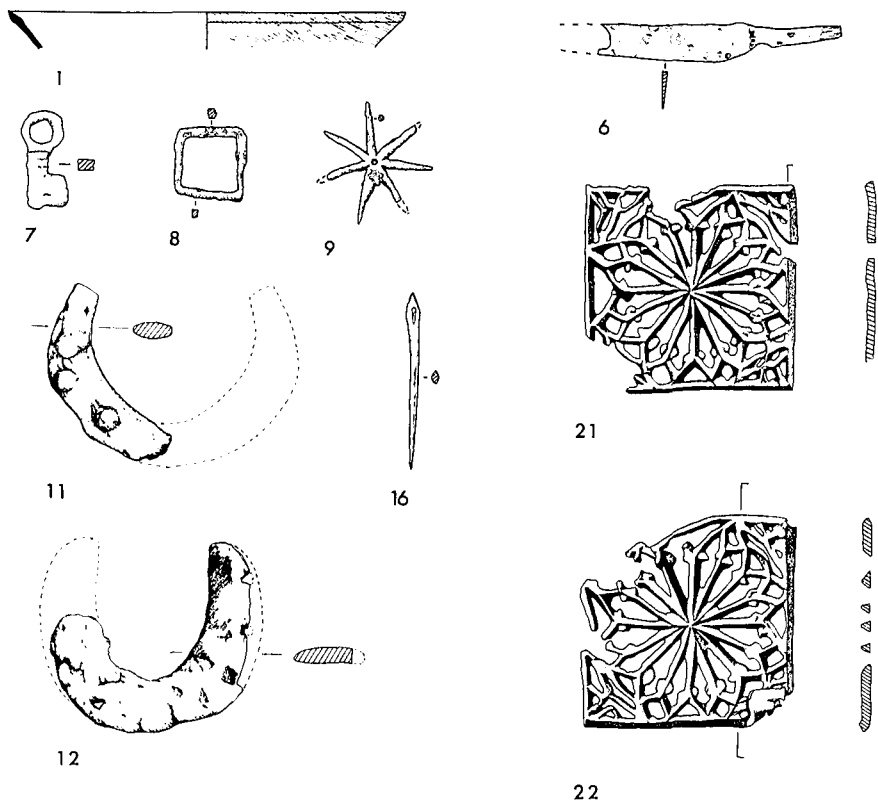
Fig. 11. Small Finds Drawings. ($\frac{1}{2}$)

1. (2, II — 6) Two fragments, perhaps plate rim; dia: 20 cm. Highly polished internal surface; exterior surface roughly smoothed with coarse file.
2. (7, I — 21) Sheet strip fragment, 0.70 cm. wide; two rivet holes, one with a rivet *in situ*. Could be binding for small box. (Not illustrated).
3. (8, III — 4) Blank disc; dia: 3 cm., 0.20 cm. thick. (Not illustrated).
4. (10, IV — 9) Small pin with twisted wire head; 3.80 cm. long, 0.05 cm. thick. (Not illustrated).
5. (19, II — 5) Two similar pins as 4. (Not illustrated).

6. (I, II — 15) Knife, straight upper edge, traces of wooden handle; part of the blade is missing.
7. (3, II — 16) Key, band around the shaft; heavy corrosion obscures the wards; probably hollow-shafted.
8. (4, IV — 8) Buckle; spike missing.
9. (5, III — 4) Seven-pointed spur rowel;²⁵ radius 3 cm.
10. (11, II — 17) Heavy sub-rectangular object, very corroded, (not illustrated).

16. (6, II — 29) Needle with key-hole eye; tool marks on shaft.
17. (20, II — 12) Piece of worked bone, sharpened to a point; 8.50 cm. long. (Not illustrated).

20. (18, II — 12) Strip of window lead; square in section, pinched at the mid line: 0.20 cm. thick, 4.30 cm. long. (Not illustrated).
- 21 and 22. (25 & 26, II — 4) Two lead ventilating panels of an architectural character, perhaps fourteenth–fifteenth century. Flat on one side with raised decorative surface on the other, giving a triangular section: 12.70 cm. square. (Traces of white mortar were found on their edges). Some similar panels are described as coming from Clarendon Palace,²⁶
