THE TOPOGRAPHY AND BUILDINGS OF HORTON MANOR, NEAR CANTERBURY*

TIM TATTON-BROWN

HORTON MANOR CHAPEL

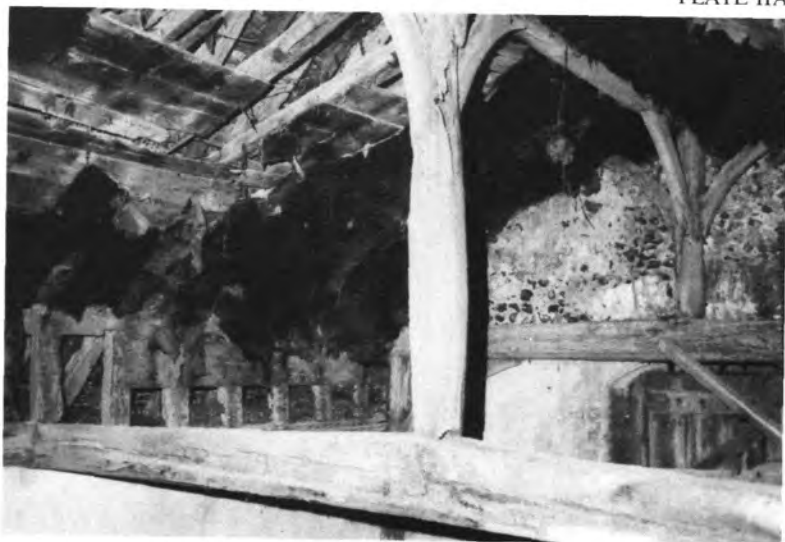
PLATE IIA

Horton Manor Chapel: Nave Roof, looking South-west.

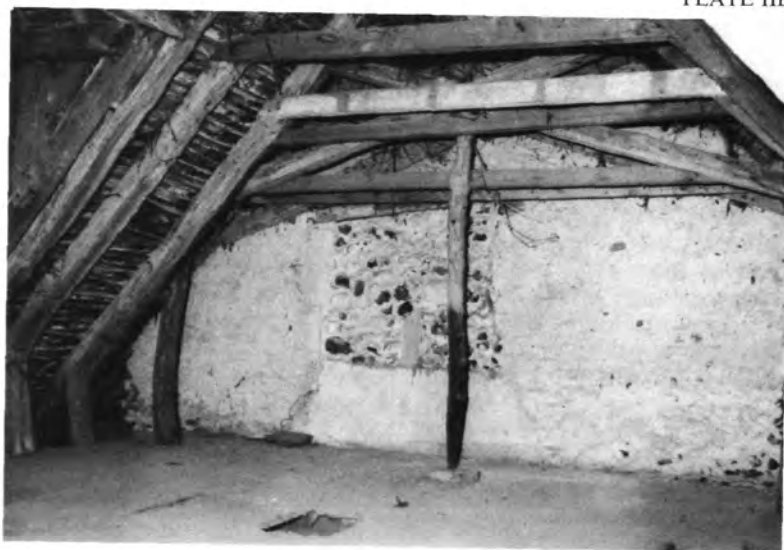
PLATE IIB

Horton Manor Chapel: Chancel Roof, looking South-west.

The chancel roof is a much simpler affair with no tie-beams or purlins. The small collars were lapped onto the eastern sides of the rafters. The junctions between the rafters, ashlar-pieces, and wall-plates were obscured by the inserted floor, but it was possible to see that the inner wall-plates only had a simple chamfer on them. In both roofs several of the rafters are missing, but this has not been

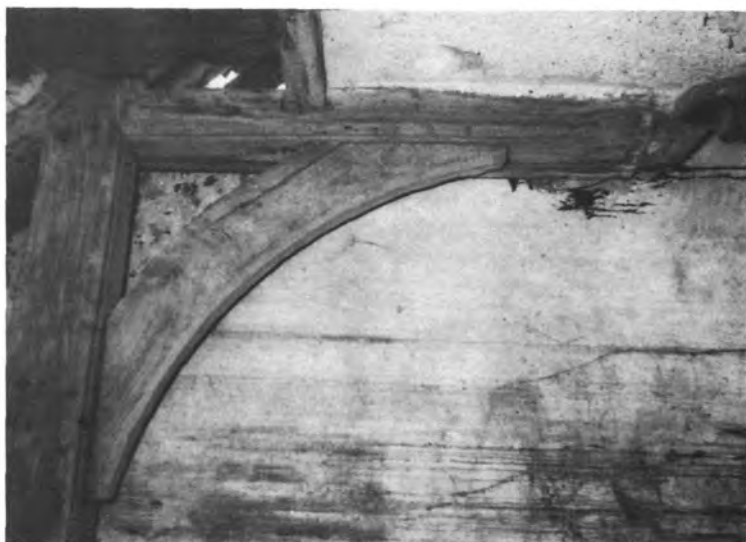
PLATE IIIB

Horton Manor Chapel: Northern Half of western Truss in the Nave Roof.

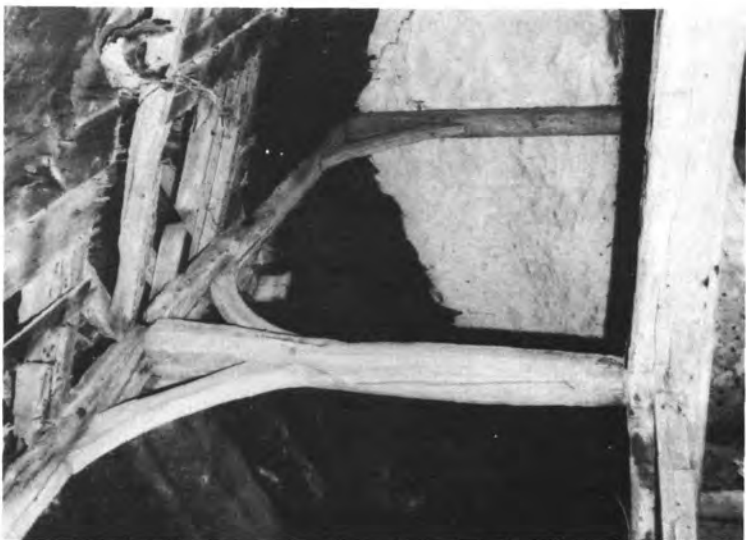
PLATE IIIA

Horton Manor Chapel: Nave Roof, looking North-east with Chancel Area below.

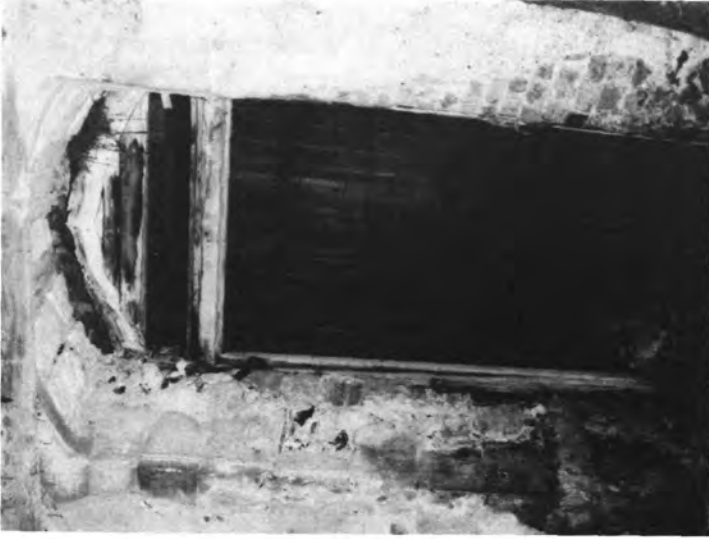
PLATE IVB

Horton Manor Chapel: North Door of the Nave from inside.

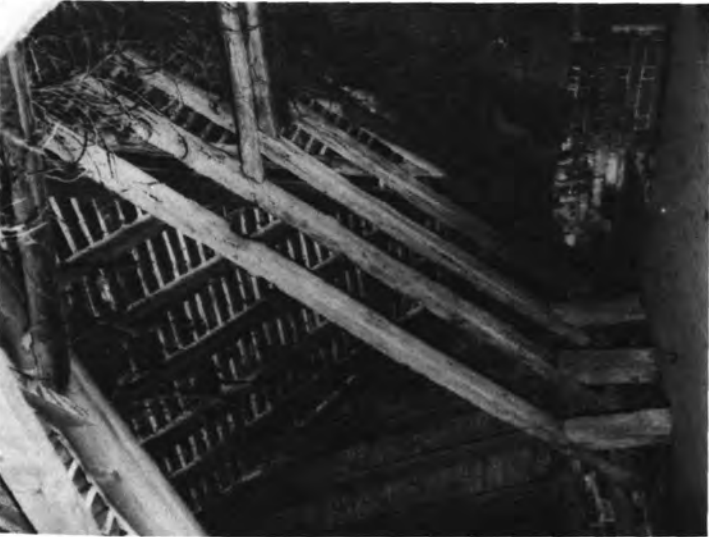
PLATE IVA

Horton Manor Chapel: Chancel Roof, looking North-east.

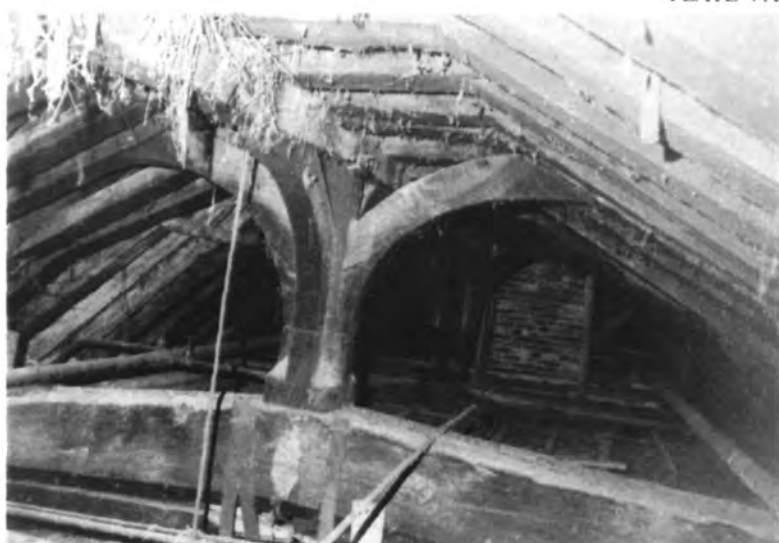
(Photo: M.G. Heenan)
Horton Manor: Hall Roof looking South.

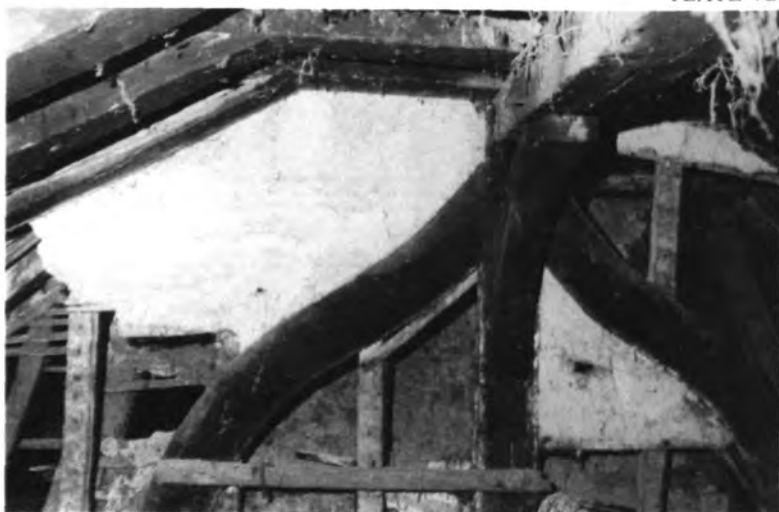
(Photo: M.G. Heenan)
Horton Manor: West End of Hall Roof.
