THE MILL ON THE LEYBOURNE STREAM AND ITS WATER MANAGEMENT IN THE EIGHTEENTH AND NINETEENTH CENTURIES

SIMON PRATT, PETER SEARY AND SHEILA SWEETINBURGH

In 2004 the Canterbury Archaeological Trust undertook a desk-based assessment of the environs of the former watermill (TQ 68715 58485) at Leybourne (**Fig. 1**), along with the recording of a surviving wall of the mill and a contour survey of an area to its south and west. The same area was sampled by evaluation trenching the following year (**Fig. 2**). These investigations into the mill's water-management system formed part of a much broader project, commissioned and coordinated by Kent County Council, to deal with the archaeological impact of the realignment of the A228 to bypass Leybourne and West Malling. The greater part of that project is reported upon elsewhere¹ whilst much of the later history of the mill has been covered in an unpublished study,² which its author generously made available.

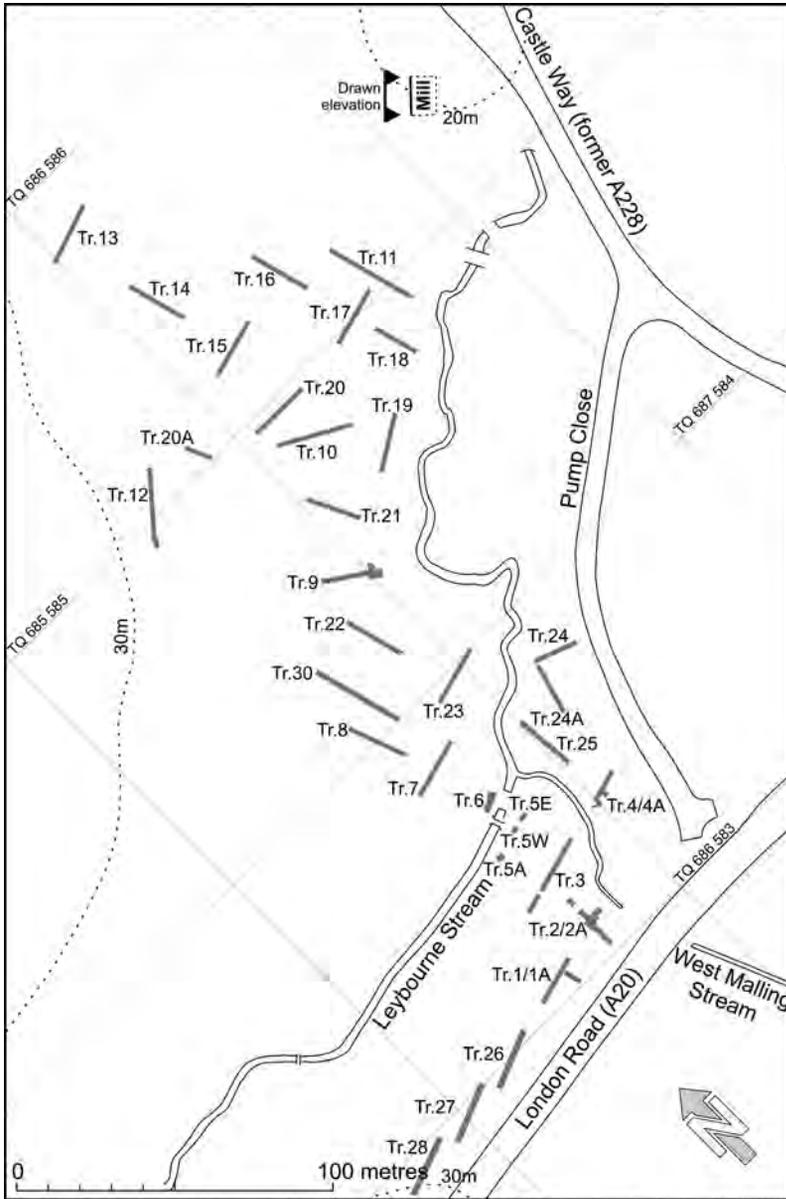
Fig. 2 Leybourne Mill: trench plan in relation to the road system before bypass construction.

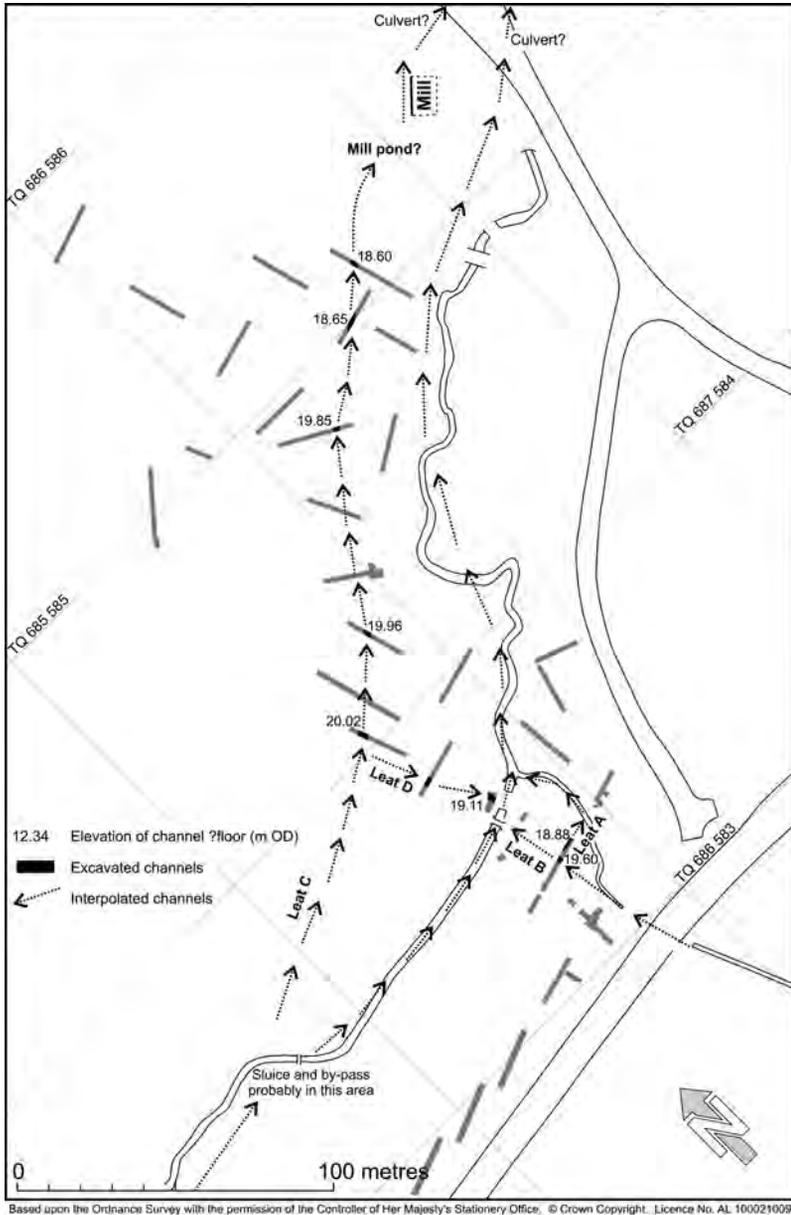
Fig. 3 Leybourne Mill: pre-aqueduct phase.

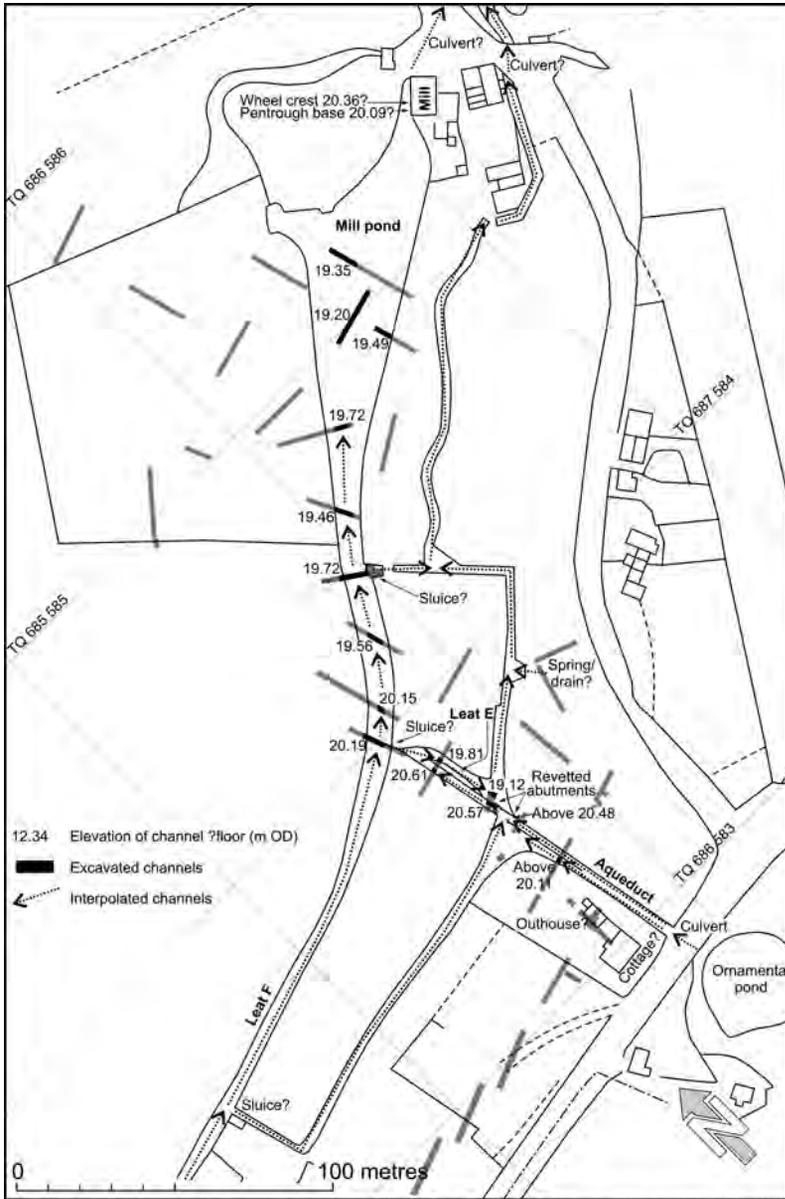
Fig. 4 Leybourne Mill: aqueduct-fed phase in relation to the 1842 tithe apportionment map.

The second main phase of water-management (Fig. 4) included the replacement of Leat B with a raised, embanked aqueduct, perhaps incorporating a lower side channel running along its western side (Fig. 7). The aqueduct probably re-used stones robbed from the wall revetting the eastern bank of B but may have re-utilised that on the western side as part of its own structure. The aqueduct crossed the current line of the Leybourne Stream and partially overlay the infilled Leat D (Figs 10-12).

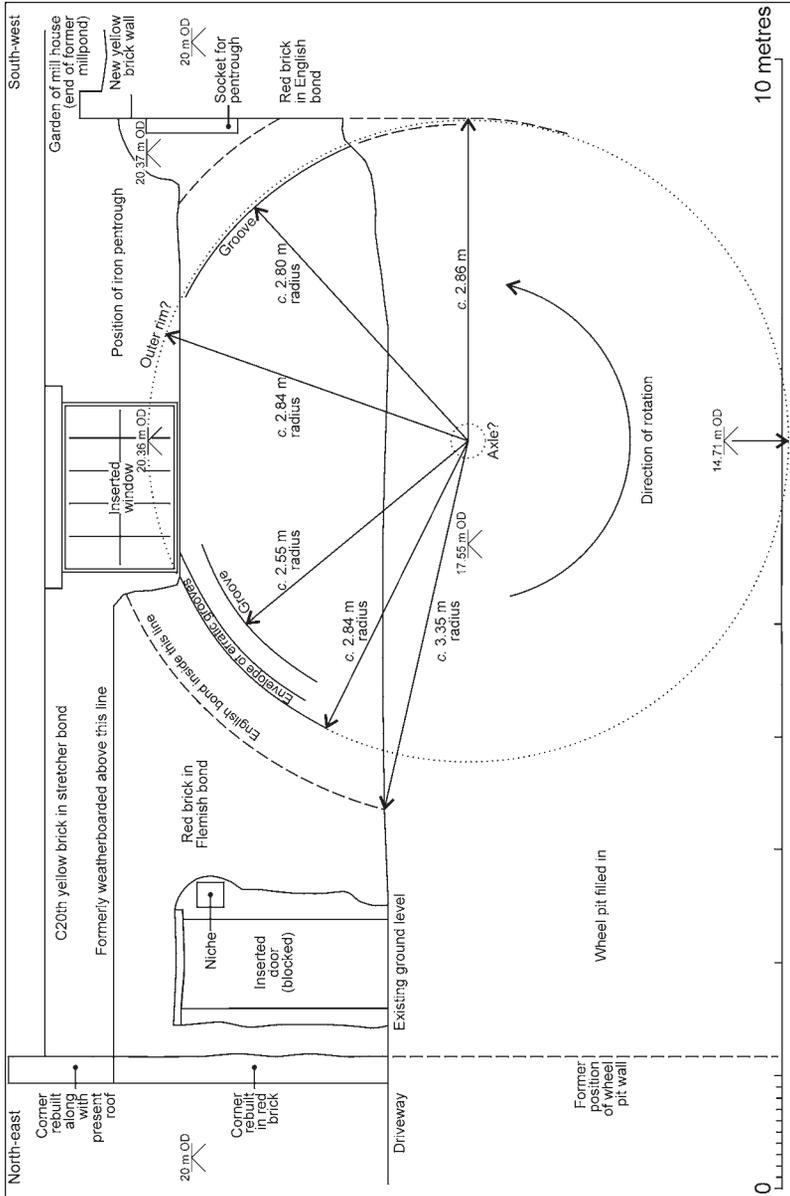
Fig. 6 Leybourne Mill: exterior elevation of north-west wall of mill, showing evidence for the size and location of the wheel.

The former wheel pit lay beside the surviving north-west wall of the mill and the well-preserved revetment walls of the headrace are to be found at its south-western end (**Fig. 6**). The brick floor of the headrace has been seen during gardening (Graham Woolton, pers. comm.). An iron pentrough would have carried the flow out over the waterwheel. Most of the physical evidence for the trough was removed when the mill wall's upper part was rebuilt in the twentieth century, though the end of its socket can still be seen in the brickwork. The projecting revetment, of English bonded red brick, carrying the headrace was about 3.1m wide. This, and the early photograph, suggest the wheel to have been about 2.0-2.5m wide and of a single bay.

The wheel had deeply grooved the brickwork of the mill's north-western wall, permitting a reasonable estimate of its centre as lying at about 17.55m OD (0.75m below current ground level), a third of the way along the wall. Within a circle of about 3.35m radius (12ft) from this centre, the wall was constructed in English bond, the remainder in Flemish, but the two elements are clearly of a single phase. The costlier English bond was doubtless intended to provide additional strength, having a greater ratio of headers to stretchers. The ascending phase, in the south-western part of the elevation, is worn smooth, the wear being deepest at the circumference, marked approximately by a groove some 2.80m from the centre. The

descending phase, by contrast, is marked by an envelope of erratic, cross-cutting grooves, up to 2.84m from the centre (a little less higher up). This is consistent with a loose minor component irregularly dropping forwards during descent. Also on the downstream side is a shallower but more regular groove about 2.55m from the centre. The hard local water has left a pronounced build-up of scale within the area encompassed by the various grooves. The radius of the wheel's outer rim cannot well have been less than that of the ascending groove (2.80m OD), nor greater than the distance to the headrace wall (2.86m), suggesting a measurement of perhaps 2.84m (9ft 3in., matching the outermost descending groove) and thus a diameter of 5.68m (18ft 6in.), with its crest at 20.36m OD. This agrees very well with the top of the pentrough socket, at 20.37m OD. The wheel was clearly an overshot example, common in the area. Its level is also typical and is consistent with the millstones being accommodated on the first floor.

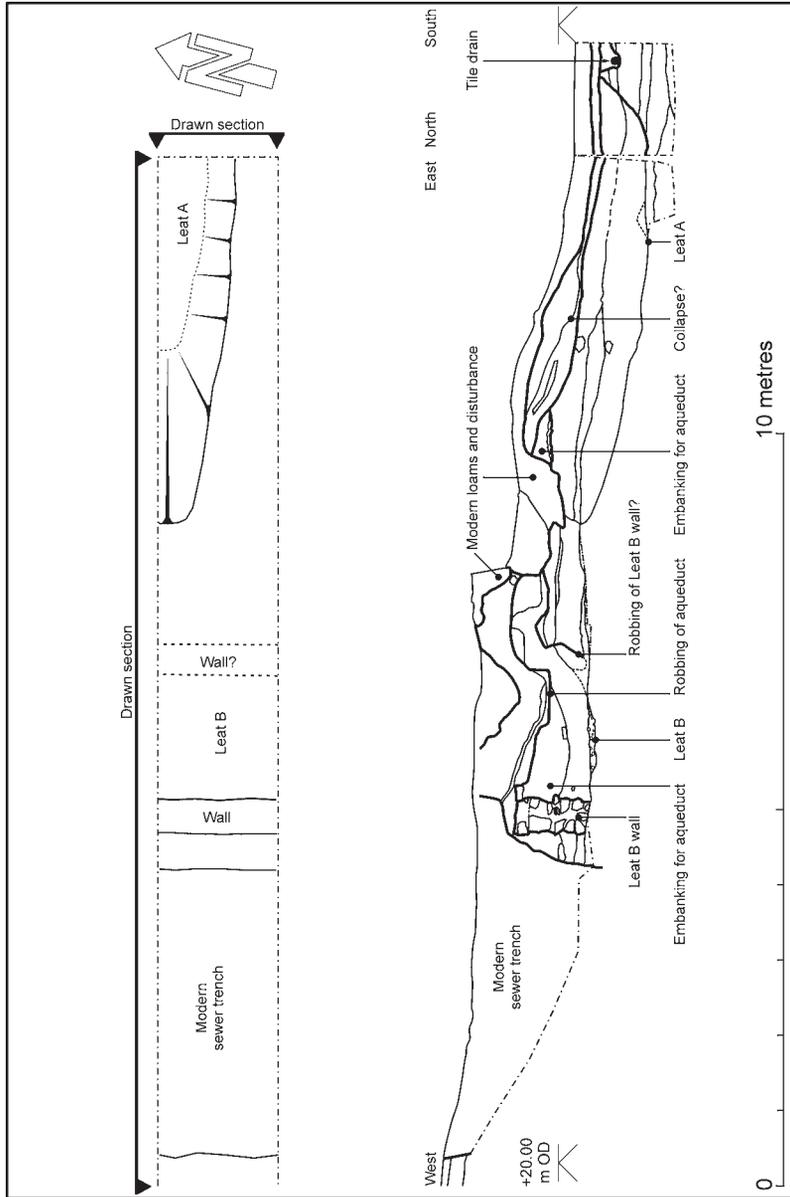
Fig. 7 Leybourne Mill: Tr.3, eastern half, plan and section, showing relationships between Leats A-B and the aqueduct.

In Tr.3 (**Fig. 7**), the uppermost fills of the western terminus of Leat A (a simple ditch) appeared to be cut by the base of the eastern embankment of the more elaborate Leat B but, given the shallow angle between the former's edge and the trench section, it is possible that this represented undercutting or subsidence and that the two were contemporary. In this case, Leat A probably served as a bypass channel when B required cleaning or repair. A partially robbed drystone(?) wall revetted the western face of B's embankment and was paralleled by a better preserved clay-bonded stone wall 1.7 m to its west: it is likely that the latter also revetted an embankment. Between the two walls, a crushed stone and clay deposit represented the base of Leat B.

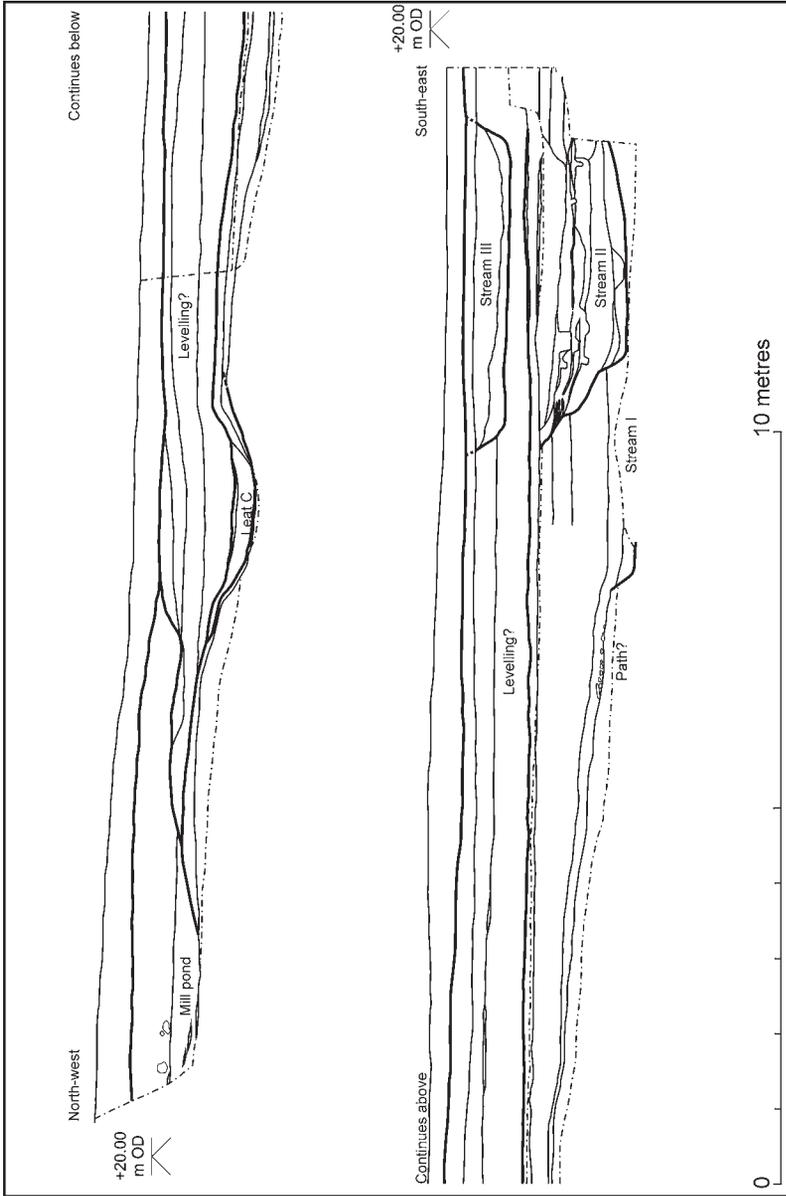
Fig. 8 Leybourne Mill: Tr. 11, section, showing relationships between valley floor streams, Leat C, later pond and intermediate levelling(?) deposits.

Downstream, Leat F gradually widened into a pond (Tr.11, 17 and 18), presumably that shown on the 1842 map. In Tr.17 the pond silts directly overlay silts and sands in Leat C (Fig. 9). In Tr.11, however, they were separated by a considerable build-up of what were probably levelling deposits (perhaps also sealing the second valley floor stream), laid to ensure that the floor of the expanded pond should not be too low in relation to the pentrough (Fig. 8).

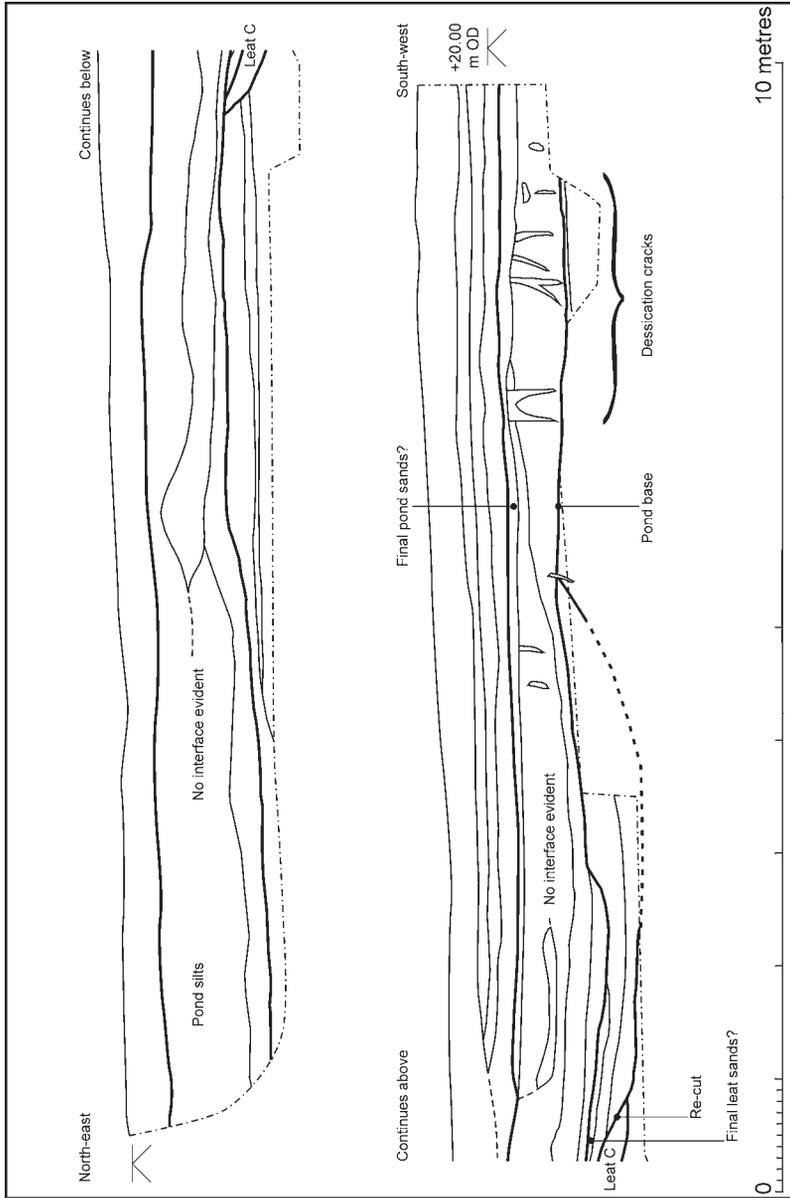
Fig. 9 Leybourne Mill: Tr. 17, section, showing silt and sand sequences in Leat C and later mill pond.

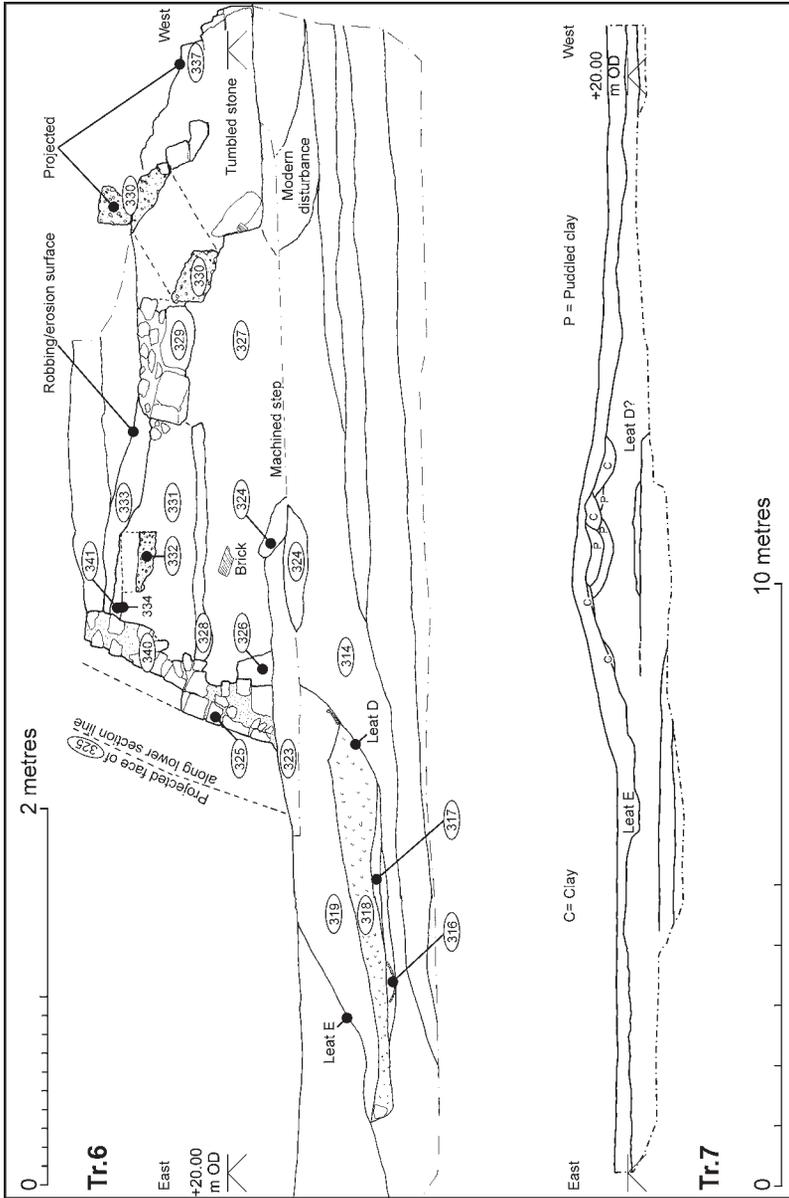
Fig. 10 Leybourne Mill: Tr.6 and 7, sections, showing construction details of the raised aqueduct.

The internal structure of the aqueduct was best seen in Tr.6, which merits a more detailed description than other trenches. Here, the earliest (clayey) fills (316-317) of D included two rim fragments of a large unglazed vessel or pipe, probably of eighteenth- or nineteenth-century date. Though it is possible that they were contemporary with the use of D, they are more likely to be associated with the main fills of rammed chalk (318) under compact loamy clay (319), which consolidated the ground in preparation for the construction of the aqueduct. After an irregular base of silty clay (323) and puddled clay (324) was laid down, the lower courses of the eastern (and, presumably, of the western) revetting wall were built, slightly battered and temporarily supported by puddled clay (326). Loamy clay (327), including a large fragment of a late eighteenth- or nineteenth-century brick, was then laid between the walls and capped, to the east by a lens of crushed ragstone (328) and, to the west, by a taller base of ragstone blocks surmounted by crushed ragstone in puddled clay (329). Immediately west of 329 were set the mortared flint and crushed ragstone footings (330) of the channel's western wall, whilst puddled

Farther uphill, in Tr.7, the aqueduct seems to have been unrevetted, the embankment probably being formed by scraping together sandy clay soils from either side, reinforced with clays and puddled clays (Fig. 10). A slight ditch formed or cut in the ground surface at the eastern foot of the embankment was probably one of the bypasses shown on the 1842 map (Leat E), which was also identified in Tr.7.

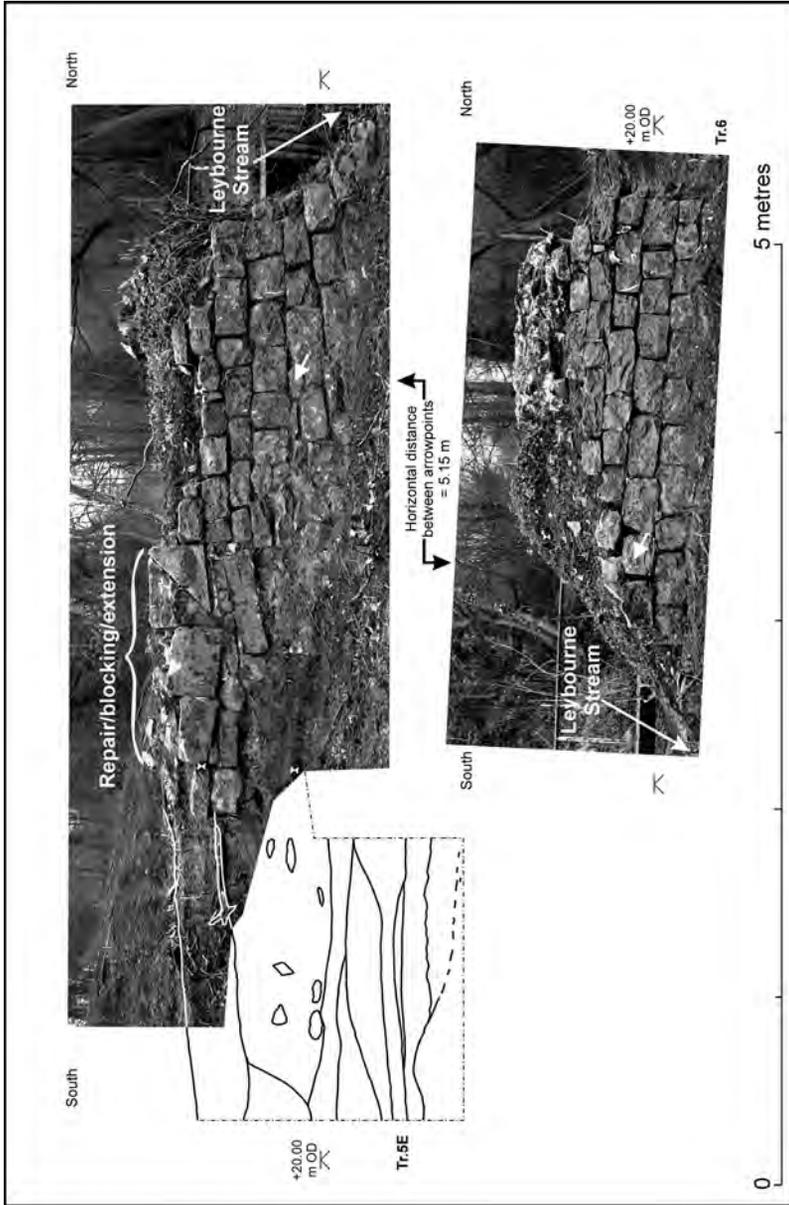
Fig. 12 Leybourne Mill: Tr.5E and 6, section and elevations of raised aqueduct crossing the Leybourne Stream.

clay (331 and 333), laid over 328, supported both the eastern channel wall and the upper part of the embankment's outer revetting wall. Though 329 may have supported a walkway, neither this nor a connection with the representation of double channels on the 1842 map, which probably mark lower by-passes, seem likely.
