PLANS OF, AND BRIEF ARCHITECTURAL NOTES ON, KENT
CHURCHES.

PART II. MAPLESCOMBE, ST. NICHOLAS HARBLEDOWN (NORMAN
HOSPITAL CHURCH), ST. BARTHOLOMEW CHATHAM, ST. BOTOLPH
RUXLEY, ST. NICHOLAS PLUMSTEAD.

BY F. C. ELLISTON-ERWOOD, F.S.A.

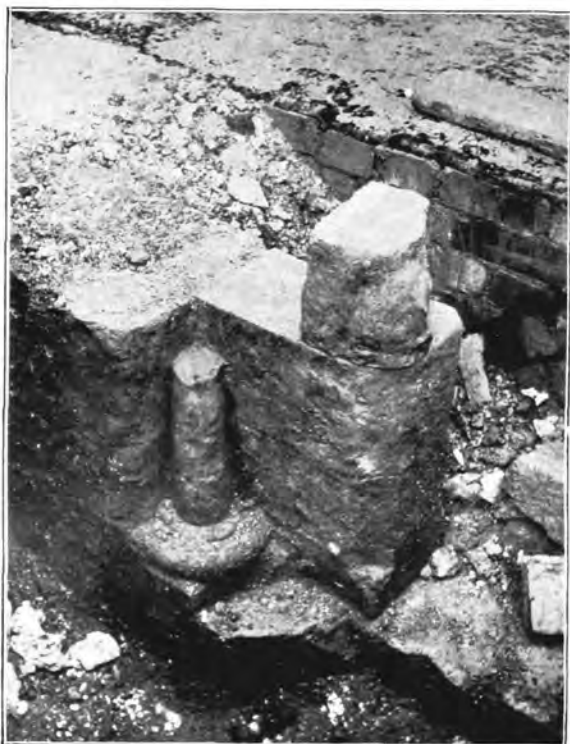
No. 1.

13TH CENTURY. This century saw great changes in planning and a scheme of enlargement was carried out at Plumstead. The parts that remain are the south transept, and the west jamb of a door into an extended chancel, discovered in 1907 and preserved under a grating in the churchyard (Plate III, No. 1). The transept was lit by two lancets

WEST JAMB OF 13TH CENT DOORWAY OF THE
OLD CHANCEL. DISCOVERED 1907.

in each wall east and west but the arrangement in the south is unknown. Internally the east wall carried an arcade of two arches enclosing the windows, with detached shafts (? purbeck marble) supporting carved caps, the mutilated fragments of one or two remaining. The doorway, as can be seen from the photograph, is clearly of 13th cent. date. All this is certain, but to complete the church as it probably was, it is necessary to suppose a symmetrical treatment, which has been done. But it must be admitted that the excavations made in 1907 for the new church did not reveal anything of these conjectural features, though no definite search was made for them. The plan I submit, though not without its problems, is I think reasonable, and does not conflict with subsequent developments. Rather it is in harmony with them.

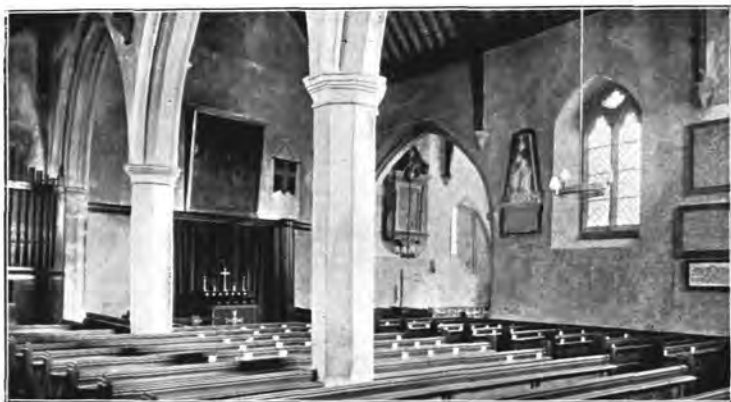
No. 2.

INTERIOR OF CHURCH, LOOKING S.E.—BEFORE ALTERATION,
c. 1900.

1820. The first attempt at restoration took place in this year. The north aisle was rebuilt in stock brick and the arcade re-opened and for the next 77 years the church remained unaltered and the illustration (Plate III, No. 2) gives some idea of the state of the building at the latter part of this time. Some further repairs are said to have taken place between 1852 and 1864 but they were only tinkering and patching, and, as the evidence shows, of very poor quality. Heavy gun fire and explosions from the nearby Arsenal contributed to its further deterioration and as repairs consisted in the main of concealing cracks rather than repairing them the thorough overhaul of the building and its enlargement to supply the needs of a large and growing industrial population was overdue. This took place in 1907 and the size of the new church compared with the original 12th century church is shown in Plan 10. The architects for the restoration, Messrs. Greenaway and Newberry, managed to make a large church without destroying any old work at all, and the tower, the 15th cent. arcade, the 13th cent. transept and the little Norman window were all
