HALL PLACE, BEXLEY

By P. J. TESTER

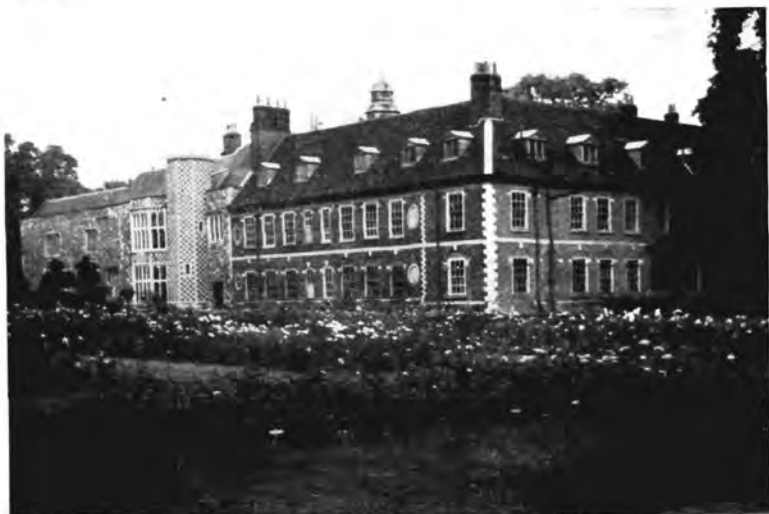
Hall Place, Bexley.  
General view from the south-west.

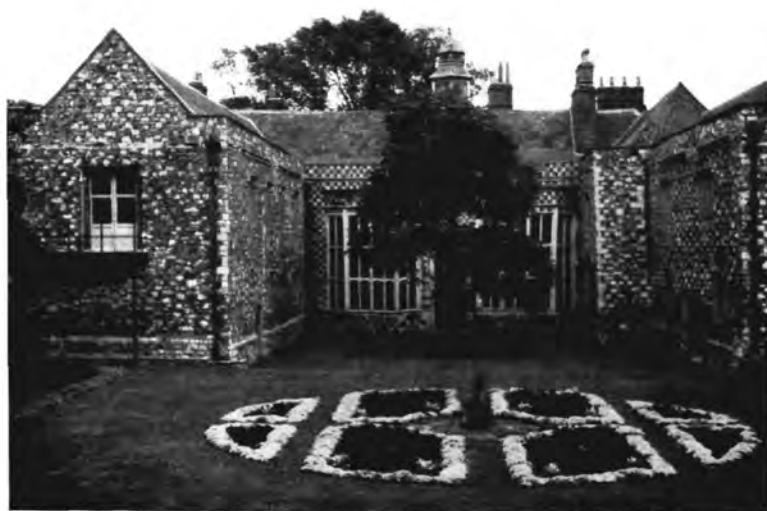
The North Front of the Tudor building.
