MONKS HORTON PRIORY.

BY CHARLES BAILY, ESQ., ARCHITECT.

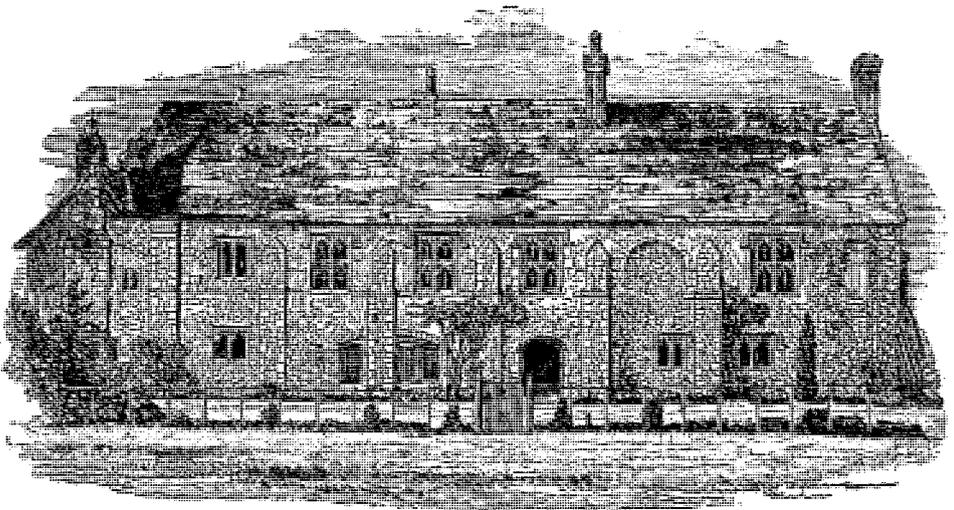
Fig. 1. HORTON PRIORY (WEST FRONT.)

We will now take a view of the long western front, and here we can again trace the architecture of the old Norman building. This long façade is divided into six bays by flat pilaster-like buttresses, measuring three

feet wide by eight inches in projection; the masonry of the wall and of these piers is very plainly of the Norman date, as is also a moulded string-course along the whole length of the face of the wall, which passes round the buttresses; this string is about twelve feet above the ground level, and it is necessary here to remark that no window lights of Norman date are to be seen below the string, the windows which do appear there are fifteenth-century work. The eleventh-century masonry is continued above the Norman string-course, but a series of large and finely designed windows, five in number, have been inserted; these are very fine examples of the class of windows which were introduced in the fourteenth century into the more domestic parts of our monastic institutions. At about three feet above the lower string, on the face of the wall, we see the remains of another string, also of Norman date; this abuts against the sides of the Norman pilasters, but it has been cut away in the centre of the bays. This would be done when the large windows were inserted, and it would appear that the pedimental heads of the buttress pilasters were introduced at the same time.

Here a question arises; it is this: Did the original building, as erected by the Norman founder, consist of more than one story in height? As there is no appearance of anything like Norman window openings below the lower string-course, and as there is no approach by stairs of Norman date, in a turret, nor in the thickness of the wall, we may say that this western range of the Priory was a one-story building. Such an arrangement was very usual with our Norman builders, as we see at Dover to the present time.

Before the large fourteenth-century windows were

inserted, it is most probable that a row of semi-circular headed openings, one in each bay above the lower string, supplied light to the apartments, and the upper string-course was most likely carried over the arches of these windows by way of a hood-moulding or label.

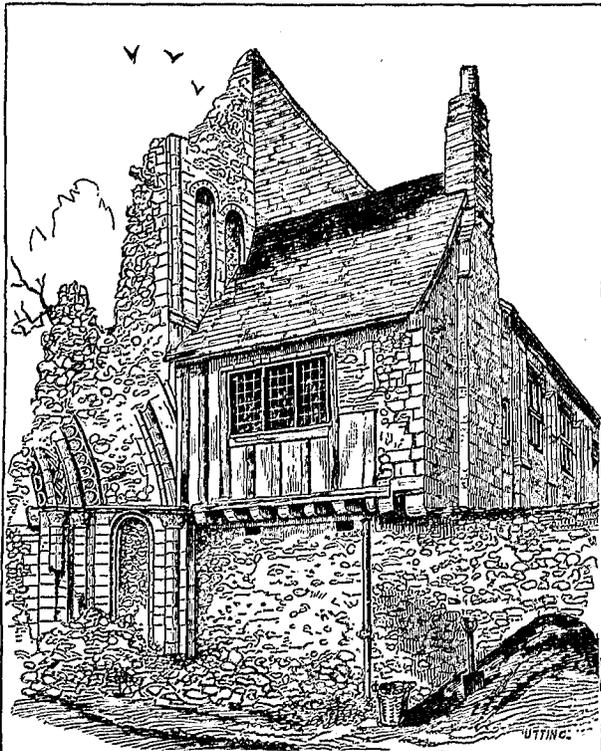
Fig. 2. RUINS OF THE WEST END OF THE CHAPEL, HORTON PRIORY.

Before viewing the interior, let us inspect the small but very beautiful remains of the western end of the chapel (fig. 2). These consist of the western end of

the south aisle of the nave, with its western window, and some Norman niches, originally external, but now only to be seen from the interior of the modern building, at the northern end of the western range. The doubly-recessed south jamb of the great western doorway of the Chapel is all which is now left of what was once one of the finest pieces of Norman architecture to be seen in the county of Kent. The columns, with their finely moulded and carved bases and capitals, together with the carved voussoirs of the arch of this entrance (fig. 3), cannot easily be surpassed.

The west wall of the chapel is six feet in thickness, and

the west end of the south aisle projects beyond the nave five feet.

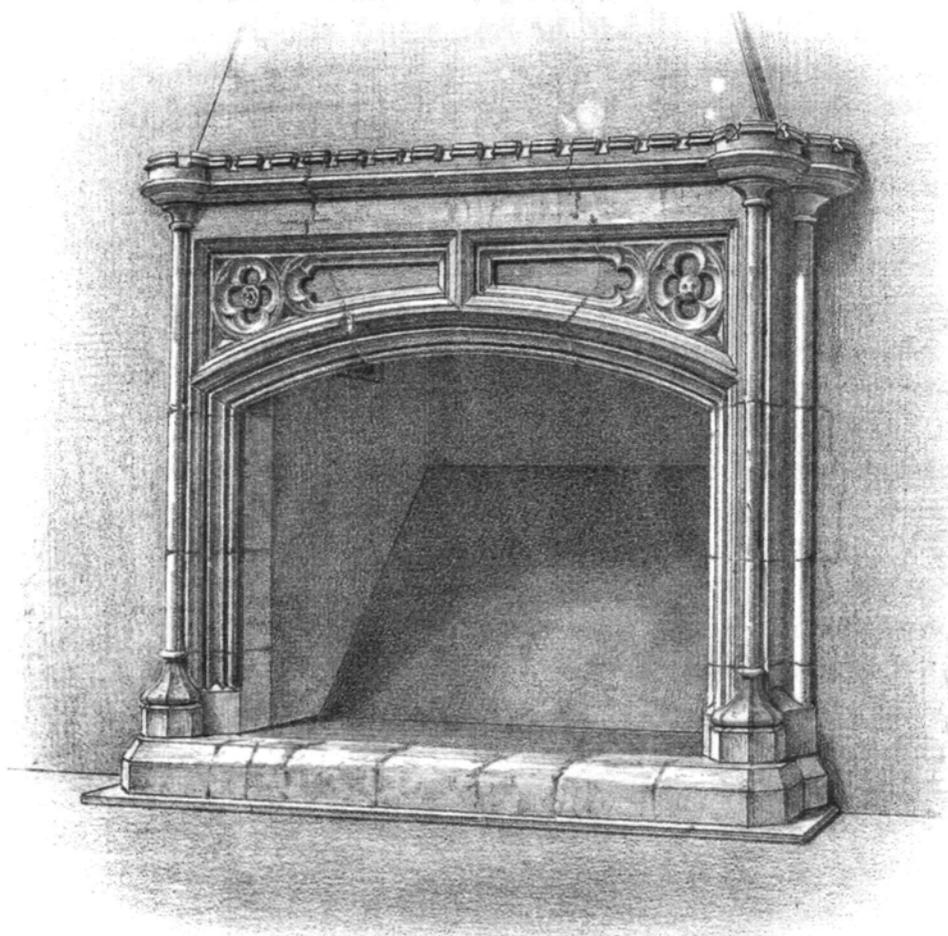
HORTON PRIORY (Fig. 4)

The most interesting portion on the upper floor is the large room on the north side of the stairs; this

is a very valuable example of fourteenth-century work, and it is even at the present day in a tolerably perfect state.

The north and south side partitions, which separate this room from the stairs and the adjoining room, are masterpieces of heavy oak framed work, very finely moulded round the plastered panels; this apartment is lighted by two of the fine fourteenth-century windows before noticed; these are two lights wide, and two lights high, with tracery in the square heads (see fig. 6, page 92). In each of the splayed jambs is a stone seat, the whole being very handsome in design. On the east side is a very fine stone chimney-piece, the corbel table of which is seen in the room below, the jambs are moulded, and the frieze is carved with fifteenth-century tracery (fig. 4). The width of the opening is five feet seven inches, and each jamb is one foot, making the total breadth seven feet seven inches; the entire height from the floor is six feet one and a-half inch, but the bottom of the stone curb, in front of the hearth, is raised one and a-half inch from the floor, so that the chimney-piece itself is just six feet high. With the exception of the paper-hangings which now cover the plastered sides of the apartment, the only original feature wanting is the old ceiling. About thirty-five years ago this was in existence, and nearly in a complete state; for some unwise reason it was taken down, and a part of it was carried away to London by an architect who was at that time employed to carry out some works—“*Restorations?*”—at the Church at Smeeth, and this gentleman at the same time carried away a finely carved poppy-head from Smeeth. It is a painful thing to notice such depredations as these,

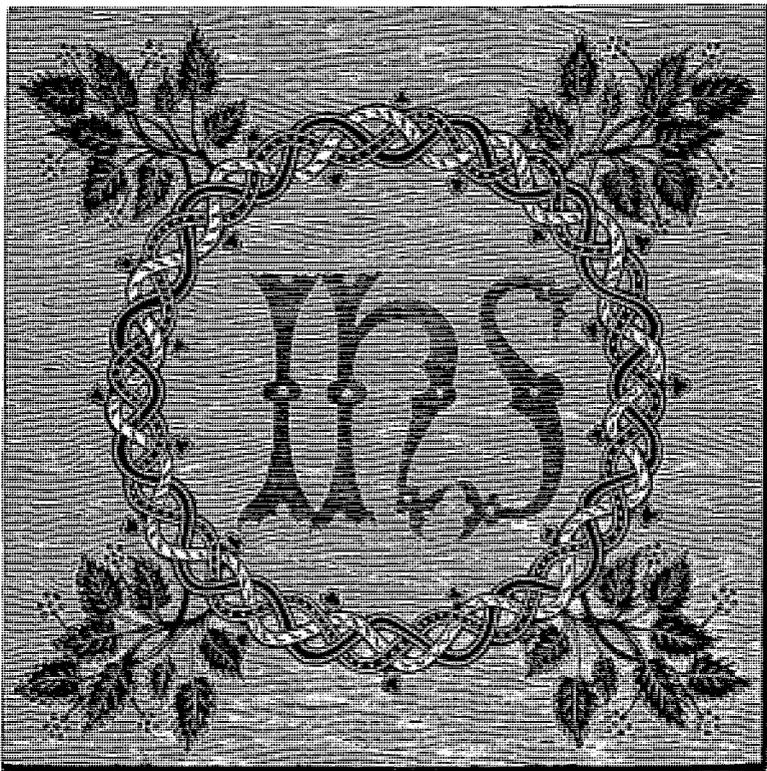
Fig. 5. PANEL OF CEILING AT HORTON PRIORY.

This ceiling was of oak ribs, dividing the whole surface into panels (fig. 5), which were boarded, and each

panel was about four feet square, and was handsomely painted, with the Crown of Thorns surrounding the sacred monogram, I.H.S. The crown was formed of three thorn branches plaited together, one was painted white with black spines, the other two were brown, edged and dotted with yellow. The sacred monogram

was in red. The timber heads of the partitions which enclose the room being cambered, shew us that the ceiling was slightly raised along the centre of the room.
