TEYNHAM CHURCH: ARCHITECTURAL  
NOTES.

BY F. C. ELLISTON ERWOOD.

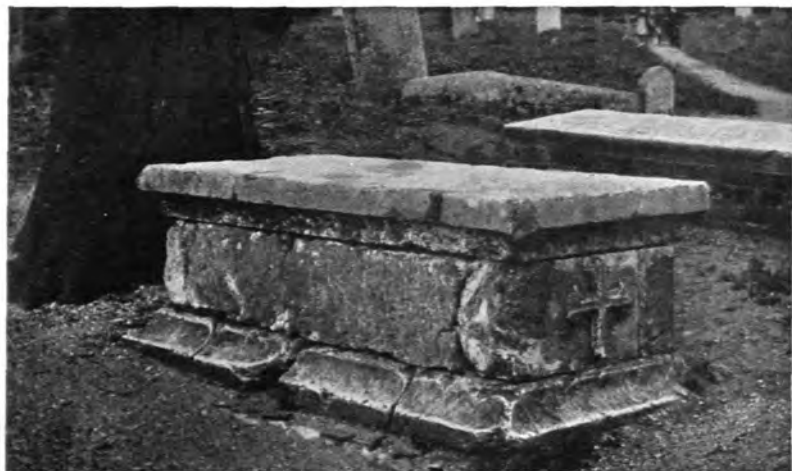
TEYNHAM CHURCH  
Tomb in the Churchyard near the West End of the Building.

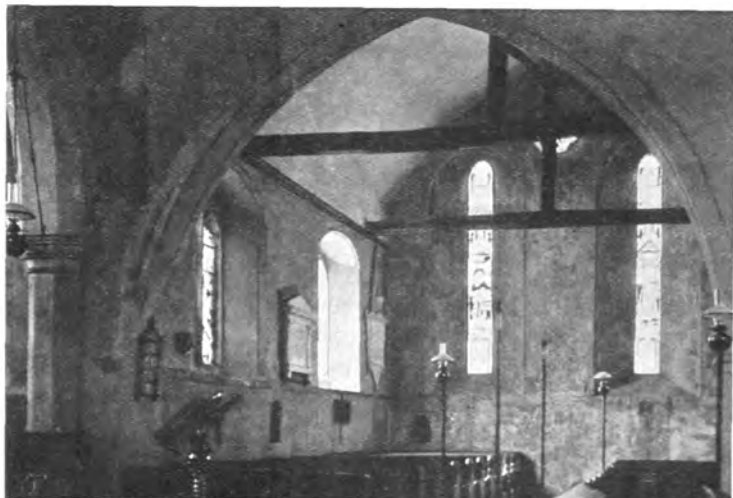
View from the Crossing into the South Transept.

The two arches at the mouths of the transepts are of the thirteenth century, though they shew signs of reconstruction, and there are indications that the eastern arm of each arch sprang originally from a respond, instead of rising weakly, as now, from a flat wall, without any sense of support. On the west, each arch rises from a simply moulded abacus.

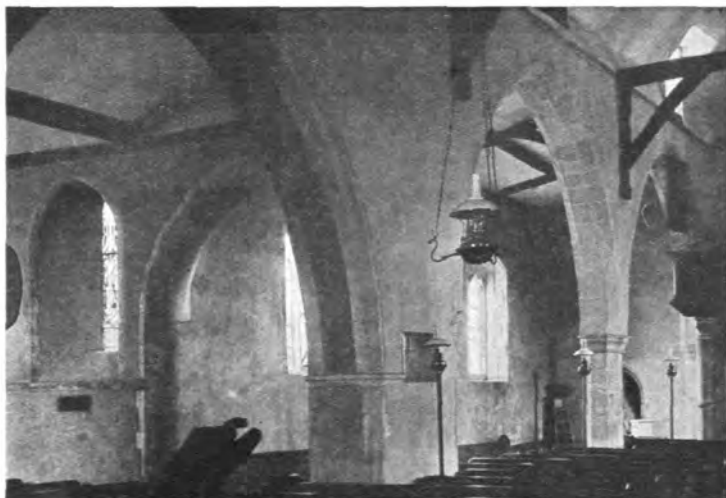
South Arcade and Aisle of the Nave, looking South-West.

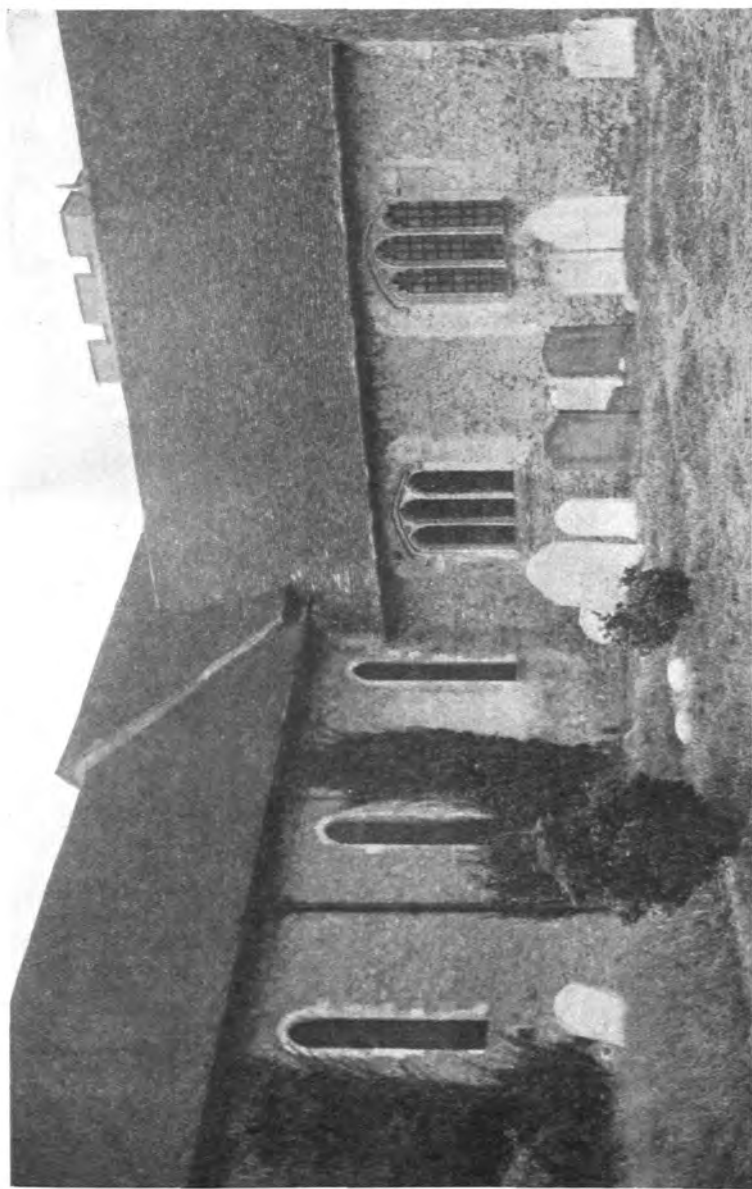
Exterior from the north-east, showing traces of Lancelot Windows in the North Arm of the Transept.

lancets have been removed and fifteenth-century three-light windows have taken their place, though on the north the original stonework of the thirteenth-century windows is apparent. The corresponding wall on the south is covered with ivy. The west wall of the south transept is complete, while the similar wall of the north transept has lost one lancet. The gable walls retain their original arrangement, though in almost every case the stonework is in a very bad condition, either almost weathered away or else clumsily patched with cement. The walls of both transepts are noteworthy for the variety of the material employed, Roman brick being especially plentiful.
