A MEDIEVAL HALL-HOUSE AT NORTH CRAY

By P. J. TESTER, F.S.A.

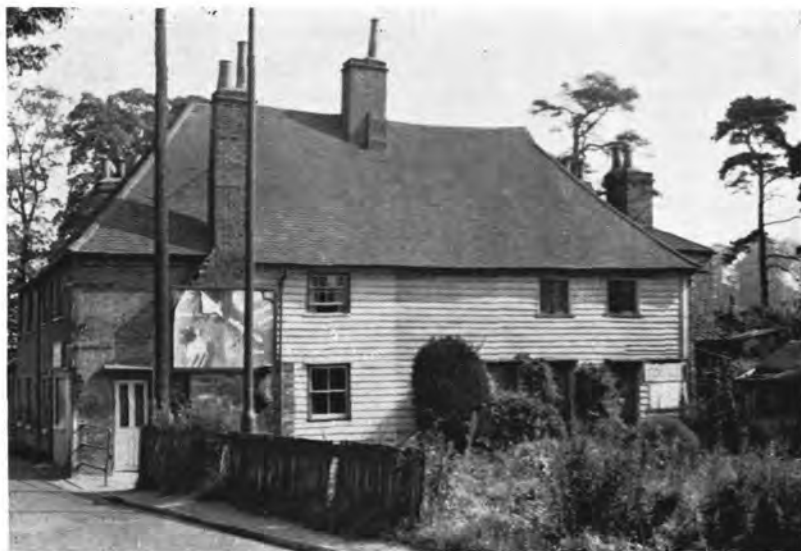
A. North Cray Hall-house viewed from North-west, 1967.

As may be seen in the accompanying photograph (Pl. IA), there was little in its latter external appearance to suggest its antiquity or architectural interest, the sides being weather-boarded and the ends partially renewed in brickwork. The part nearest the road served as a grocer's shop and the rest was divided into two cottages. When the local authority purchased the place for demolition in 1967, I obtained permission to examine the interior and was rewarded by discovering, above the attic ceilings, the heavily soot-encrusted rafters of a medieval crown-post roof. In the following months, I was able, with the help of some friends and the full support of Bexley Council, to strip-out the interior and reveal and record the features of interest. Considerable public interest was shown in what was brought to light, and the Council undertook the expense of careful dismantling in order that the house could be rebuilt elsewhere as a place of historic interest. Their subsequent unwillingness to provide the funds necessary to complete the project caused disappointment to those whose voluntary labours had been responsible for the discovery.

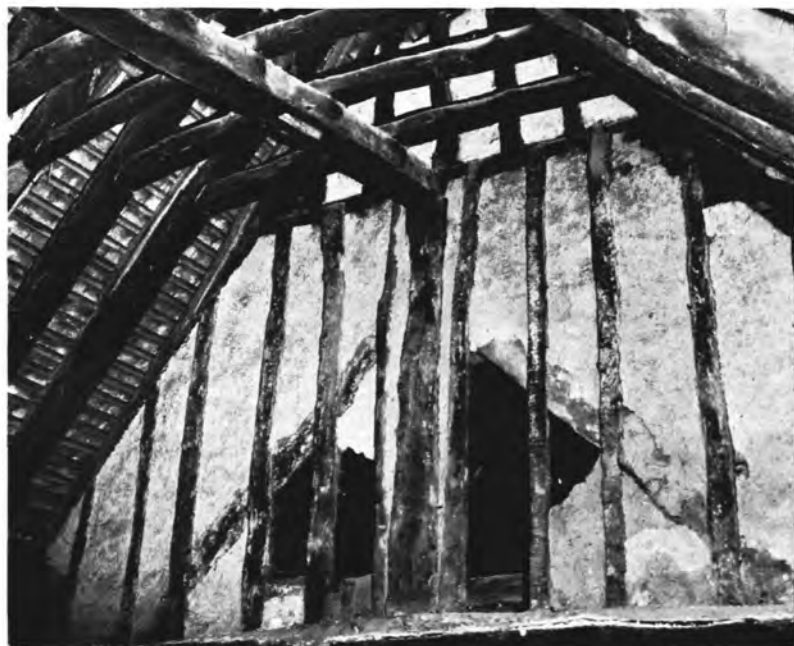
B. Upper part of North-west side of Partition between Hall and Room above Service.

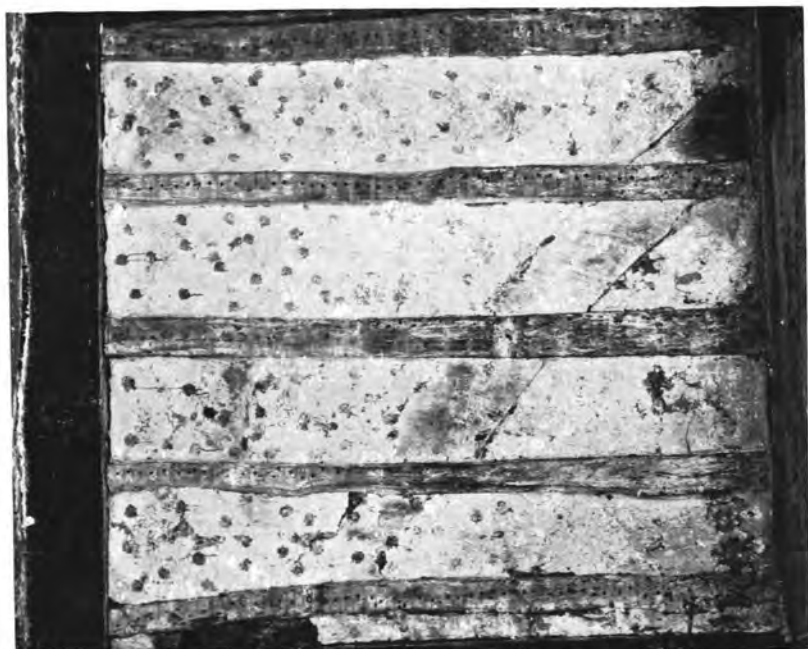
B. Decoration on lime-washed Daub Filling between Studs in lower half of Partition shown in Plate 1B.

Original daub filling of the frame in all external walls had been almost entirely removed but it remained in the internal partitions and consisted of brown clay liberally mixed with chopped straw. The surfaces were thinly plastered and lime-washed. In the room over the service some decoration remained in the form of red spots crudely applied to the lime-washed surface (Pl. IIB). This suggests that the room was at one time used as more than a storage loft, despite its inconvenient access, a conclusion supported by evidence of attempts to exclude smoke entering from the hall, as previously described.

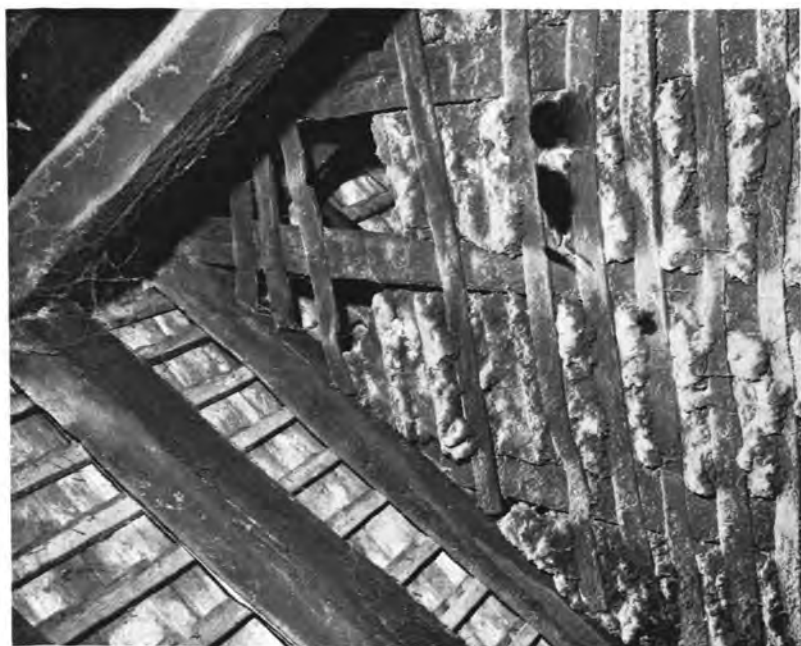
A. Space above Collar on line of Service Truss, showing Daub Filling unsmoothed towards Hall.

Both end bays were closed from the hall by stud-and-daub partitions extensively blackened on their faces towards the hall. In the first phase of occupation, the smoke from the hall fire escaped from the gablets at each end of the roof. At the north-west end the triangular space above the collar of the truss between hall and service was left open so that smoke could enter the upper part of the room above the service and so make its way out through the gablet. Later, this space above the collar was lathed across and daub applied from the service side, this being more readily accessible, the daub being left unsmoothed towards the hall where it became soot-encrusted like the older parts of the partition (Pl. IIA). From that time the only smoke outlet was presumably the gablet at the south-east end. Smoke-staining on the rafters over the solar was very pronounced and can be explained by assuming that smoke penetrated to the upper level from the hall through the opening for the solar stair. As the gablet at this end was on the line of the solar truss, smoke could escape directly without entering the solar, in contrast to the arrangement at the service end previously described.
