INTERIM REPORT ON WORK IN 1983 BY THE CANTERBURY ARCHAEOLOGICAL TRUST

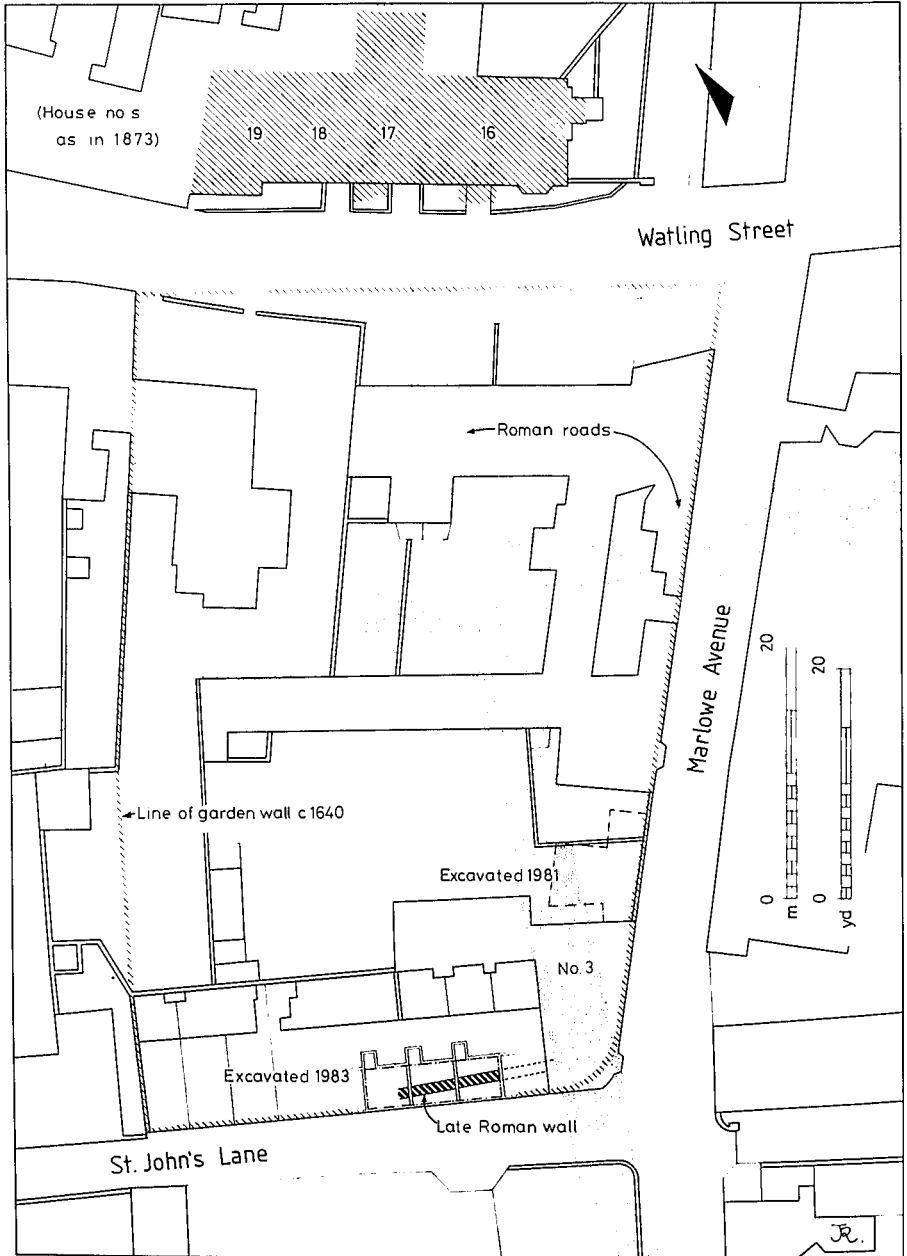
Fig. 1. St. John's Lane and Marlowe Avenue Sites showing Roman streets and the Line of the seventeenth-century Garden Boundary Wall of 16 Watling Street.

Following the excavation next to 3 Marlowe Avenue in 1981,³ excavations in advance of redevelopment took place on the same site but adjacent to St. John's Lane in July 1983, about 14 m. to the west of the original dig (Fig. 1). The excavation⁴ was confined to three half-cellars belonging to a row of early nineteenth-century cottages which were demolished in the late 1960s.

but it is probable that the wall turned to the south at this point. No conclusive date for the wall was obtained, but it was almost certainly of late Roman construction. A *terminus ante quem* of possibly the late fourth century was provided by a pit that cut the west end of the foundation. The wall was also perpendicular to the Roman Street, and therefore probably represented part of a building fronting onto it (Fig. 1).

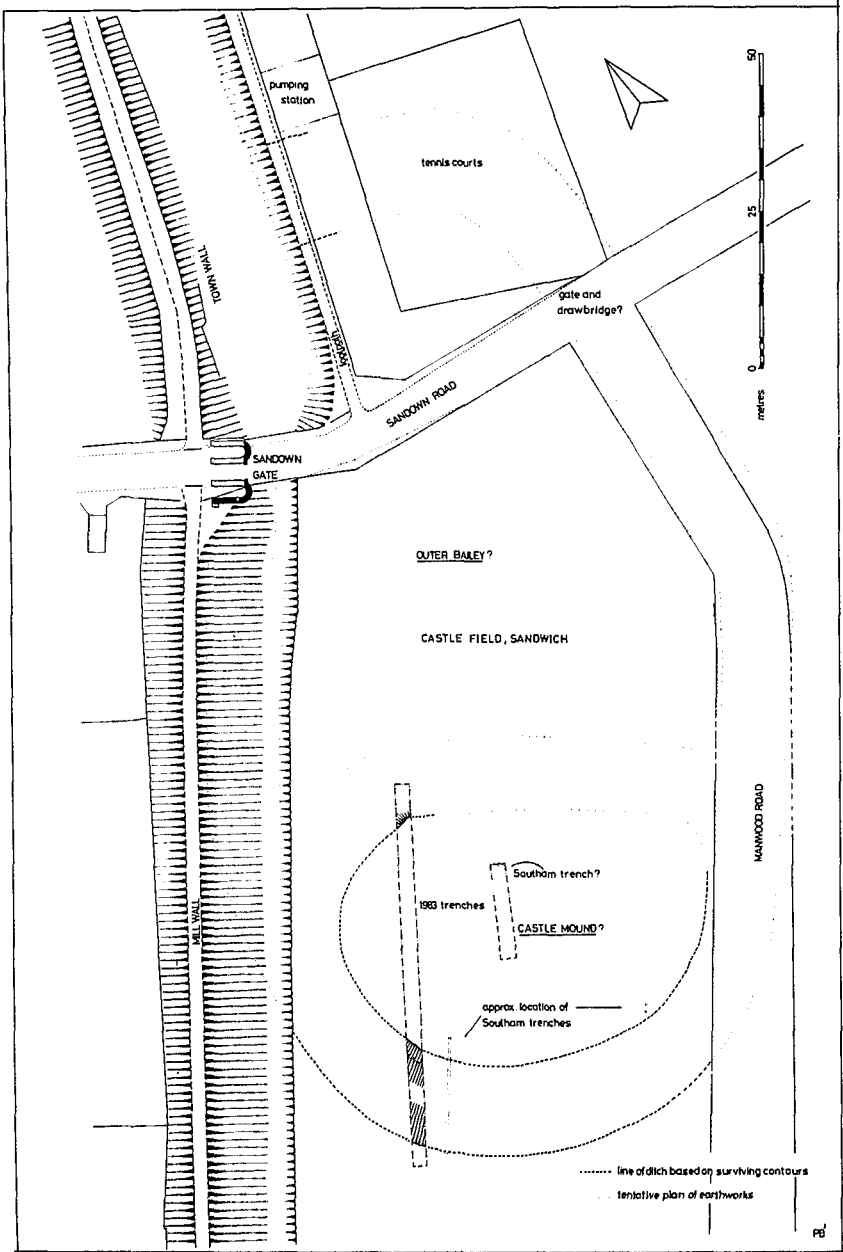
Fig. 2. Sandwich Castle.

Cutting the early levels at the south end of trench II was a massive ditch, approximately 14.25 m. wide and 4.5 m. deep. The ditch, on a curving alignment, conformed precisely with the depression surviving in the field. A second ditch located some 35.50 m. north of the first and also on a curving alignment, indicated the north side of the earthwork. This ditch was only partially excavated, but appeared to be of considerable depth and width. The upcast from the cutting of the earthwork was probably thrown up inside the area defined by the ditches (sealing the topsoil deposits) to create a substantial mound. The ditches may have continued under the line of Manwood Road on the east and the later town ditch on the west making the east and west sides of a bailey enclosure. A well-defined dip in the footpath north-west of the tennis courts (north of the Sandown road) (Fig. 2) may well indicate the north side of the defensive circuit. The drawbridge mentioned in the building work undertaken at the castle in 1384-85 may have existed just outside the north-east corner of castle field at the point where Manwood Road joins the Sandown road. Overall, the shape of this defensive earthwork suggests that Sandwich Castle was of motte-and-bailey type. No trace of a masonry or timber structures was found during the excavations, though the documentary evidence suggests the presence of some substantial buildings. The exact nature of the structure capping the mound may perhaps be found in further larger-scale excavation.

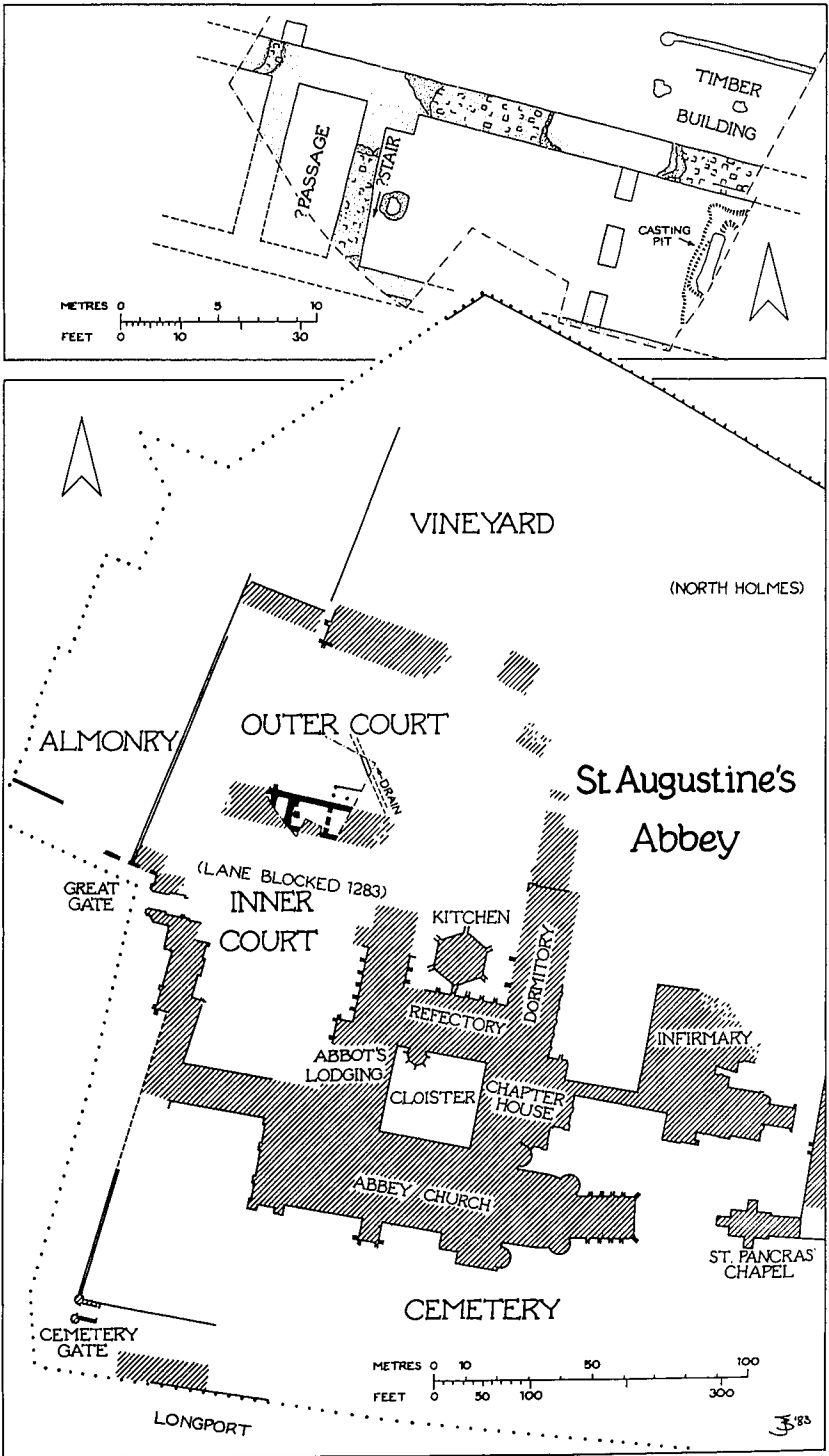
Fig. 3. St. Augustine's Abbey, showing the newly excavated Building (inset).

Only the rammed chalk foundations and poured mortar sub-foundations of the building survived and even this together with the construction levels were heavily bulldozed before cleaning and recording could begin. The main north and south walls of the range were uncovered (Fig. 3), indicating an external building width of 9.15 m. Two transverse walls set 3.66 m. apart may indicate the position of a through-passage or gateway. A single external buttress was located opposite the western cross-wall. An internal pier base, capped by a large greensand block, and a corresponding fattening of the main north wall foundation east of the parallel walls, may indicate the position of a staircase entered from the north leading up to the first floor. A third internal wall to the east consisting of three independent foundations perhaps suggested the existence of two major internal doors at undercroft level. The undercroft would have presumably contained the cellarer's stores, The principal floor may have been divided into a hall and other services for guests. The remains of a timber building, defined by a single sleeper-beam foundation trench, a number of internal post-holes and an extensive sequence of internal floors, were located immediately north of and adjoining the masonry building. Metallings associated with the outer courtyard surfaces were also located 'in section' after the machine clearance of the site.
