THE SOUTHERN DEFENCES OF MEDIEVAL ROCHESTER

COLIN FLIGHT, M.A., and A.C. HARRISON, B.A., F.S.A.

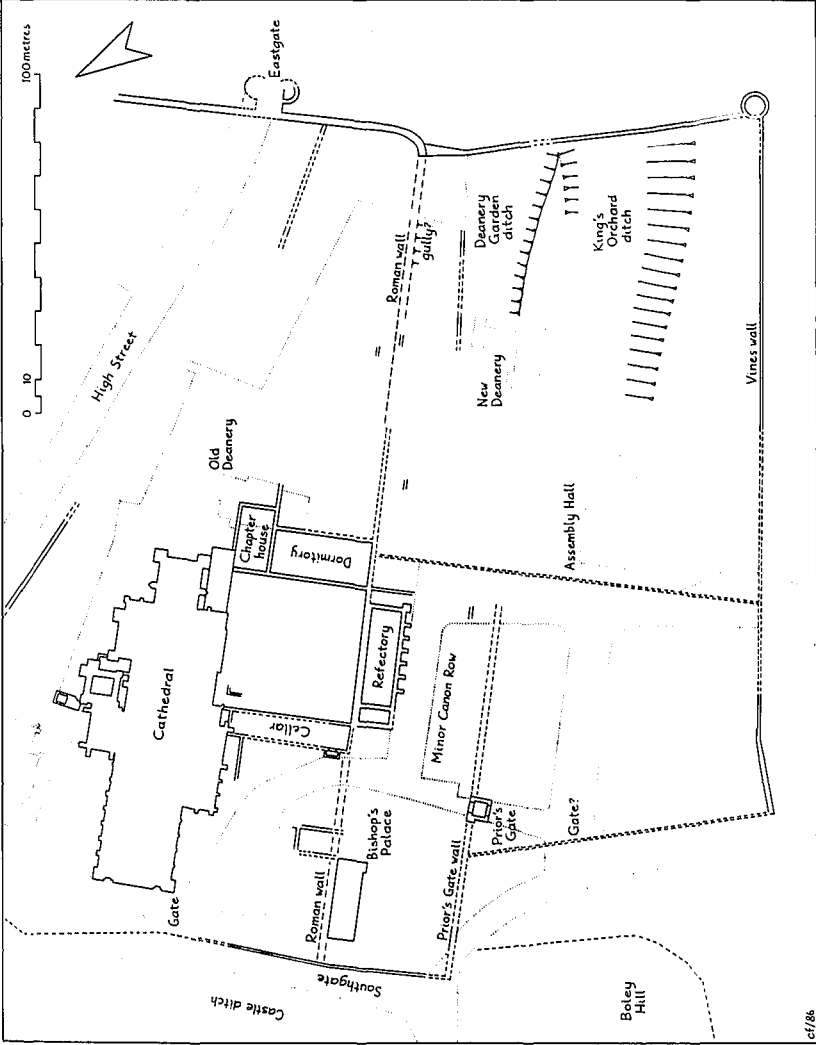
Fig. 1. Rochester: The south-east Quarter of the medieval City.

The principal features for which we need to find room in any interpretation are shown in the plan (Fig. 1). For the purposes of this discussion, it will be understood that we have had to refer to the medieval features by names which are merely descriptive, in order

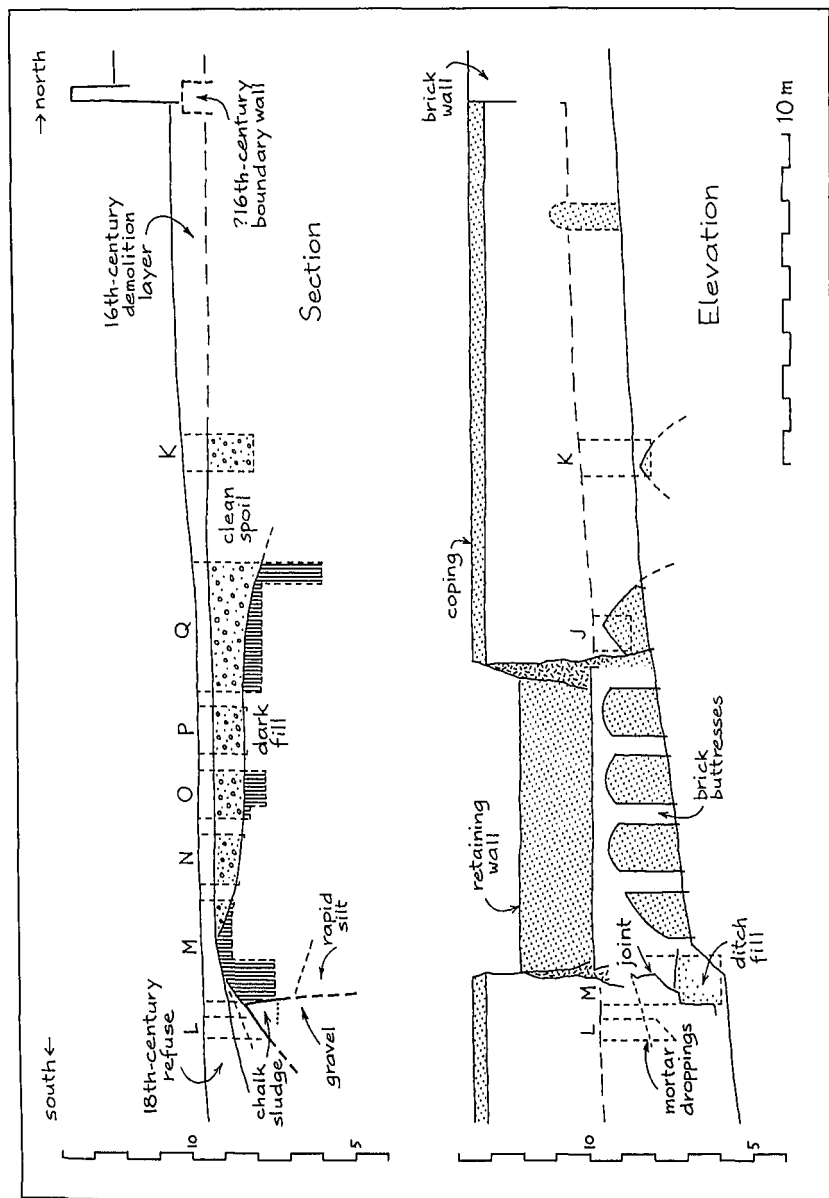
Fig. 2. Above: A Section through the Filling of the Deanery Garden Ditch, with the inner slope of the King's Orchard ditch to the south. Below: An Elevation View of the City Wall, from the outside, showing also some of the features revealed by excavation internally. (For the location of cuttings J-Q, see the plan in *Arch. Cant.*, lxxxiii (1968), facing p. 57.)

From these sections, it is clear that the profile of the ditch had become very considerably degraded, even before it was filled with sand and gravel. Little was found in any of these deposits. The most significant item is a single sherd, of twelfth- or early thirteenth-century date, from the layer of dark silt in cutting M.⁴⁹

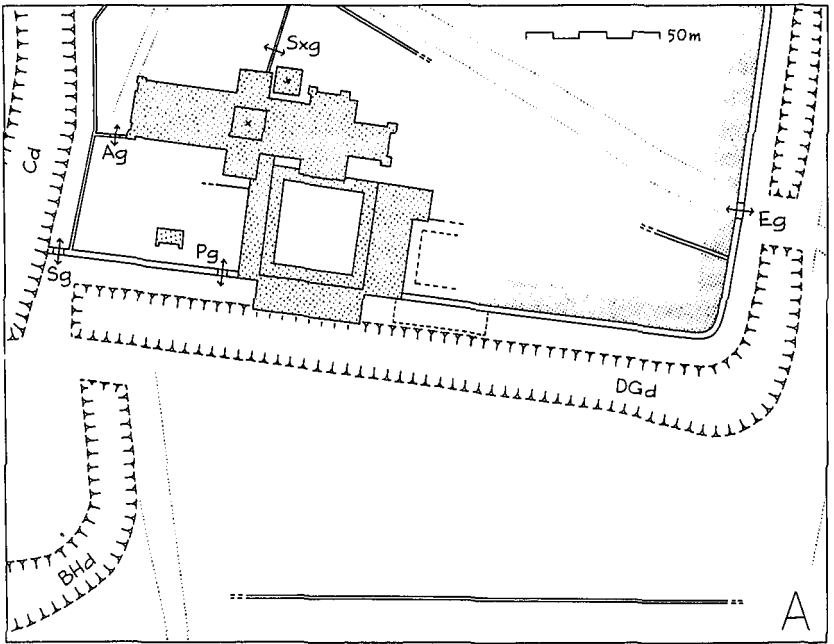
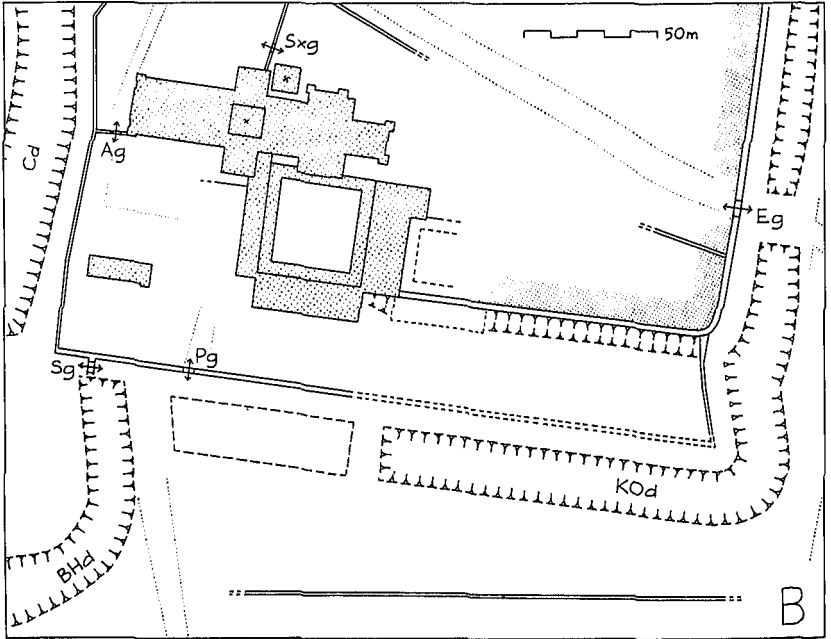
Fig. 3. Hypothetical Plans showing the State of the Defences on the South Side of the City, after 1225, according to scenarios A and B, respectively. Cd = Castle ditch. DGd = Deanery Garden ditch (A only), BHd = Boley Hill ditch, KOd = King's Orchard ditch (B only). Sg = Southgate (alternative sites), Pg = Prior's Gate (alternative sites), Ag = Almonry gate, Sxg = Sextry gate, Eg = Eastgate

The view we used to share – the view which still seems preferable on balance to one of us – is what we speak of henceforth as scenario A. On this view, the Deanery Garden ditch is identified as part of the 'great ditch', known to have been dug in 1225. The filling of this ditch, and the digging of the King's Orchard ditch further south, are then assumed to have taken place in 1344, in accordance with a scheme for the redevelopment of the defences devised by the prior and convent (see below).

A dislocation of this chronology produces an alternative interpretation, scenario B. On this view, it is the King's Orchard ditch which was dug in 1225. The Deanery Garden ditch then has to be regarded as a feature of earlier but otherwise uncertain date, for the digging of which there is no explicit documentary evidence. Correspondingly, the scheme proposed in 1344 is assumed to have been abandoned, more or less.
